LIMITED INCIDENT INVESTIGATION REPORT
--

Reference Number		CA18/3/2/1348					
Classification	Incident	Date	13 June 2021	Time	1348Z		
Type of Operation		Private (Part 94)					
Location							
Place of Departure	Inungi farm airstrip in Kokstad, KwaZulu-Natal Province		Place of Intended Landing	Inungi farm airstrip in Kokstad, KwaZulu-Natal Province			
Place of Accident	Inungi farm airstrip in Kokstad, KwaZulu-Natal Province						
GPS Co-ordinates	Latitude	S30° 33' 03.9"	Longitude	E29° 25' 33.4"	Elevation	4 340 feet	
Aircraft Information							
Registration	ZU-TGH						
Model/Make	Jabiru J170						
Damage to Aircraft	Substantial		Total Aircraft Hours	38.9			
Pilot-in-command							
Licence Valid	Yes	Gender	Male	Age	64		
Licence Type	National Pilot Licence						
Total Hours on Type	8.1		Total Flying Hours	147.1			
People On-board	1 + 1	Injuries:	0	Fatalities:	0	Other (On Ground)	0
What Happened							
<p>On Sunday, 13 June 2021, the pilot accompanied by a passenger on-board a Jabiru J170 light-sport aircraft with registration ZU-TGH were on a private flight from Inungi farm airstrip in Kokstad, KwaZulu-Natal Province, with the intention to return to the same airstrip. The flight was c

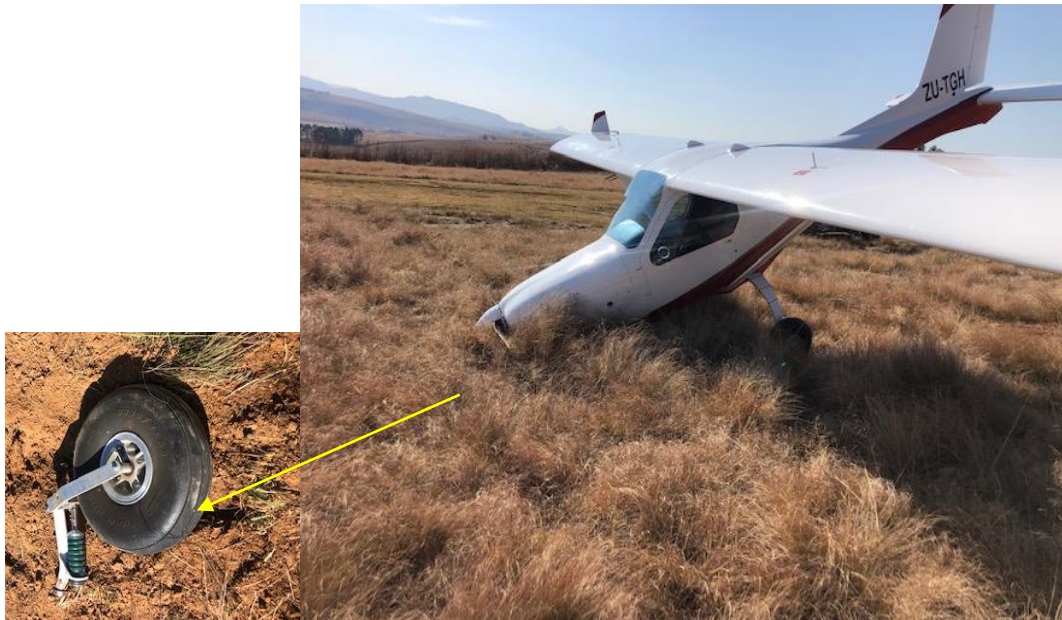
a ditch. The nose gear strut broke off due to overload and the propeller blades struck the ground. The aircraft skidded for about eight metres before coming to a halt.

The pilot switched off the master before he and the passenger disembarked the aircraft. The aircraft sustained substantial damage to the nose gear strut and the propeller blades. No injuries were reported; and the pilot reported no mechanical malfunctions or failure of the steering and/or the brake system that would have prevented normal rudder pedals operation.

Figures 1 & 2: The final resting position of the aircraft (right picture); and a broken nose gear strut and wheel assembly (left picture). (Source: Pilot)

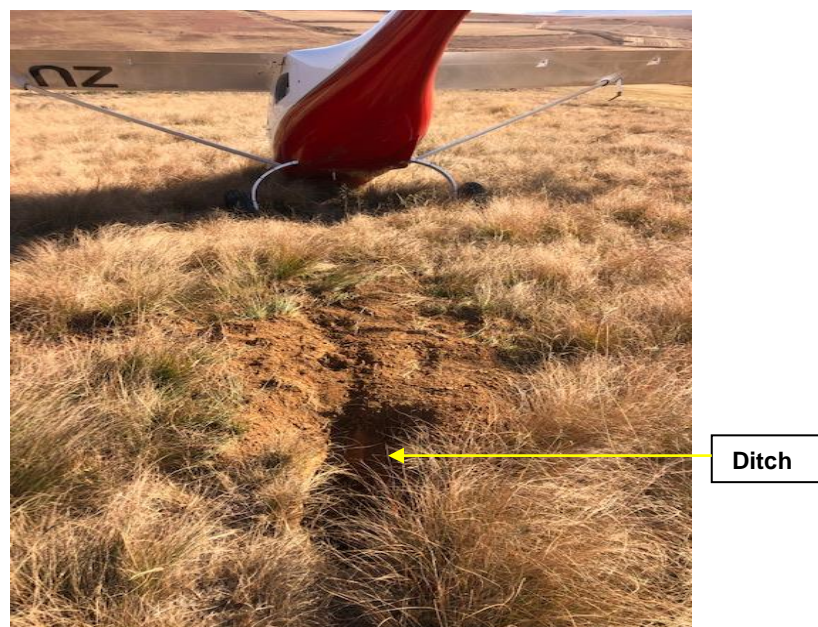
Figure 3: The rear side picture of the aircraft and the ditch that the nose wheel ran over. (Source: Pilot)

The cause of the incident was due to the pilot losing directional control of the aircraft during the

landing roll, resulting in the aircraft veering off to the left of Runway 34.
Safety Action/s
None.
Safety Message and/or Safety Recommendation/s
None.
Purpose of the Investigation
<i>In terms of Regulation 12.03.1 of the Civil Aviation Regulations (CAR) 2011, this report was compiled in the interest of the promotion of aviation safety and the reduction of the risk of aviation accidents or incidents and not to apportion blame or liability.</i>
About this Report
<i>Decisions regarding whether to investigate, and the scope of an investigation are based on many factors, including the level of safety benefit likely to be obtained from an investigation. For this occurrence, no investigation has been conducted, and the Accident and Incident Investigations Division (AIID) has relied on the information submitted by the affected person/s and organisation/s to compile this brief report. The report has been compiled using information supplied in the initial notification, as well as follow-up information to bring awareness of potential safety issues to the industry in respect of this occurrence, as well as possible safety action/s that the industry might want to consider in preventing a recurrence of a similar accident.</i>
