LIMITED SERIOUS INCIDENT INVESTIGATION REPORT

Reference Number	CA18/3/2/1349						
Classification	Serious Incident	Date	11 June 2021	Time	1100Z		
Type of Operation	Private (Part 91)						
Location							
Place of Departure	Kagga Kamma private airstrip, Western Cape Province		Place of Intended Landing	Robertson Airfield (FARS), Western Cape Province			
Place of Occurrence	Kagga Kamma private airstrip						
GPS Co-ordinates	Latitude	S 32°44'03"	Longitude	E 019°32'28"	Elevation	3494 ft	
Aircraft Information							
Registration	ZS-PLU						
Model/Make	Cessna C152						
Damage to Aircraft	Minor		Total Aircraft Hours	11145.2			
Pilot-in-command							
Licence Type	Private Pilot Licence		Gender	Male	Age	63	
Licence Valid	Yes						
Total Hours on Type	91		Total Flying Hours	91			
People On-board	1 + 1	Injuries	0	Fatalities	0	Other (On ground)	0
What Happened							
<p>On Friday 11 June 2021, the pilot accompanied by a passenger on-board a Cessna C152 aircraft with registration ZS-PLU was taxiing towards the holding point of Runway 36 at Kagga Kamma private airstrip, with the intention to conduct a private flight to Robertson Airfield (FARS). The flight was to be conducted under Visual Fli

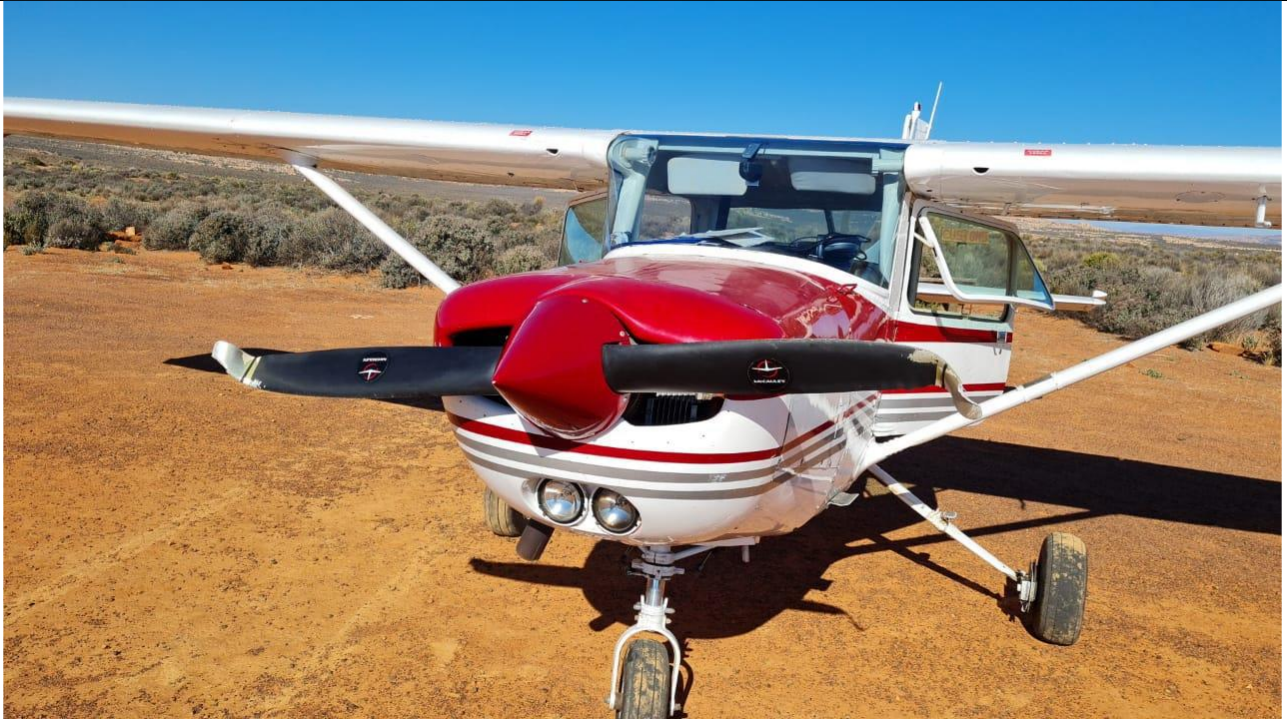
Figure 1: The aircraft at the parking bay with damage to the propeller. (Source: Pilot)

The pilot used a large stone as a chock and failed to remove it before commencing his flight.

1. Pilots are encouraged to always conduct a thorough safety pre-flight inspection to ensure that the area around the aircraft is clear of any obstacles before each flight.
2. Pilots and owners are urged to use equipment supplied by the manufacturer in securing the aircraft and to ensure the removal, thereof, before commencing with flight; as well as observing the environment in which the aircraft is parked.
