<b>LIMITED SERIOUS INCIDENT INVESTIGATION REPORT</b>
--

<b>Reference Number</b>		CA18/3/2/1350						
<b>Classification</b>	Serious Incident	<b>Date</b>	27 June 2021		<b>Time</b>	0647Z		
<b>Type of Operation</b>		Training (Part 141)						
<b>Location</b>								
Place of Departure		Port Alfred Aerodrome (FAPA), Eastern Cape Province		Place of Intended Landing		Port Alfred Aerodrome (FAPA), Eastern Cape Province		
Place of Occurrence		On a field close to R72 road, about 2 nautical miles (nm) north-east of Kenton on Sea, Eastern Cape Province						
GPS Co-ordinates		Latitude	S33° 66' 07.09"	Longitude	E26°54' .15.31"	Elevation	300 feet	
<b>Aircraft Information</b>								
Registration		ZS-ISU						
Model/Make		Piper PA-28-180 Cherokee						
Damage to Aircraft		Minor		Total Aircraft Hours		2422.2		
<b>Pilot-in-command</b>								
Licence Valid		Yes	Gender		Male	Age	22	
Licence Type		Commercial Pilot Licence (CPL)						
Total Hours on Type		520.3		Total Flying Hours		635.2

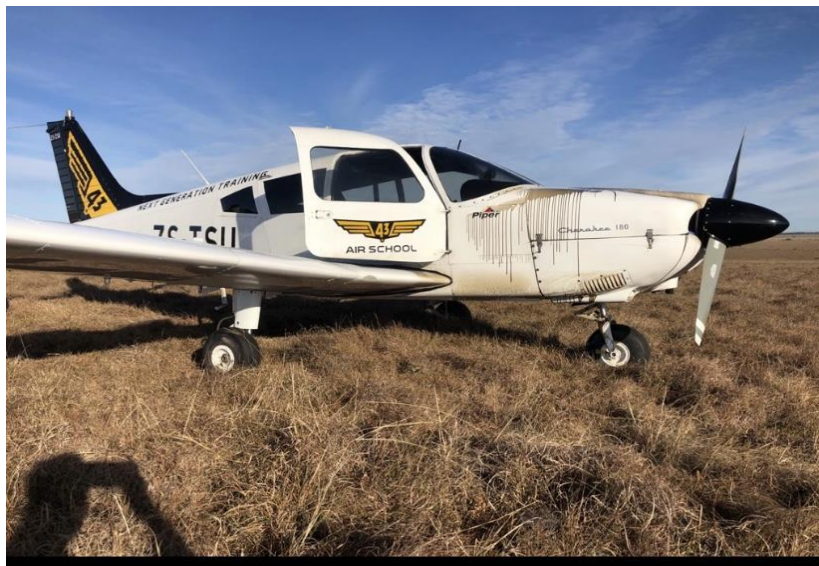
**Figure 1:** The aircraft at the accident site with oil streaking down the side of the engine cowling. (Source: Operator)

After the aircraft landed, oil was observed dripping from the engine cowlings. The flight lasted about 30 minutes. The aircraft sustained minor damages and no persons were injured. Examination of the engine at the incident site indicated that the No.3 connecting rod had detached from the crankshaft journal, the connecting rod had suffered severe impact damage, and the upper left part of the crankcase had a hole of an approximate 6 x 8 inches on it.

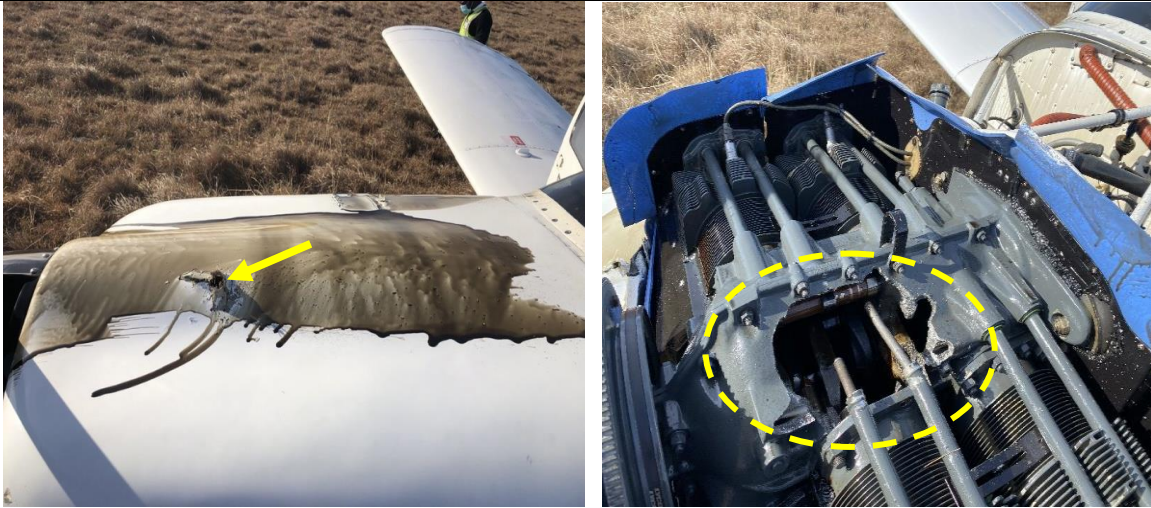
**Figures 2 and 3:** Damage on the engine top cowling (left picture). Damage on the upper left part of the crankcase (right picture). (Source: Operator)

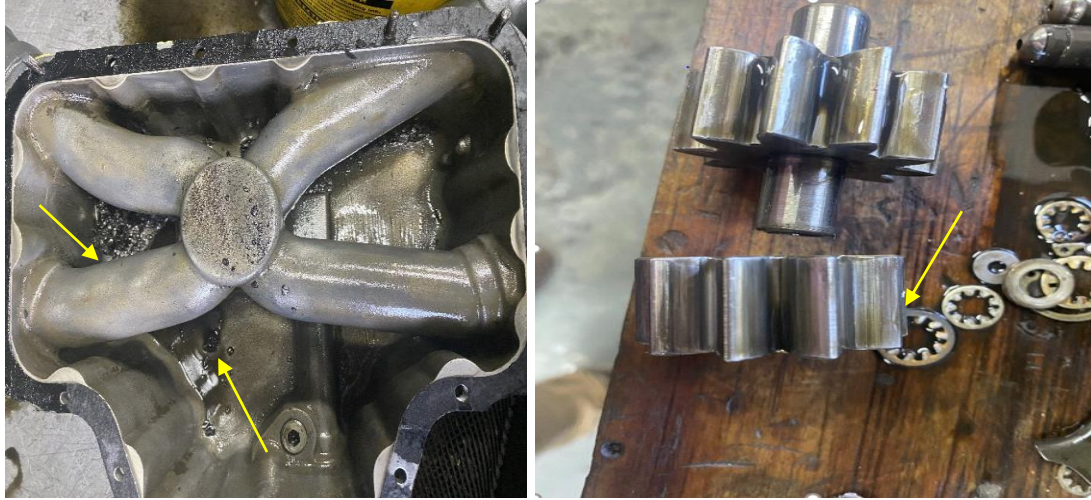
- I. The engine sump and the oil filter were removed and found to contain a large number of metallic debris.

- II. A substantial amount of engine oil had escaped through the hole on the upper left part of the crankcase. The oil pump was inspected and its components were found to be in good condition, with minor damage on the gear teeth. The pump did not show any signs of having been operated without oil.

**Figures 4 and 5:** The oil sump indicating the presence of metal debris (left picture). The oil pump gear teeth indicating minor damage (right picture). (Source: Operator)

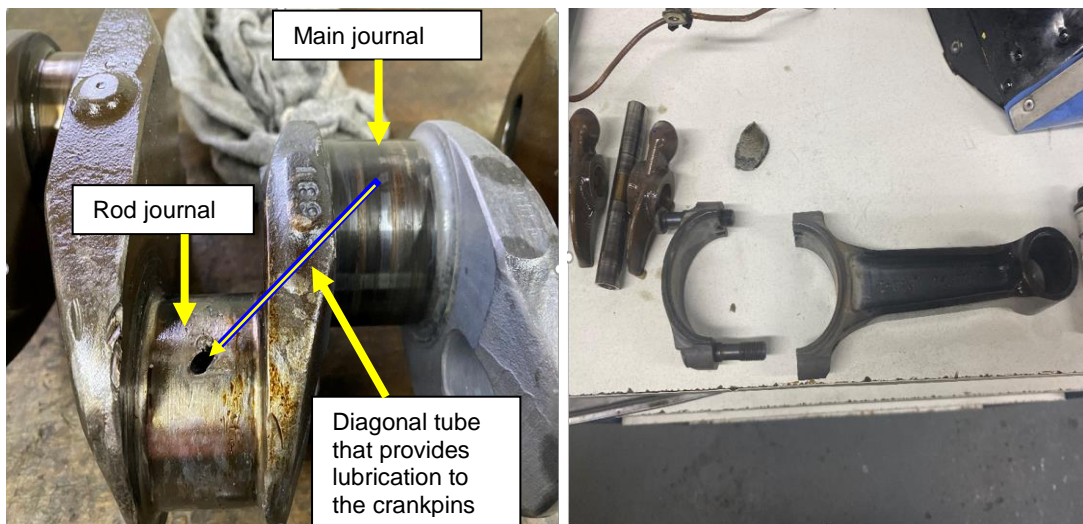
- III. Examination of the engine crankcase halves indicated that the bearing shells were firmly locked into their respective saddles and that all three main bearings were firmly in their seats and did not shift, meaning that each main bearing shell oil supply hole had lined up with its respective oil passage in the saddle.
- IV. Numbers 1, 2 and 4 main crankcase bearings and journals indicated no signs of wear or damage.

**Figures 6 and 7:** Damage (rubbing) on No. 3 main bearing and the connecting rod journal (left picture). The No. 3 connecting rod that separated (right picture).

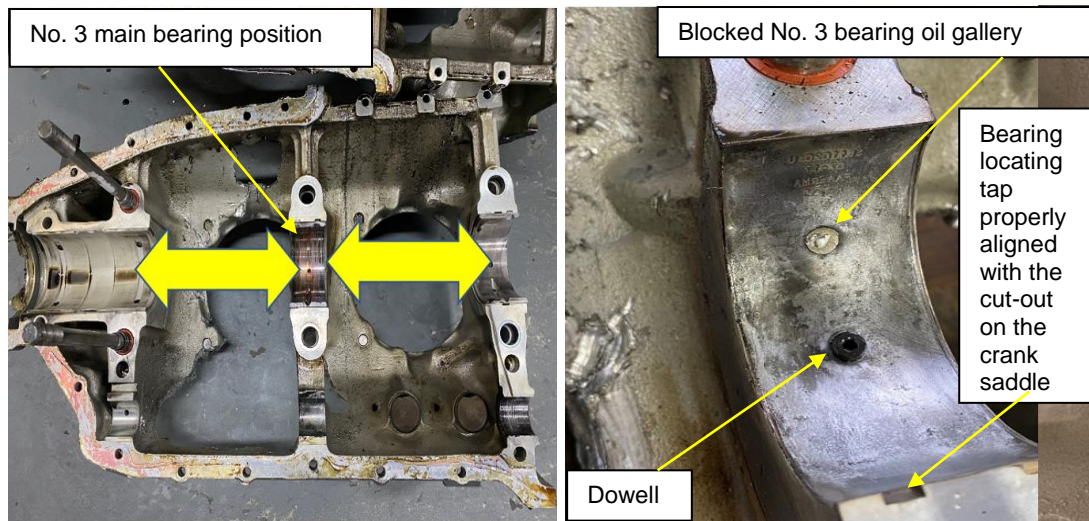
- V. The accessory drive of the engine indicated no signs of damage.
- VI. No. 3 main bearing (main journal) overheated due to lack of lubrication caused by a blocked main bearing oil gallery.

**Figures 8 and 9:** The crankcase half showing excessive heat damage on the No. 3 (centre) main bearing (left picture). The No 3 main bearing showing a blocked oil gallery, a bearing locating tap and a dowell (right picture).

The investigation concluded that a blocked main bearing oil gallery which was supposed to supply the No. 3 connecting rod connecting journal (main and big end bearings) with oil caused the No.3 connecting rod to overheat from excessive heat emanating from lack of hydrodynamic lubrication. The blockage of the oil gallery on the No.3 main bearing was caused by unexplained foreign particles or contaminants which found their way into the lubrication gap between the main bearing and crankshaft. This subsequently created metal-to-metal contact, thus, causing the metal to expand, either compressing the aluminium of the No.3 connecting rod bearing cap or stretching the steel bolts and causing them to lose their pre-load, at which point they started backing out.
