LIMITED SERIOUS INCIDENT INVESTIGATION REPORT

Reference Number	CA18/3/2/1351						
Classification	Serious Incident	Date	2 July 2021	Time	0907Z		
Type of Operation	Training (Part 141)						
Location							
Place of Departure	Virginia Airfield (FAVG)	Place of Intended Landing	Virginia Airfield (FAVG)				
Place of Accident	Runway 05 at Virginia Airfield (FAVG) in KwaZulu-Natal, Province						
GPS Co-ordinates	Latitude	S 29° 46' 19"	Longitude	E 31° 3' 26"	Elevation	27 ft	
Aircraft Information							
Registration	ZS-FEK						
Model/Make	Piper PA-28-140						
Damage to Aircraft	Minor	Total Aircraft Hours	10 551.94				
Pilot-in-command							
Licence Valid	Yes	Gender	Female	Age	21		
Licence Type	Student Pilot Licence (Aeroplane)						
Total Hours on Type	31.5		Total Flying Hours	35.4			
People On-board	1 + 0	Injuries	0	Fatalities	0	Other (On Ground)	0
What Happened							
<p>On 2 July 2021, an instructor and a student pilot on-board a Piper Cherokee aircraft with registration ZS-FEK took off from Virginia Aerodrome (FAVG) in KwaZulu-Natal province for circuit training exercises on Runway 05. The flight was conducted under the provisions of Part 141 of the Civil Aviation Regulations (CAR)

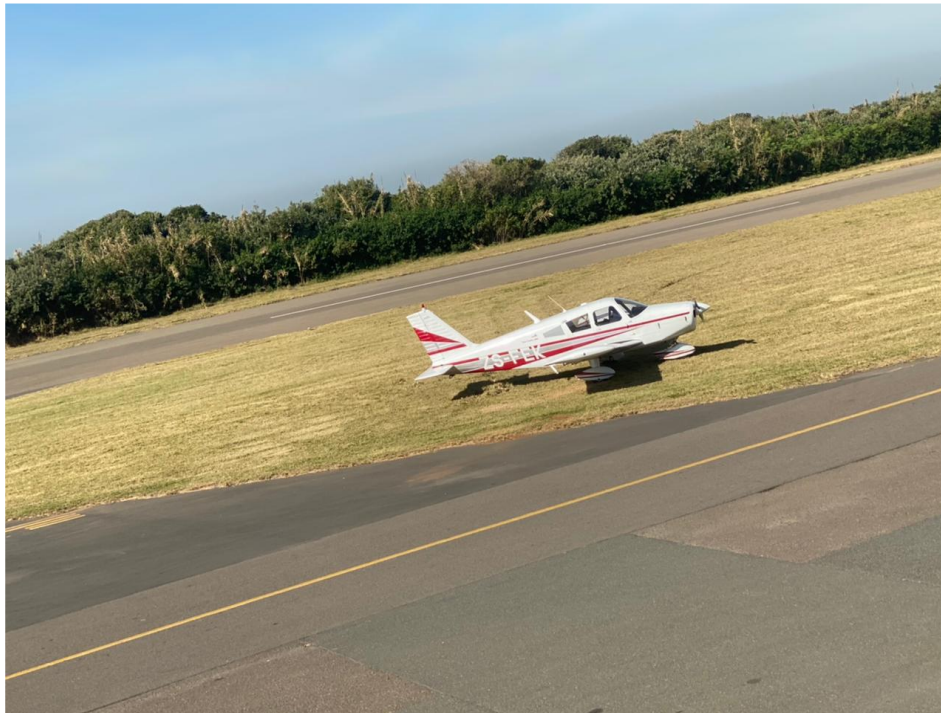
The aircraft sustained minor damage to the nose gear during the incident sequence, and the student pilot was not injured.

Figure 1: The aircraft at the accident site. (Source: Approved Training Organisation)

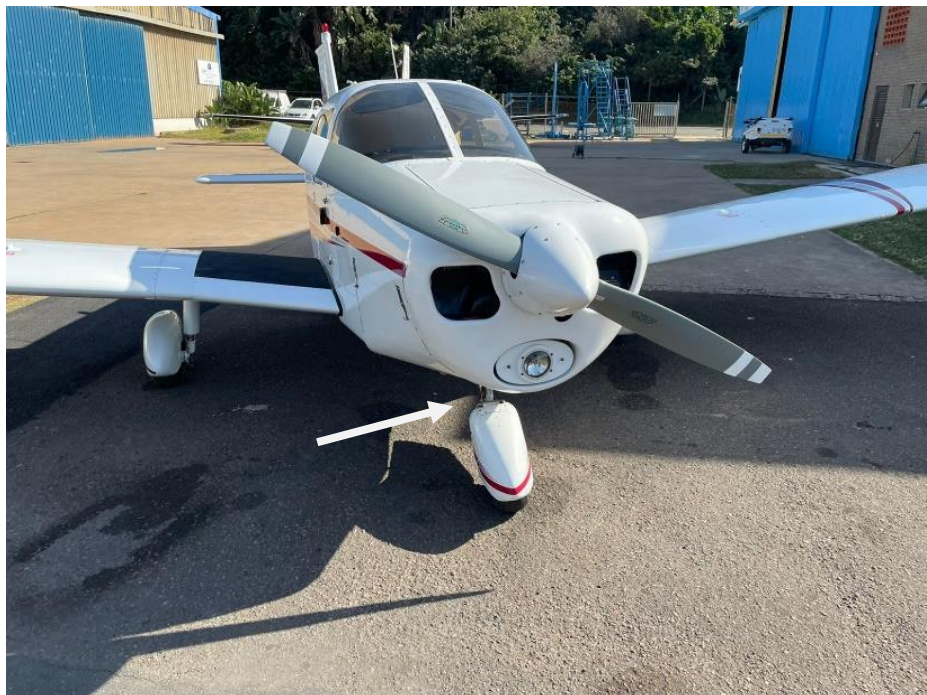
Post-incident inspection revealed no fault with the nose gear prior to the flight; the gear was damaged due to the student pilot executing incorrect technique during landing.

Figure 2: The nose landing gear post-accident. (Source: Approved Training Organisation)

It is likely that the student pilot approached the runway and touched down with the right rudder

<p>depressed, resulting in the aircraft veering off to the right-side. To correct the direction of the aircraft, the student pilot used incorrect recovery technique by applying power and, immediately thereafter, decreasing power and depressing the left rudder to steer the aircraft to the left-side, instead of just applying left rudder to steer the aircraft.</p> <p>Probable cause:</p> <p>The student pilot touched down with the right rudder applied which caused the aircraft to veer off to the right. The student pilot corrected the direction by steering to the left, however, he lost control and the aircraft veered off to the left-side of the runway.</p>
<p>Safety Action/s</p> <p>The student pilot completed a remedial flight with a Grade 2 instructor on 22 July 2021. The instructor assessed her landing technique and, later, flew for 0.7 hours before being signed off.</p>
<p>Safety Message and/or Safety Recommendation/s</p> <p>None.</p>
