**LIMITED SERIOUS INCIDENT INVESTIGATION REPORT**

<b>Reference Number</b>	CA18/3/2/1354					
<b>Classification</b>	Serious Incident	<b>Date</b>	24 July 2021	<b>Time</b>	0820Z	
<b>Type of Operation</b>	Private (Part 94)					
<b>Location</b>						
<b>Place of Departure</b>	Worcester Aerodrome (FAWC), Western Cape Province	<b>Place of Intended Landing</b>	Morning Star Aerodrome, Western Cape Province			
<b>Place of Incident</b>	Left of Runway 02 at Morning Star Aerodrome					
<b>GPS Co-ordinates</b>	<b>Latitude</b>	S 33°45'44.37"	<b>Longitude</b>	E18°32'54.69"	<b>Elevation</b>	200 ft
<b>Aircraft Information</b>						
<b>Registration</b>	ZU-FIT					
<b>Model/Make</b>	Kitfox 7					
<b>Damage to Aircraft</b>	Substantial	<b>Total Aircraft Hours</b>	1347.9			
<b>Pilot-in-command</b>						
<b>Licence Valid</b>	Yes	<b>Gender</b>	Male	<b>Age</b>	62	
<b>Licence Type</b>	Private Pilot Licence					
<b>Total Hours on Type</b>	157	<b>Total Flying Hours</b>	818			
<b>People On-board</b>	1 + 0	<b>Injuries</b>	0	<b>Fatalities</b>	0	<b>Other</b> 0

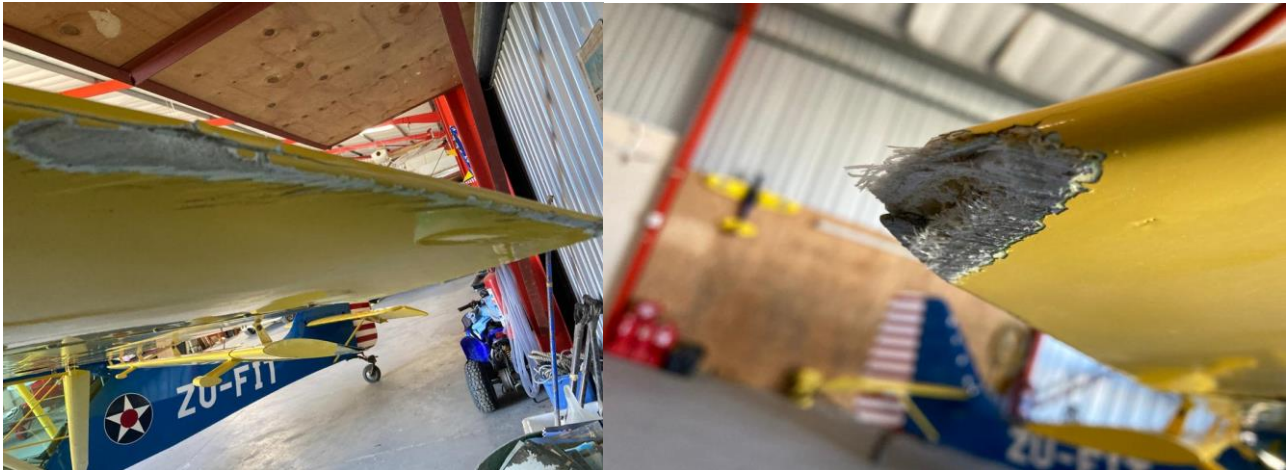
**Figure 1:** Scrape marks on the left-side wing tip. **Figure 2:** Marks on the right-side wing tip.

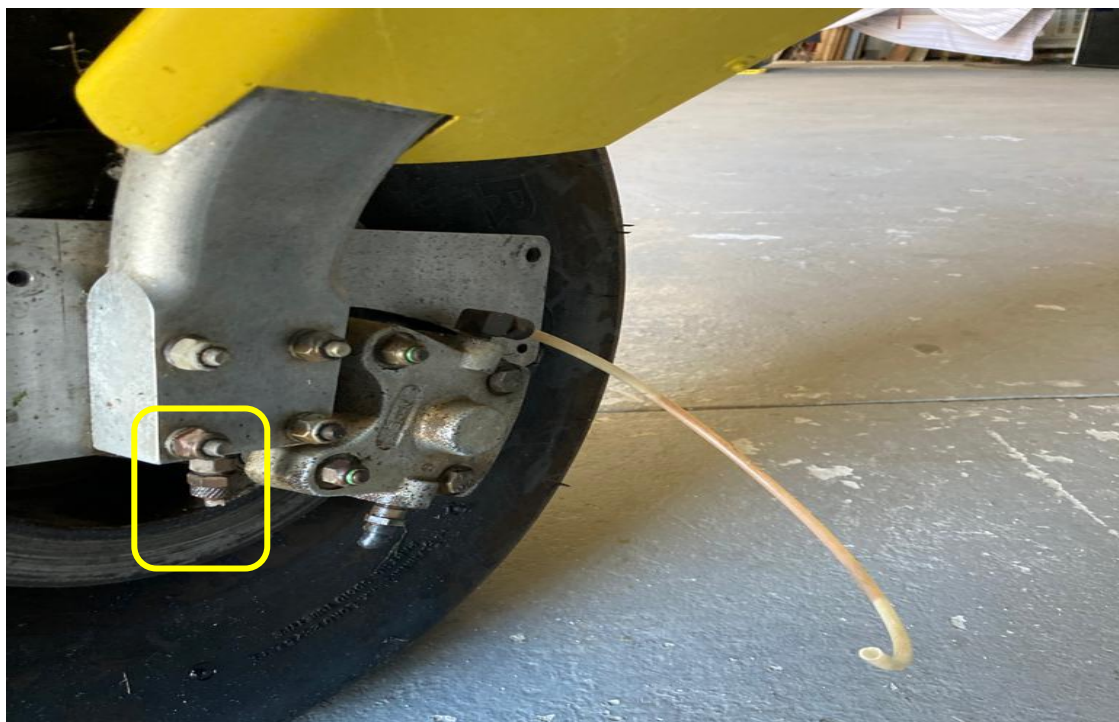
The brake hoses that were fitted to the serious incident aircraft were considered to be of inferior quality which, over time, became brittle. Subsequently, the right brake hose failed (as depicted in the yellow window in Figure 3).

**Figure 3:** Brake hose broke off from the right side brake assembly (yellow window).

<p><b>Probable cause:</b></p> <p>Asymmetric braking which occurred as a result of the failure of the right brake hose. Directional control could not be maintained using only the left operative brake, thus, the aircraft exited the runway.</p>
<p><b>Safety Action/s</b></p>
<p>None.</p>
<p><b>Safety Message</b></p>
<p>It is recommended that the brake tubing/hoses be inspected on a regular basis as they have the potential to become brittle which may lead to failure. A more robust type of tubing (steel brace hose) should be considered and accordingly replaced on all aircraft types similar to the serious incident aircraft to prevent recurrence of such incidents.</p>
<p><b>Purpose of the Investigation</b></p>
<p><i>In terms of Regulation 12.03.1 of the Civil Aviation Regulations (CAR) 2011, this report was compiled in the interest of the promotion of aviation safety and the reduction of the risk of aviation accidents or incidents and <b>not to apportion blame or liability.</b></i></p>
