<b>LIMITED SERIOUS INCIDENT INVESTIGATION REPORT</b>
--

<b>Reference Number</b>	CA18/3/2/1355						
<b>Classification</b>	Serious Incident	<b>Date</b>	24 July 2021	<b>Time</b>	0842Z		
<b>Type of Operation</b>	Private (Part 91)						
<b>Location</b>							
Place of Departure	The Coves Private Airstrip, North West Province		Place of Intended Landing	Kralingen Farm Private Airstrip, Limpopo Province			
Place of Incident	Kralingen Farm Private Airstrip, Limpopo Province						
GPS Co-ordinates	Latitude	S 24° 35' 40"	Longitude	E 028° 06' 24"	Elevation	4492ft	
<b>Aircraft Information</b>							
Registration	ZS-FTC						
Model/Make	Piper PA-28-235 Cherokee						
Damage to Aircraft	Substantial		Total Aircraft Hours	3613.3			
<b>Pilot-in-command</b>							
Licence Valid	Yes	Gender	Male		Age	48	
Licence Type	Private Pilot Licence (PPL)						
Total Hours on Type	22.8		Total Flying Hours	96.2			
<b>People On-board</b>	1+3	Injuries	0	Fatalities	0	Other (on ground)	0
<b>What Happened</b>

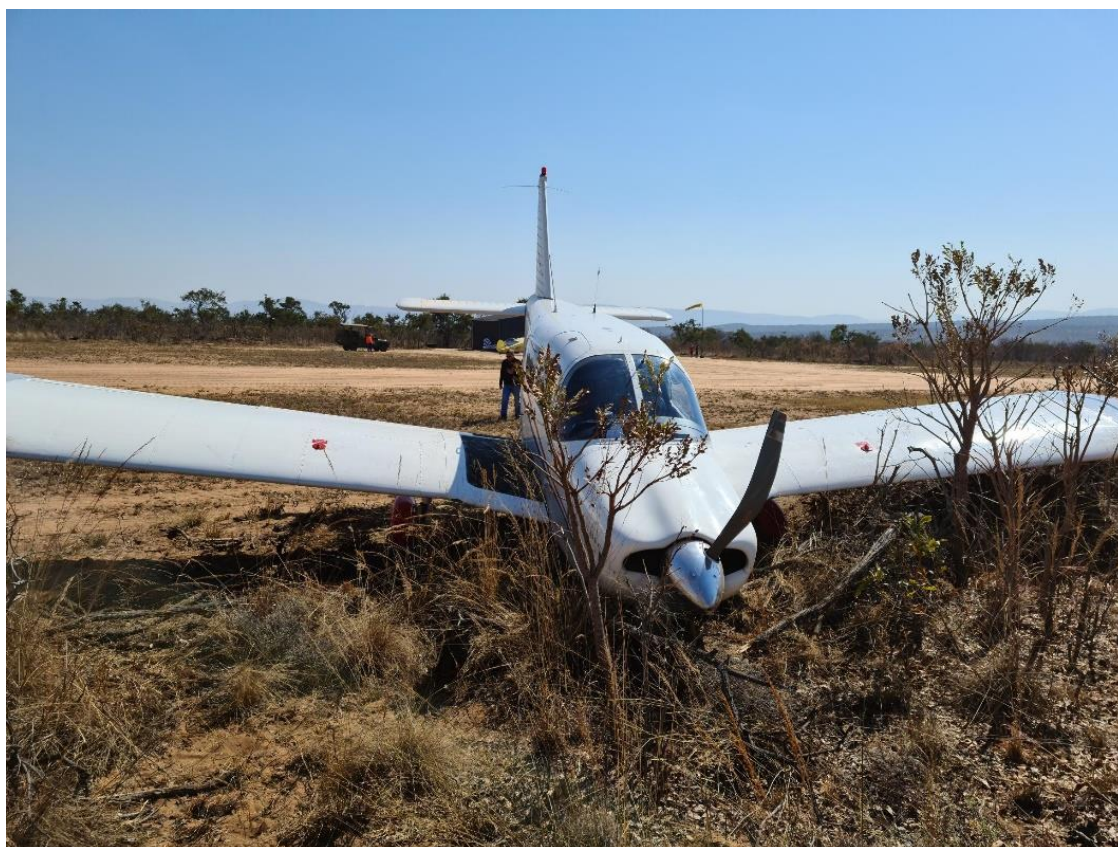
Following the serious incident, the pilot switched off the master switch, completed aircraft shutdown procedures and disembarked the aircraft unassisted together with his passengers. There were no injuries sustained by the occupants during the serious incident sequence. The aircraft sustained substantial damage to the nose landing gear strut and the propeller.

**Figure 1:** The aircraft post-incident.

The pilot lost directional control of the aircraft after touchdown on an uneven runway surface, which led to the aircraft veering off to the left-side of the runway. This resulted in the collapse of the nose gear strut and, subsequently, the propeller blades hit the ground.

The pilot not being familiar with the airstrip conditions; and improper landing technique.

Pilots are encouraged to always conduct a thorough flight planning and enquire about the conditions of the destination's airport or airfield.
