LIMITED SERIOUS INCIDENT INVESTIGATION REPORT
--

Reference Number		CA18/3/2/1358					
Classification	Serious Incident	Date	30 July 2021	Time	1330Z		
Type of Operation	Training (Part 141)						
Location							
Place of Departure	Wonderboom Aerodrome (FAWB)		Place of Intended Landing	Wonderboom Aerodrome (FAWB)			
Place of Incident	Runway 11 at Wonderboom Aerodrome (FAWB)						
GPS Co-ordinates	Latitude	25°39'19.11" S	Longitude	028°13'16.81" E	Elevation	4 095 ft	
Aircraft Information							
Registration	ZS-GDA						
Make/Model	Cessna 172P (Serial No. 172-75033)						
Damage to Aircraft	No damage		Total Aircraft Hours	18 370.7			
Pilot-in-command							
Licence Valid	Yes		Gender	Female	Age	25	
Licence Type	Commercial Pilot Licence						
Total Hours on Type	70.9		Total Flying Hours	419.6			
People On-board	2 + 0	Injuries	0	Fatalities	0	Other (On Ground)	0
What Happened							
<p>On Friday afternoon, 30 July 2021, a flight instructor and a student pilot on-board a Cessna 172P aircraft with registration ZS-GDA were intending to engage in a circuit training flight at Wonderboom Aerodrome (FAWB). They were instructed by air traffic control (ATC) to hold at the holding point of Runway 11 f

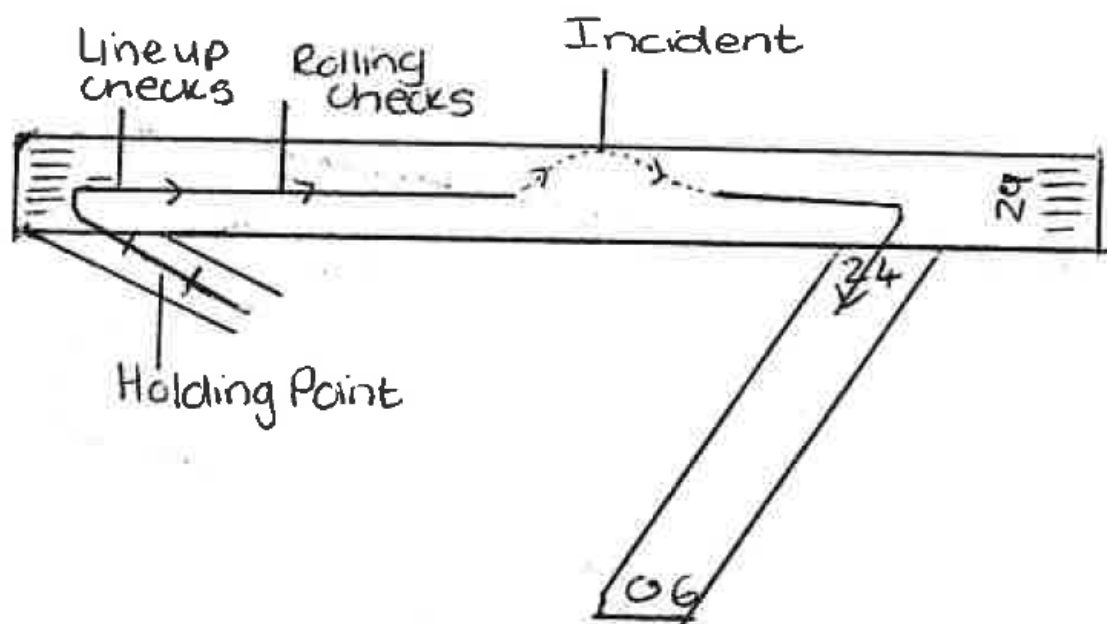
rolled backwards, making it impossible for her to reach any of the controls. The aircraft then yawed to the left; at that stage, the student pilot took over control of the aircraft again and steered it back to the runway centreline while the flight instructor moved her seat forward and re-latched it. Once in position, the flight instructor took control of the aircraft once more and vacated the active runway via Runway 24. She taxied the aircraft back to the Aviation Training Organisation (ATO) flight line. Neither of the two crew members were injured during the serious incident, and the aircraft did not sustain damage. *The flight instructor provided the sketch below to illustrate the sequence of events.*

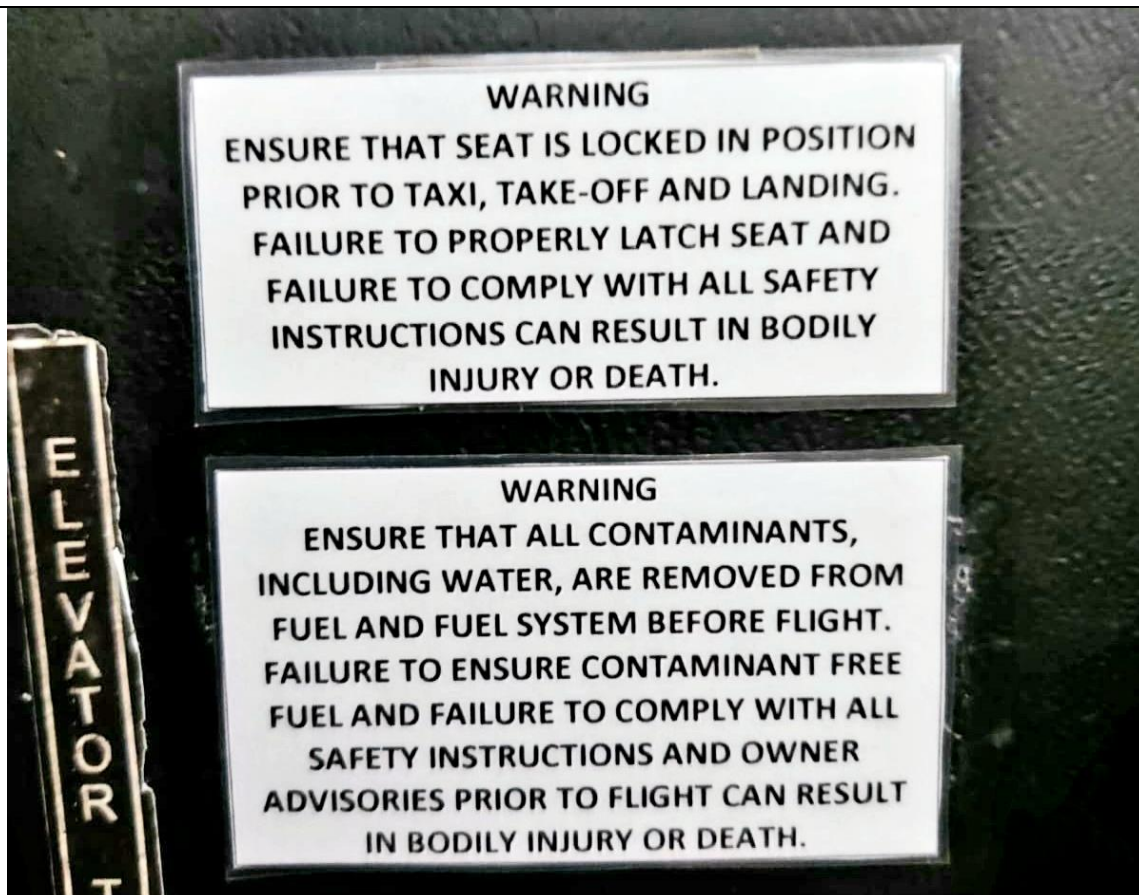
A placard was placed on the aircraft's instrument panel (see Figure 1) which read: *"Ensure that seat is locked in position prior to taxi, take-off and landing. Failure to properly latch seat and failure to comply with all safety instructions can result in bodily injury or death"*.

Figure 1: Placard in the cockpit of ZS-GDA. (Source: ATO)
