**LIMITED SERIOUS INCIDENT INVESTIGATION REPORT**

<b>Reference Number</b>		CA18/3/2/1359					
<b>Classification</b>	Serious Incident	<b>Date</b>	3 August 2021	<b>Time</b>	1400Z		
<b>Type of Operation</b>	Private (Part 91)						
<b>Location</b>							
Place of Departure	Wonderboom Airport (FAWB)		Place of Intended Landing	Wonderboom Airport (FAWB)			
Place of Accident	Morningside private farm in Rustenburg, North West province						
GPS Co-ordinates	Latitude	S 25° 38' 08"	Longitude	E 26° 55' 03"	Elevation	4200 ft	
<b>Aircraft Information</b>							
Registration	ZS-FWK						
Model/Make	Piper PA-28-140						
Damage to Aircraft	Minor		Total Aircraft Hours	12120.65			
<b>Pilot-in-command</b>							
Licence Valid	Yes	Gender	Female	Age	29		
Licence Type	Private Pilot Licence (Aeroplane)						
Total Hours on Type	134.0		Total Flying Hours	144.0			
<b>People On-board</b>	1 + 1	Injuries	0	Fatalities	0	Other (On Ground)	0
<b>What Happened</b>							
<p>On 3 August 2021, a pilot and a passenger on-board a Piper Cherokee aircraft with registration ZS-FWK took off on a cross-country flight from Wonderboom Airport (FAWB) routing via waypoint UTRUK, Rustenburg Airfield (FARG) and Zeerust Airfield

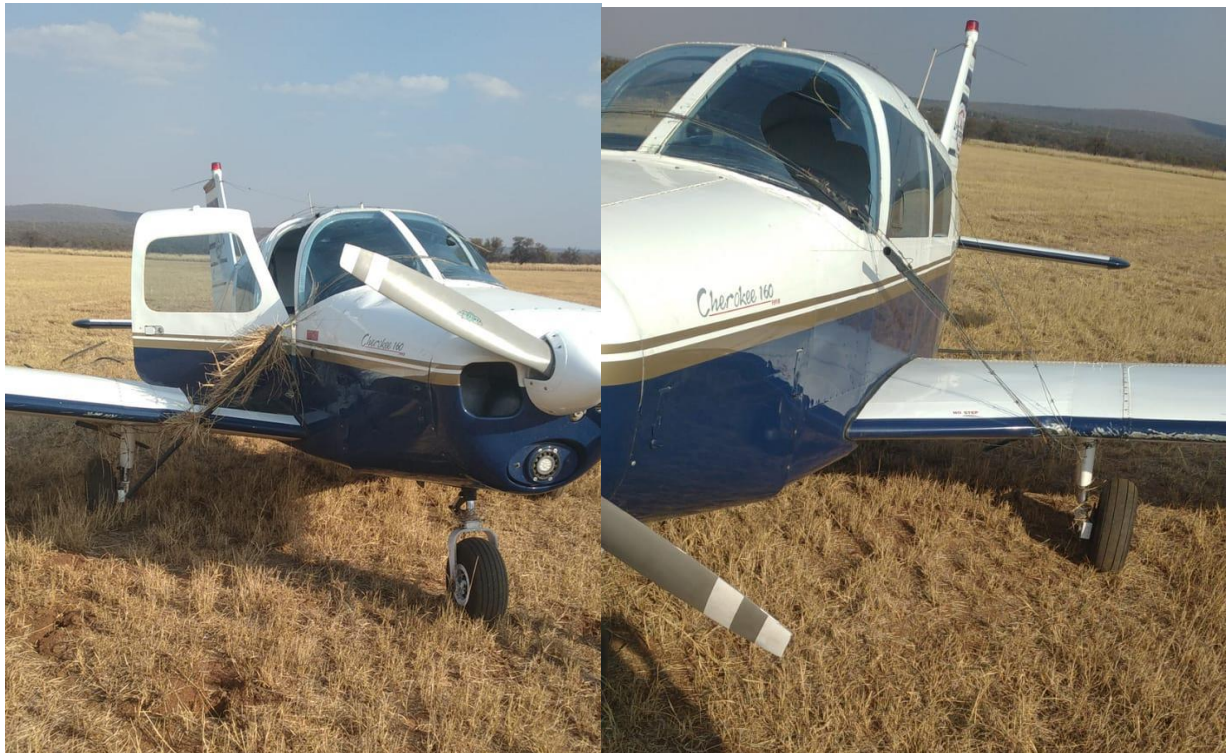
The aircraft sustained scratches on both wings and the windscreen. The pilot and the passenger were not injured during the serious incident.

**Figure 1:** The aircraft at the accident site. (Source: Approved Training Organisation)

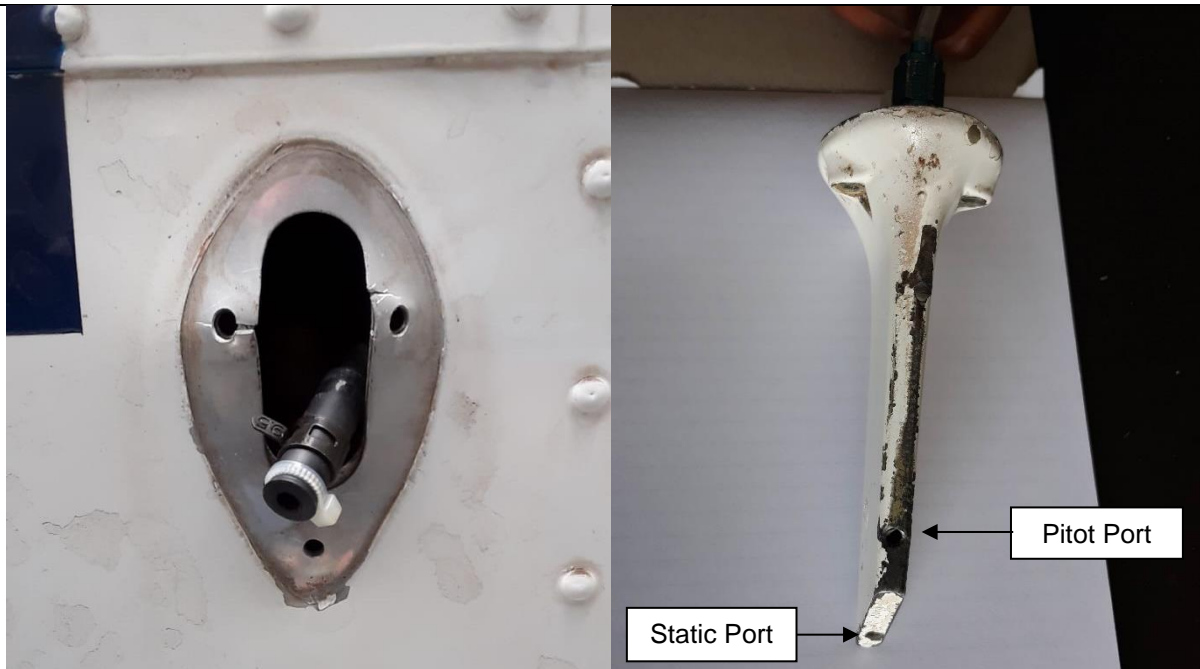
Post-incident inspection revealed that the pitot tube (installed on the underside of the left wing) had been severed by the wire fence during the landing roll. The aircraft maintenance engineer (AME) conducted an on-site test on the pitot tube by blowing into both the pitot and static port. The pitot port was clear, but the static port was blocked with no air coming out on the other end.

**Figure 2:** The pitot tube severed from the aircraft. (Source: aircraft maintenance engineer)

- The serious incident aircraft started to show signs of static port failure only when the aircraft started to descend as stated in the FAA handbook “*may go unrecognized until a critical phase of flight*”.
- When the serious incident aircraft was descending, the airspeed remained high but when it climbed, the airspeed reduced as stated in the FAA handbook “*While descending, the airspeed indicator, unable to tell whether it is experiencing more airspeed pitot pressure or less static reference pressure, indicates a higher airspeed than actual. If the pilot begins a climb, the indicated airspeed, however, may begin to decrease at an alarming rate*”.
- The pilot was able to continue operating during the flight and landing phases while the aircraft had reached Never Exceed Speed (Vne). This could have been a successful forced landing if the wire fence was not in the landing roll path.

It is probable that whilst flying over the mountain range, the aircraft experienced a downdraft which caused the aircraft to start descending. With the static port blocked, the airspeed indicator began to give inaccurate readings which the pilot interpreted as actual.

Pilots should be made aware, through training, of possible signs in-flight when the aircraft experiences a pitot system failure.

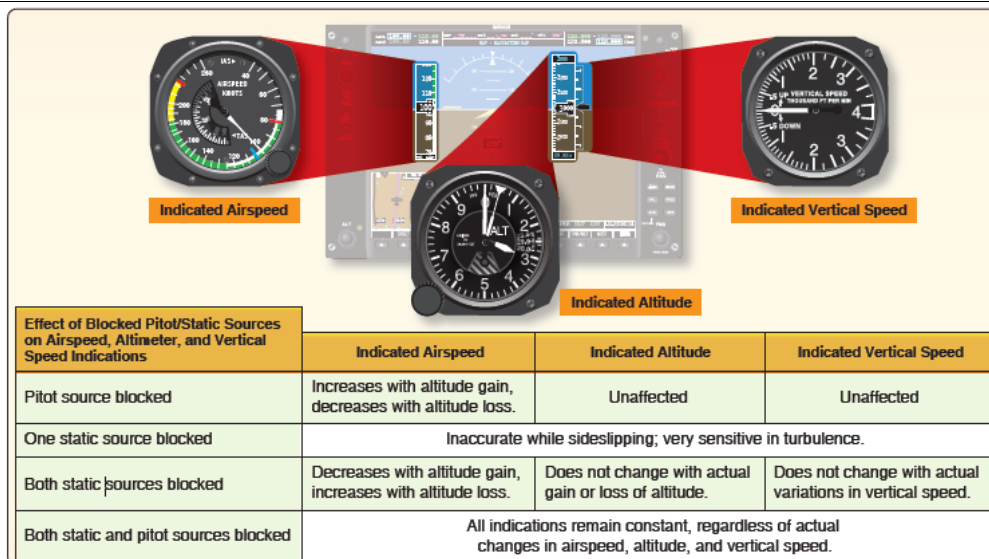
Partial static system blockage is insidious in that it may go unrecognized until a critical phase of flight. During take-off, climb, and level-off at cruise altitude the altimeter, airspeed indicator, and VSI may operate normally. No indication of malfunction may be present until the airplane begins a descent.

If the static reference system is severely restricted, but not entirely blocked, as the airplane descends, the static reference pressure at the instruments begins to lag behind the actual outside air pressure. While descending, the altimeter may indicate that the airplane is higher than actual because the obstruction slows the airflow from the static port to the altimeter. The VSI confirms the altimeter's information regarding rate of change because the reference pressure is not changing at the same rate as the outside air pressure. The airspeed indicator, unable to tell whether it is experiencing more airspeed pitot pressure or less static reference pressure, indicates a higher airspeed than actual. To the pilot, the instruments indicate that the airplane is too high, too fast, and descending at a rate much less than desired.

If the pilot levels off and then begins a climb, the altitude indication may still lag. The VSI indicates that the airplane is not climbing as fast as actual. The indicated airspeed, however, may begin to decrease at an alarming rate. The least amount of pitch-up attitude may cause the airspeed needle to indicate dangerously near stall speed.

**Figure 3:** The effects of a blocked pitot tube. (Source: FAA, Airplane Flying Handbook)
