LIMITED SERIOUS INCIDENT REPORT
--

Reference Number		CA18/3/2/1363					
Classification	Serious Incident	Date	16 August 2021		Time	1150Z	
Type of Operation		Training (Part 141)					
Location							
Place of Departure		Port Alfred Aerodrome (FAPA), Eastern Cape Province		Place of Intended Landing		Port Alfred Aerodrome (FAPA), Eastern Cape Province	
Place of Occurrence		Runway 11 at East London Airport (FAEL), Eastern Cape Province					
GPS Co-ordinates		Latitude		Longitude		Elevation	
		S33° 2'.23"		E27°48'.42"		433 feet	
Aircraft Information							
Registration		ZS-EVJ					
Model/Make		Piper PA-28-140 Cherokee					
Damage to Aircraft		Substantial		Total Aircraft Hours		2422.2	
Pilot-in-command							
Licence Valid		Yes		Gender		Female	
				Age		19	
Licence Type		Student Pilot Licence (SPL)					
Total Hours on Type		59.3		Total Flying Hours		59.3	
People On-board		1 + 0		Injuries		0	
				Fatalities		0	
				Other (On Ground)		0	
What Happened

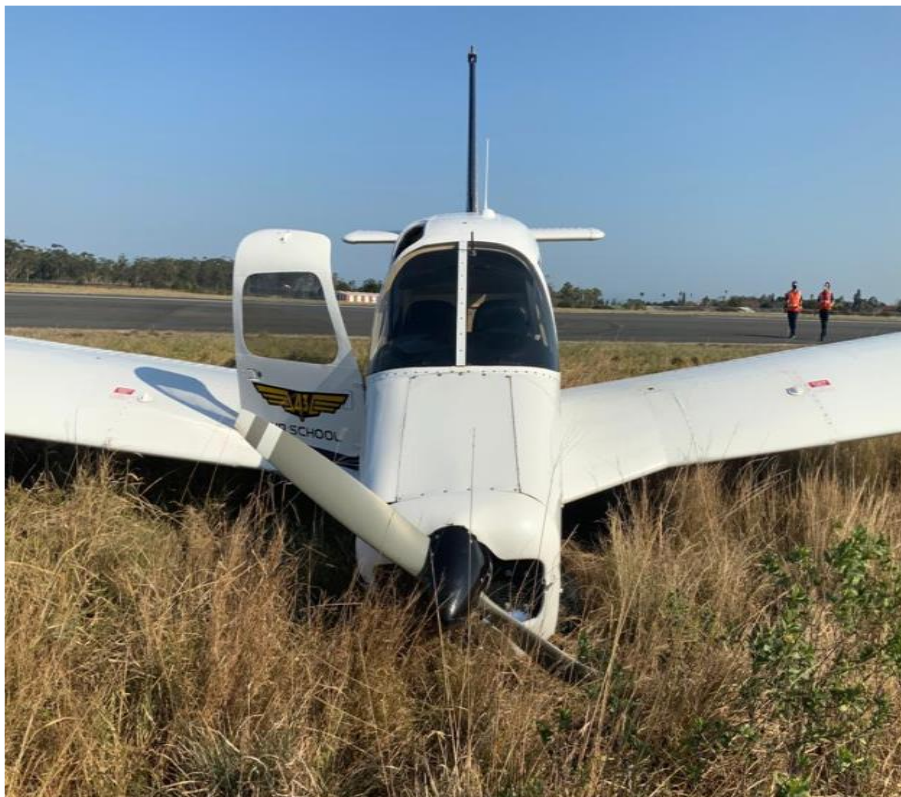
Upon approaching FAEL, the student pilot broadcasted her intentions to FAEL approach on 120.10-Megahertz (MHz) frequency. The pilot was instructed to use asphalt Runway 11 for landing, which is about 1939 metres (m) in length. In addition, the weather condition update was communicated to the student pilot and it was reported to be fine with no clouds and with light turbulence; the wind was approximately 090/20 knots. The student pilot stated that the approach was stable and touchdown on the main wheels on Runway 11, about 370m from the threshold, was smooth. After the nose wheel had touched down on the runway surface, the student pilot opened the throttle with the intention to take-off and return to FAPA. During the take-off run, the student pilot felt what appeared to be a zig-zag movement and an imbalance on the aircraft's main landing gear. She then decided to reject the take-off. The student pilot closed the throttle and applied maximum brakes with the intention to bring the aircraft to a stop on the remaining runway surface, but without success. The aircraft continued to veer off to the left, exited the runway and came to a stop on the grass in a nose down position, about 900m from Runway 11 threshold (see Figure 1). During the serious incident, the aircraft's nose gear oleo bent, and the propeller blades struck the ground.

Figure 1: The position of ZS-EVJ aircraft as found post-incident. (Source: Operator)

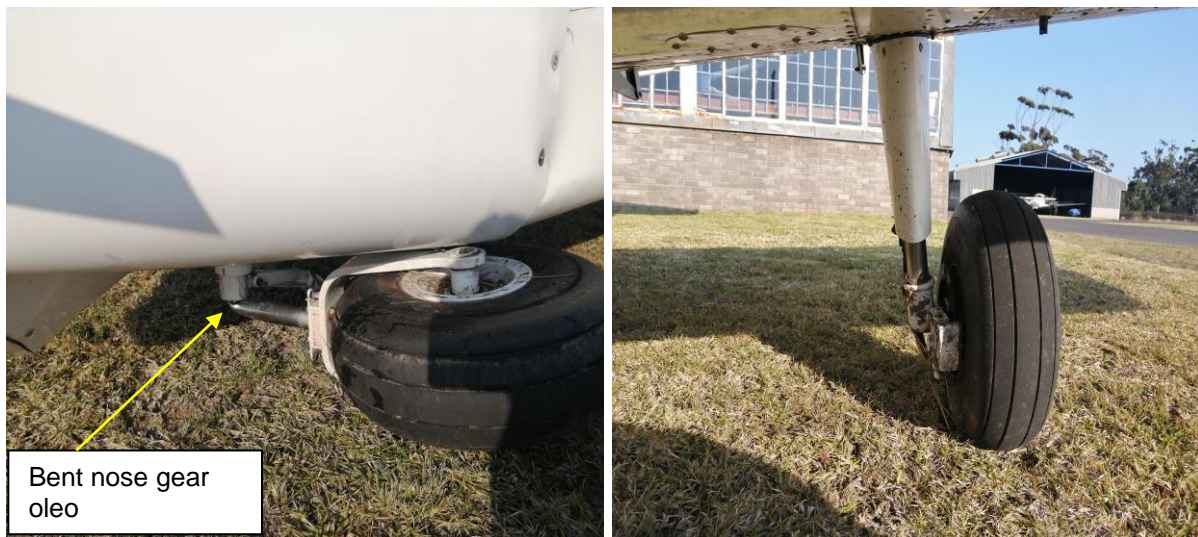
Post-incident examination of the main landing gear by the Aircraft Maintenance Organisation (AMO) chief engineer indicated that each main gear wheel assembly (combination of 6.00 x 6 Goodyear brand six ply tyre and 2 Cleveland hubs) bearings and caps (2 per wheel assembly) and nuts (1 per gear axle) with split pins (1 per gear axle) were fitted in accordance with (IAW) the aircraft maintenance manual (AMM), chapter 32-40-00. Both main wheel assemblies rotated freely on their respective axles. The main landing gear oleo-pneumatic (air-oil) shock absorbers were inflated to 150 pounds per square inch (psi) and about 4.50 inches of chrome was showing on each main landing gear oleo IAW the AMM. The main gear tyres were inflated to 26 psi of nitrogen each IAW the AMM. Examination of the nose wheel assembly indicated nothing abnormal, except the failure that occurred during the serious incident. The nose gear tyre was inflated to 26 psi IAW the AMM.

Figures 2/3: The aircraft resting on a failed nose gear strut oleo (left picture); and the condition of the left main landing gear (right picture). (Source: Operator)
