**LIMITED SERIOUS INCIDENT INVESTIGATION REPORT**

<b>Reference Number</b>	CA18/3/2/1364						
<b>Classification</b>	Serious Incident	<b>Date</b>	16 August 2021	<b>Time</b>	1350Z		
<b>Type of Operation</b>	Private (Part 91)						
<b>Location</b>							
<b>Place of Departure</b>	Lanseria International Airport (FALA), Gauteng Province		<b>Place of Intended Landing</b>	Ondangwa Airport (OND), Namibia			
<b>Place of Incident</b>	Overhead North West province during climb to flight level 135						
<b>GPS Co-ordinates</b>	<b>Latitude</b>	S 25°20'2.01"	<b>Longitude</b>	E 027°10'24.61"	<b>Elevation</b>	5280ft	
<b>Aircraft Information</b>							
<b>Registration</b>	ZS-JNE						
<b>Model/Make</b>	421C – Cessna Aircraft Company						
<b>Damage to Aircraft</b>	None		<b>Total Aircraft Hours</b>	903			
<b>Pilot-in-command</b>							
<b>Licence Type</b>	Commercial Pilot Licence		<b>Gender</b>	Male	<b>Age</b>	37	
<b>Licence Valid</b>	Yes						
<b>Total Hours on Type</b>	45		<b>Total Flying Hours</b>	500

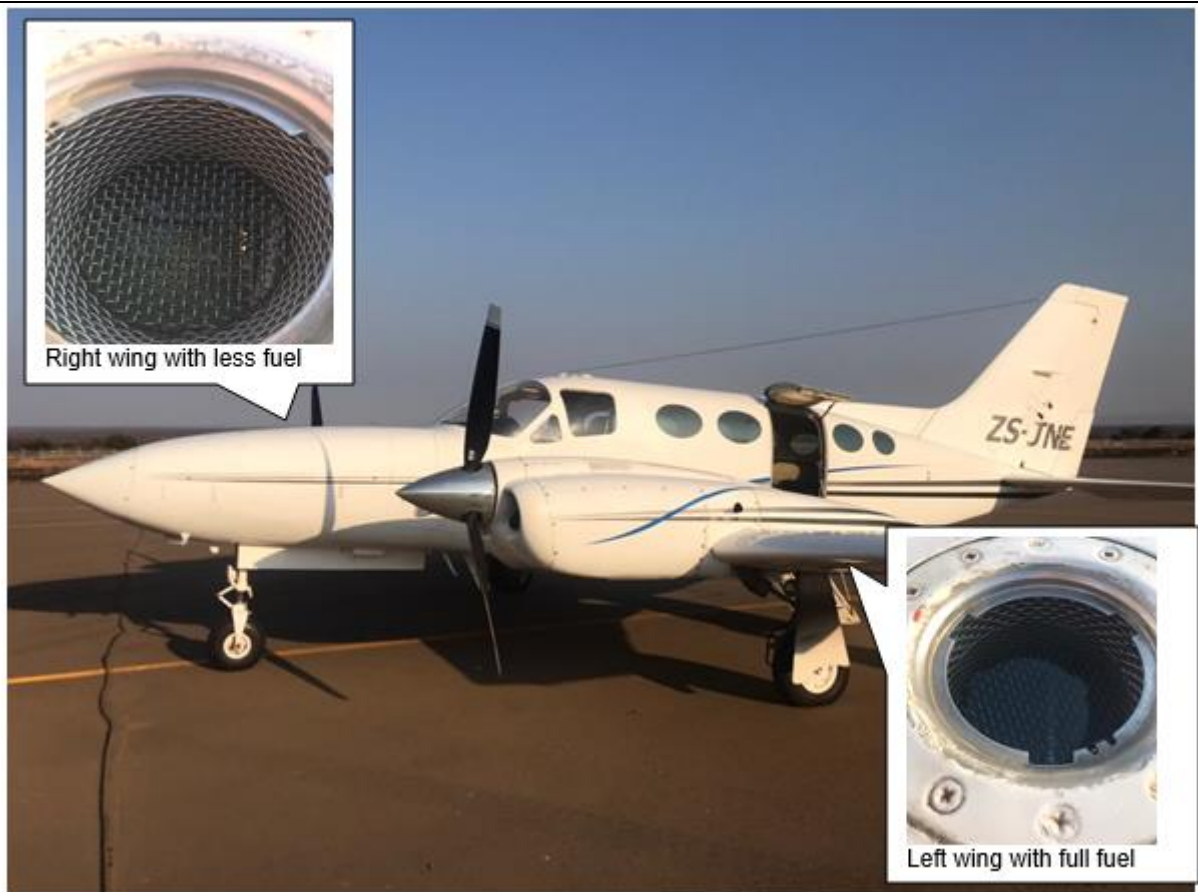
**Figure 1:** The aircraft post-incident with insets of right- and left-wing fuel tanks.

After the aircraft landed safely, the pilot visually checked the fuel in each tank and noted that the left fuel tank had more fuel than the right fuel tank. The pilot further stated that during flight whilst conducting the checklist in the cockpit, he was distracted by an incoming call on his cellular phone, hence, he missed noting that both engines were selected to feed from the right-side fuel tank as he took off. Following the fuel upliftment in the right tank at FAPN, the aircraft took off to its intended destination (Namibia) as planned.

The cause of the aircraft flying with the left-wing low was due to an imbalance of fuel in the fuel tanks, which resulted in the left wing dropping because the left fuel tank had more fuel (heavier) than the right tank.

<b>Contributing factor:</b>	
Cellphone distraction whilst engaged in checklist procedures in the cockpit.	
<b>Safety Action</b>	
None.	
<b>Safety Message and/or Safety Recommendation</b>	
Pilots should ensure that there are no distractions such as active mobile phones during operation of aircraft.	
<b>Purpose of the Investigation</b>	
<i>In terms of Regulation 12.03.1 of the Civil Aviation Regulations (CAR) 2011, this report was compiled in the interest of the promotion of aviation safety and the reduction of the risk of aviation accidents or incidents and <b>not to apportion blame or liability</b>.</i>	
<b>About this Report</b>	
<i>Decisions regarding whether to investigate, and the scope of an investigation are based on many factors, including the level of safety benefit likely to be obtained from an investigation. For this occurrence, no investigation has been conducted, and the Accident and Incident Investigations Division (AIID) has relied on the information submitted by the affected person/s and organisation/s to compile this brief report. The report has been compiled using information supplied in the initial notification, as well as follow-up information to bring awareness of potential safety issues to the industry in respect of this occurrence, as well as possible safety action/s that the industry might want to consider in preventing a recurrence of a similar accident.</i>
