**LIMITED INCIDENT INVESTIGATION REPORT**

<b>Reference Number</b>	CA18/3/2/1366						
<b>Classification</b>	Incident	<b>Date</b>	25 August 2021	<b>Time</b>	0628Z		
<b>Type of Operation</b>	Private (Part 94)						
<b>Location</b>							
<b>Place of Departure</b>	Wonderboom Aerodrome (FAWB), Gauteng Province		<b>Place of Intended Landing</b>	Rhino Park Airfield, Gauteng Province			
<b>Place of Incident</b>	In-flight after departing Wonderboom Aerodrome (FAWB) Runway 29						
<b>GPS Co-ordinates</b>	<b>Longitude</b>	S 25°39'19"	<b>Latitude</b>	E 28°13'16"	<b>Elevation</b>	4780 feet	
<b>Aircraft Information</b>							
<b>Registration</b>	ZU-DFR						
<b>Model/Make</b>	Jabiru J450 (Serial no. 107)						
<b>Damage to Aircraft</b>	None		<b>Total Aircraft Hours</b>	890.3			
<b>Pilot-in-command</b>							
<b>Licence Type</b>	Commercial Pilot Licence (CPL)	<b>Gender</b>	Male		<b>Age:</b> 25		
<b>Licence Valid</b>	Yes						
<b>Total Hours on Type</b>	263.8		<b>Total Flying Hours</b>	1276.1

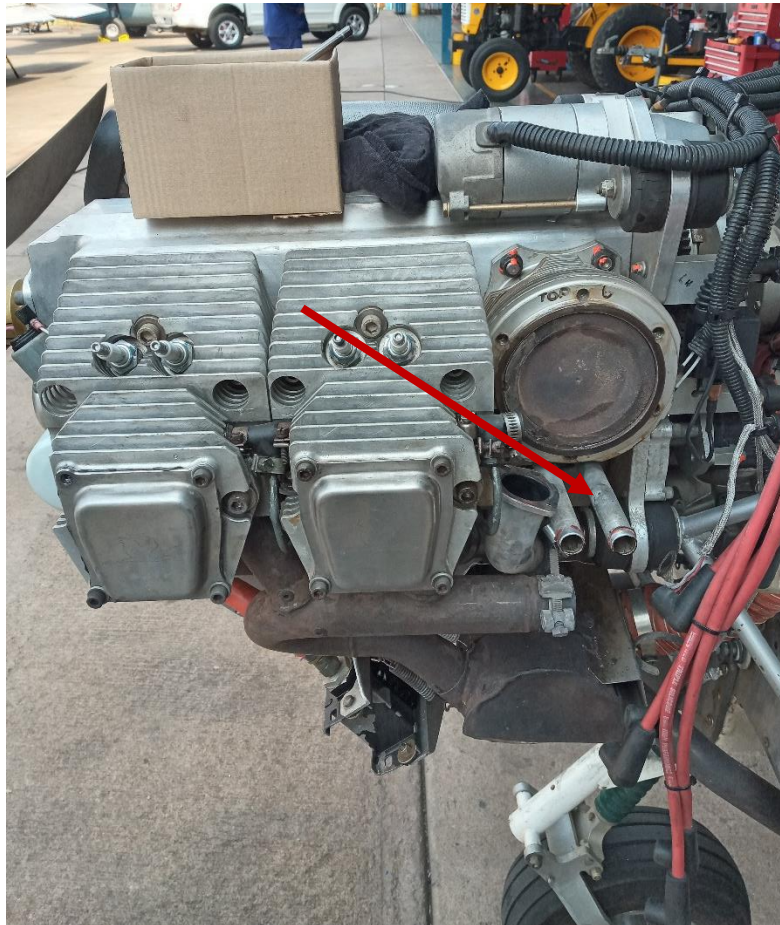
After removing the engine cowlings during the investigation, the AP found out that the rear spark plug on the number 6 cylinder had ejected from its position due to damaged threads. Thorough inspection of the spark plug suggested that the damage might have been caused by the spark plug cross-threading and over-torquing during installation. The number 6 cylinder was removed from

**Figure 2:** The number 6 cylinder out for repairs.

The rear spark plug on the number 6 cylinder ejected from its position (hole) due to damaged threads. The threads were most probably damaged by cross-threading during installation.

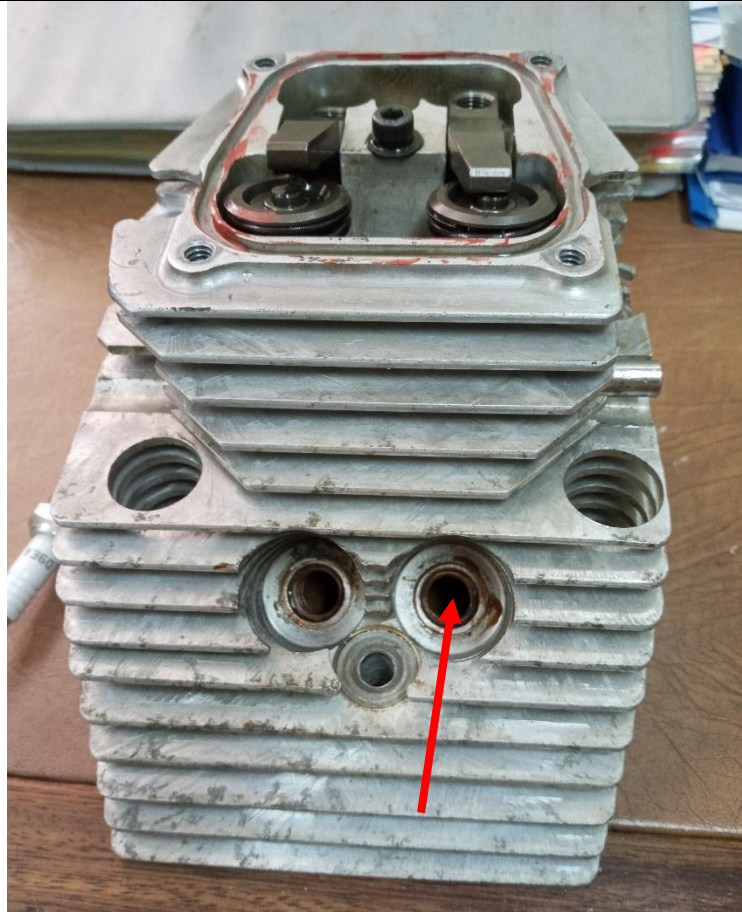
**Figure 3:** The repaired cylinder with new threads.

the engine and taken to an engineering shop for maintenance. A new thread shell was inserted into the cylinder head spark plug hole and the new spark plug was installed and torqued in accordance with (IAW) the engine manufacturer's specifications. The torque wrench used was correctly calibrated. The engine run was carried out after maintenance and it met all the parameters.
