LIMITED INCIDENT INVESTIGATION REPORT

Reference Number	CA18/3/2/1369						
Classification	Serious Incident	Date	3 September 2021		Time	0730Z	
Type of Operation	Private (Part 91)						
Location							
Place of Departure	East London Airport (FAEL), Eastern Cape Province			Place of Intended Landing	Brown's Landing in Morgan Bay, Eastern Cape Province		
Place of Incident	Near Kei River						
GPS Co-ordinates	Latitude	S 32° 43' 19.6"	Longitude	E 028° 18' 53.5"	Elevation	250ft	
Aircraft Information							
Registration	ZS-HOY						
Model/Make	Eurocopter EC 130 B4						
Damage to Aircraft	Minor		Total Aircraft Hours	2 427			
Pilot-in-command							
Licence Type	Private Pilot Licence (PPL)		Gender	Male	Age	65	
Licence Valid	Yes						
Total Hours on Type	225		Total Flying Hours	4933			
People on board	1+0	Injuries	0	Fatalities	0	Other (on ground)	0
What Happened							
<p>On 3 September 2021 at approximately 0730Z, a Eurocopter EC 130 B4 helicopter with registration marking ZS-HOY was engaged in a private flight when the incident occurred. The pilot on-board the helicopter took off from East London Airport (FAEL) in the Eastern Cape province with the intention to land at Brown's Landing in

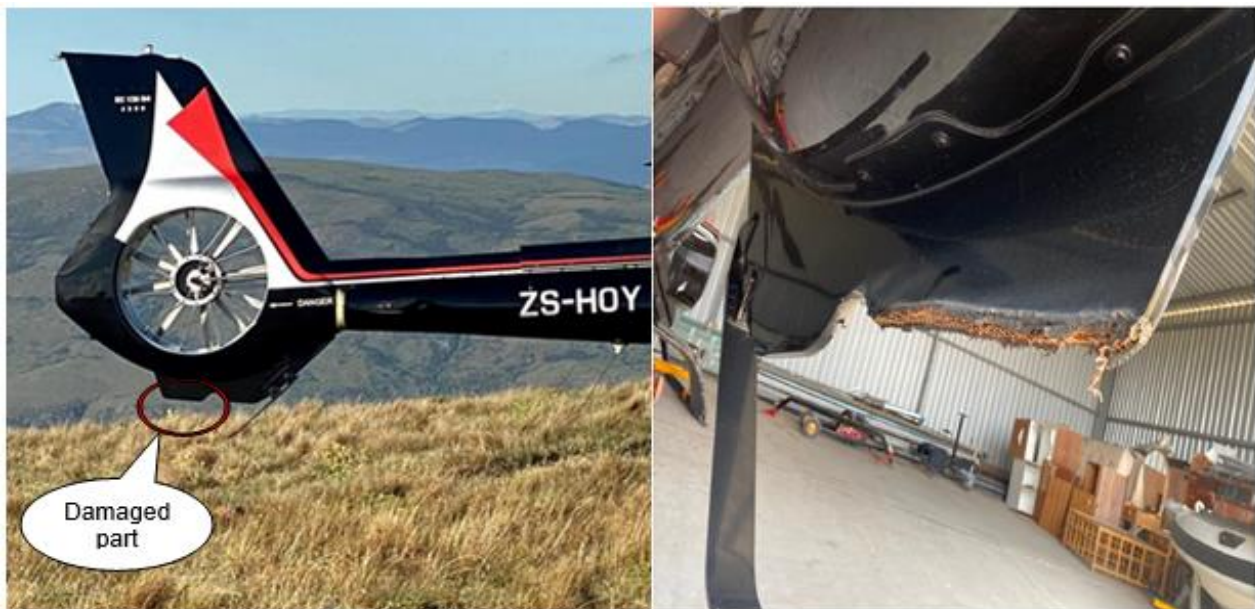
The pilot continued with the flight to the intended destination where he landed safely. After a complete shutdown of the electrical system and during the walk-around, the pilot noticed that the helicopter sustained minor damage on the fenestron fairing's lower fin. No other damage was observed on the fuselage. The pilot did not sustain any injuries during this incident.

Figure 1: The helicopter fenestron damage following the incident. (Source: Pilot)

The helicopter collided with electrical power lines while flying at low level at a height of 50ft AGL.

Disregard/non-adherence to safe flying conditions as stipulated in the regulatory procedures. The pilot flew the helicopter at a low height above ground level with obstacles above his flight path.

Private helicopter operator in remote areas must ensure to always adhere to safe flying conditions despite their knowledge of their surrounding area or flight path.
