LIMITED SERIOUS INCIDENT INVESTIGATION REPORT

Reference Number	CA18/3/2/1370						
Classification	Serious Incident	Date	5 September 2021	Time	±1620Z		
Type of Operation	Private (Part 91) Hire-and-Fly						
Location							
Place of Departure	Wonderboom Aerodrome (FAWB)		Place of Intended Landing	Wonderboom Aerodrome			
Place of Incident	Powerline that crosses overhead the M35 roadway near Soshanguve						
GPS Co-ordinates	Latitude	25°24'25.85" S	Longitude	028°06'00.83" E	Elevation	3 644 ft	
Aircraft Information							
Registration	ZS-SSB						
Make / Model	Cessna 172M						
Damage to Aircraft	Substantial		Total Aircraft Hours	3 716.2			
Pilot-in-command							
Licence Valid	Yes		Gender	Male		Age: 28	
Licence Type	Commercial Pilot Licence						
Total Hours on Type	296.7		Total Flying Hours	762.2			
People On-board	1 + 3	Injuries	0	Fatalities	0	Other (On Ground)	0
What Happened							
<p>On Sunday, 5 September 2021, a commercial pilot accompanied by 3 passengers took off from Wonderboom Aerodrome (FAWB) on a private flight at approximately 1545Z. The aircraft was hired from an Aviation Training Organisation (ATO) at the aerodrome and a weight and balance was submitted as per the hire

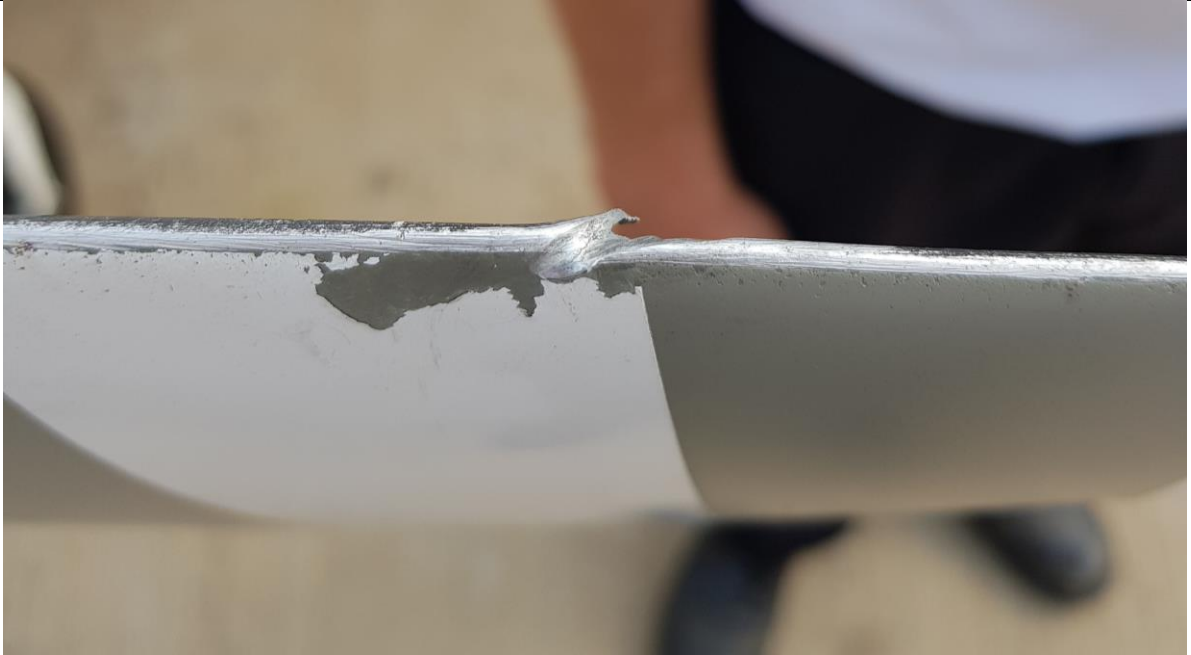
On Tuesday, 7 September 2021, the operations manager at the ATO was called in by one of the flight instructors to examine the damage on one of the propeller blades. He then interrogated the booking system to see who flew the aircraft last. After he had engaged three of the four occupants who were on-board the aircraft, which included the PIC, none of the occupants came forward with what might have caused the damage. The fourth occupant was, at the time, visiting Pretoria for a weekend as she was residing in Durban. The next day, the operations manager was informed that new information regarding the flight on Sunday evening had become available. Following a detailed inspection of the aircraft, it was noted that the exhaust as well as the lower left main gear strut displayed evidence of wire markings. The aircraft was sent to an aircraft maintenance

Figure 1: Indentation from the powerline on the propeller blade. (Source: ATO).

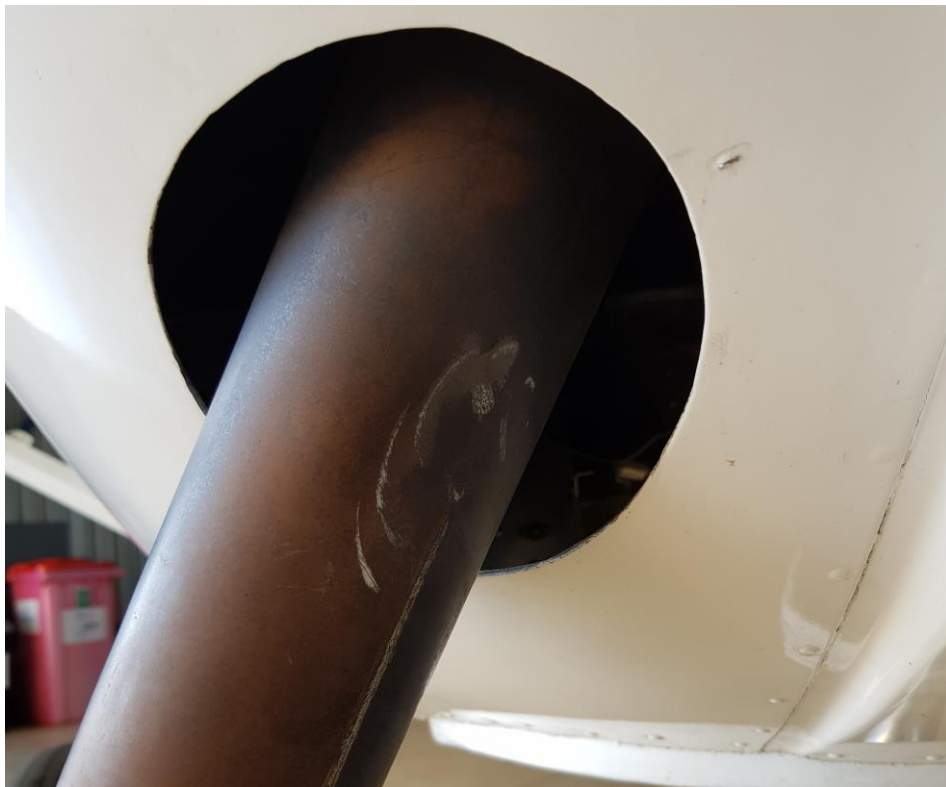
Figure 2: Wire strike markings on the exhaust.

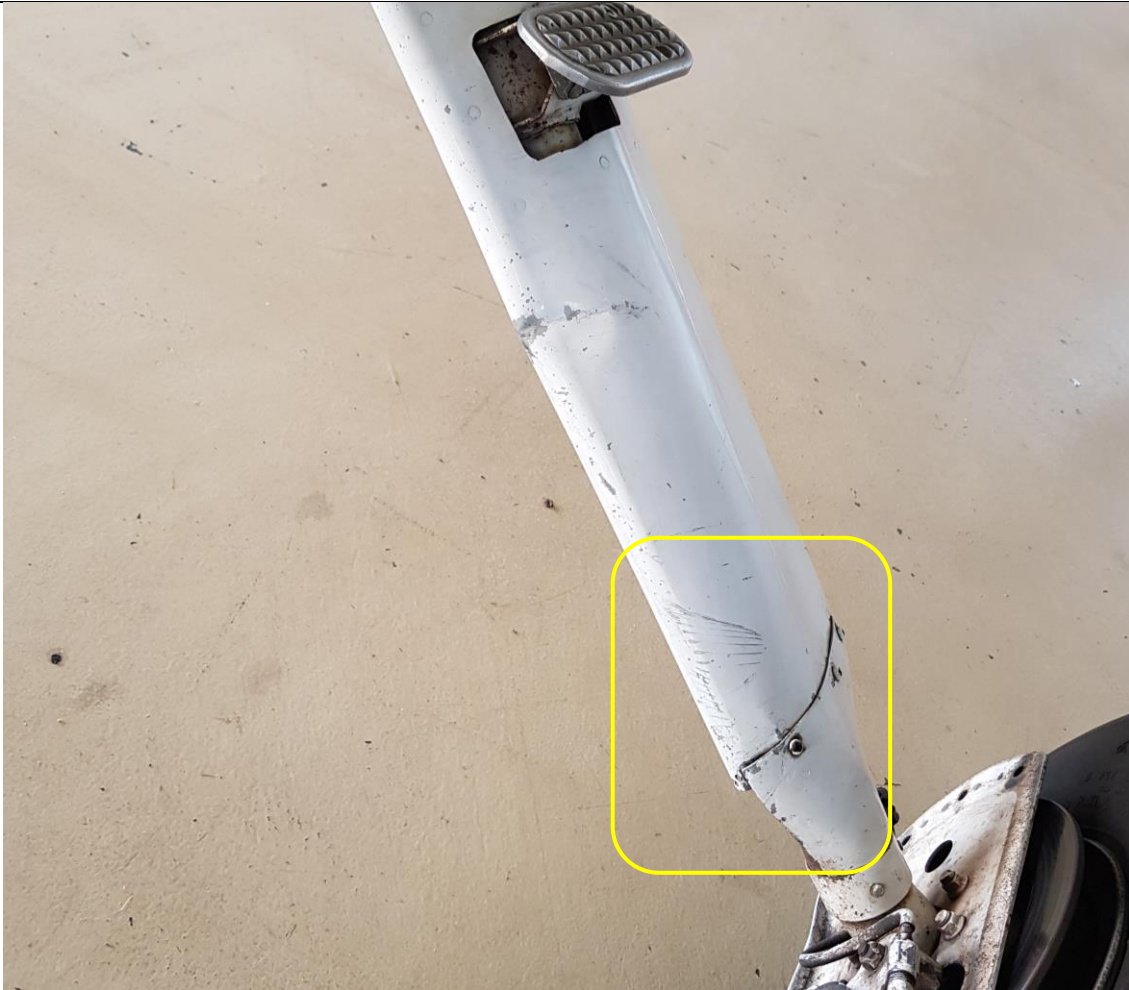
Figure 3: Wire strike markings on the lower left main gear strut.

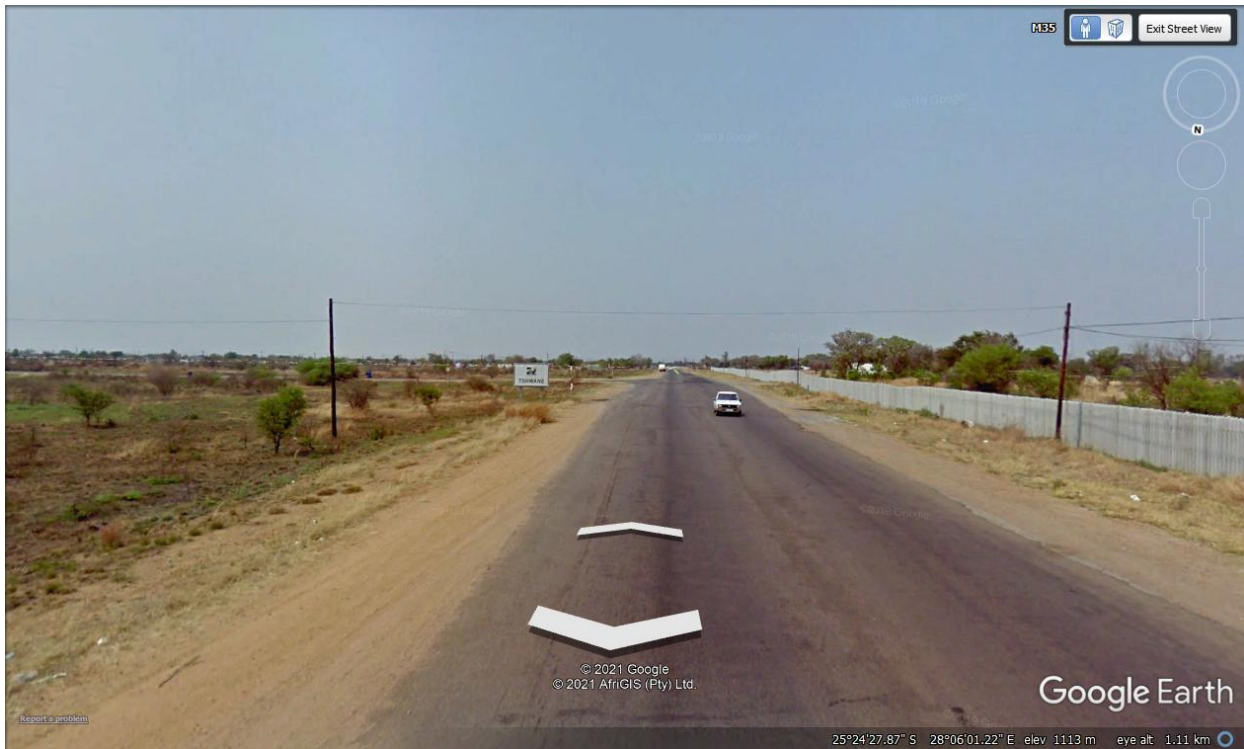
Figure 4: Powerline overhead the M35 roadway that was struck by the aircraft's propeller.

The propeller struck a powerline while the pilot was flying the aircraft at a very low height over a road, endangering the safety of the aircraft, the occupants and property.
