AIRCRAFT SERIOUS INCIDENT REPORT AND EXECUTIVE SUMMARY

Reference:		CA18/3/2/1371	
Helicopter Registration	ZS-HEW	Date of Incident	23 September 2021		Time of Incident	1400Z
Type of Helicopter	Schweizer 269C		Type of Operation		Game Capture (Part 137)	
Pilot-in-command Licence Type	Commercial Pilot Licence (CPL) Helicopter		Age	47	Licence Valid	Yes
Pilot-in-command Flying Experience	Total Flying Hours	10092.5		Hours on Type	377.6	
Last Point of Departure	Camdeboo Game Reserve in Graaf-Reinet, Eastern Cape Province					
Next Point of Intended Landing	Camdeboo Game Reserve in Graaf-Reinet, Eastern Cape Province					
Damage to Helicopter	Substantial					
Location of the incident site with reference to easily defined geographical points (GPS readings if possible)						
Camdeboo Game Reserve in Graaf Reinet, Eastern Cape province at Global Position System (GPS) co-ordinates S 32°13'11.10", E 024°32'28.61" at a field elevation of 2624ft.						
Meteorological Information	Wind direction: 220°; Wind Speed: 5kts; Visibility: Good; Air temperature: 18°C

Reference Number : CA18/3/2/1371
Occurrence Category : Category 2
Type of Operation : Game Capture Part 137
Name of Operator : E'scape Airtou

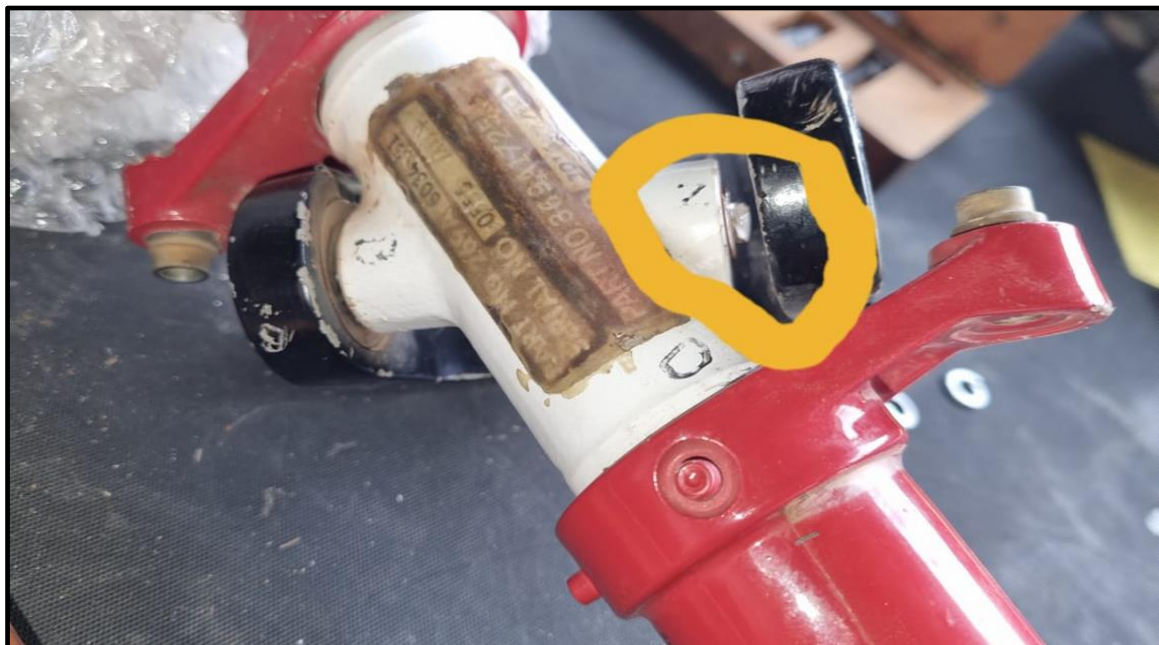
Figure 2: Damaged fork hinge bolt. (Source: Pilot)

- 1.6.3. Post-incident examination of the helicopter revealed a broken teetering bolt in the tail rotor assembly. The bolt broke in the solid shaft area and the broken piece was found trapped in the fork area (marked 23 on the tail rotor assembly Illustrated Parts Catalogue [IPC] in Diagram 1). The bolt's function was to secure the tail rotor hub onto the fork. Preliminary investigation revealed that no maintenance was carried out on the tail rotor assembly apart from the daily inspections and the previous MPIs. The helicopter had flown for 784.1 hours since new. The remaining piece of the fork hinge bolt was recovered for further metallurgical testing (Refer to 1.16).

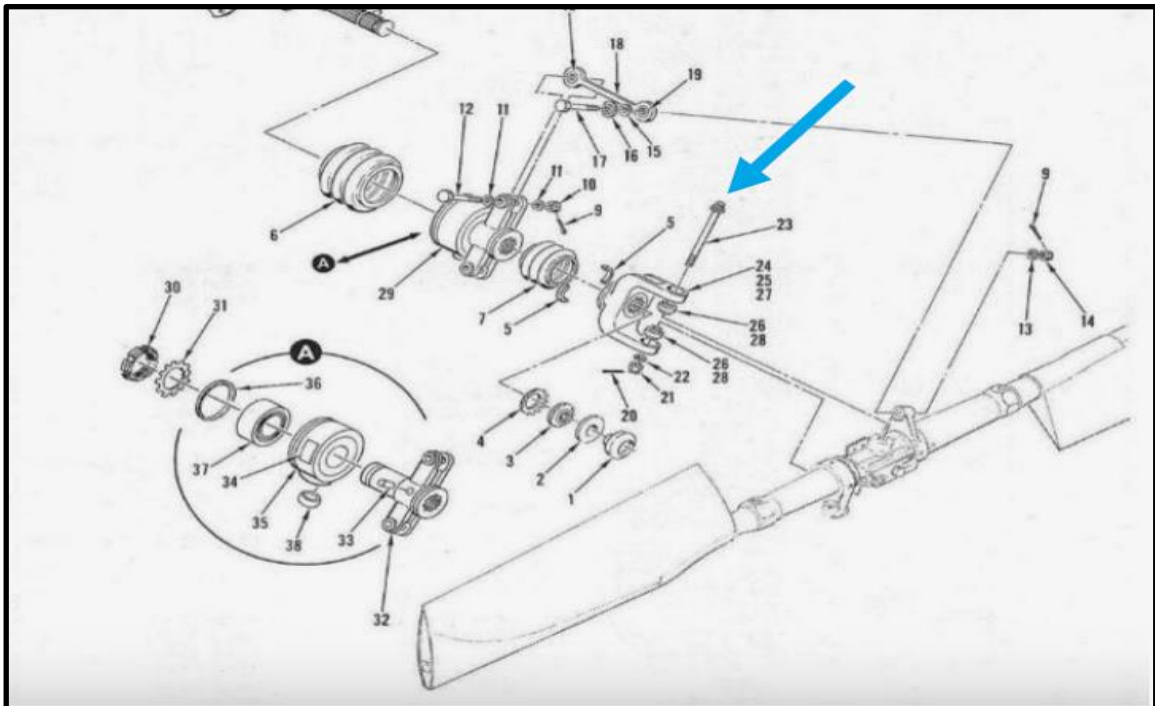
Diagram 1: An illustration of the failed fork hinge on the tail rotor assembly.
(Source: Illustrated Parts Catalogue)

The bolt is secured and tensioned by a nut which, when the assembly is correctly installed, ensures that the inner races, (i.e. the smaller diameter elements of the hub bearings) the nut, bolt, hub, shoe, threaded insert, shim washers and the dust shields all oscillate in unison relative to the fork as the rotor rotates during forward flight.

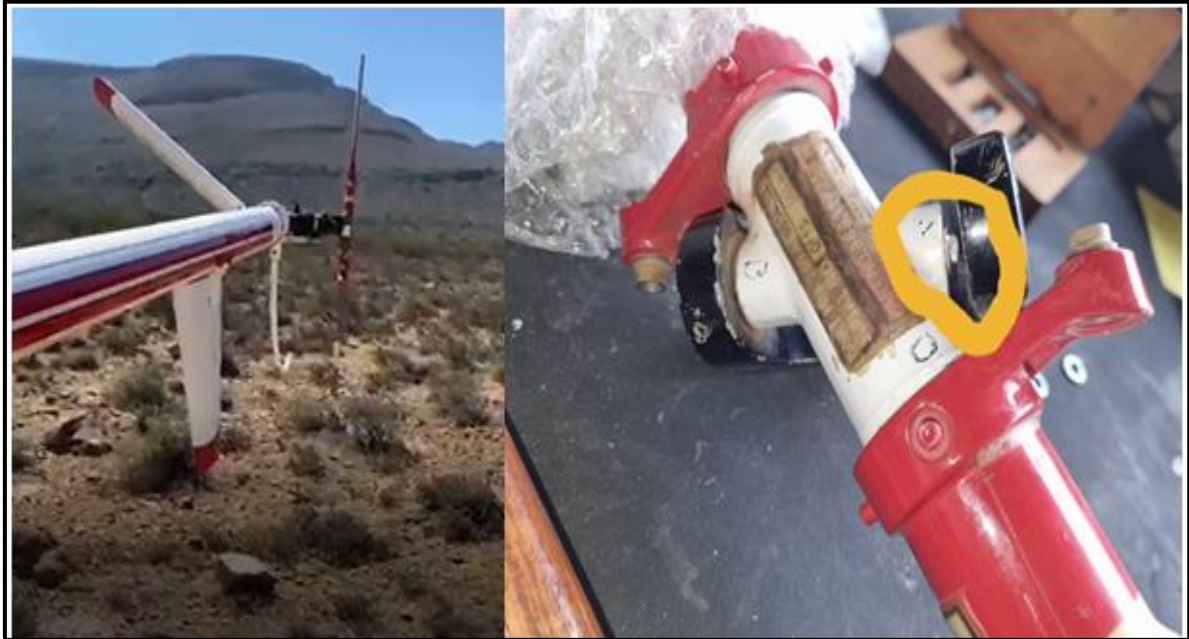
1.12.2 Upon disembarking the helicopter, the pilot noted dents on the tail stabiliser, as well as damage on the tail boom aft section and on the tail rotor drive shaft link. All damages were sustained during the severe vibrations.

Figure 3: The aft tail boom section and the failed fork hinge bolt.

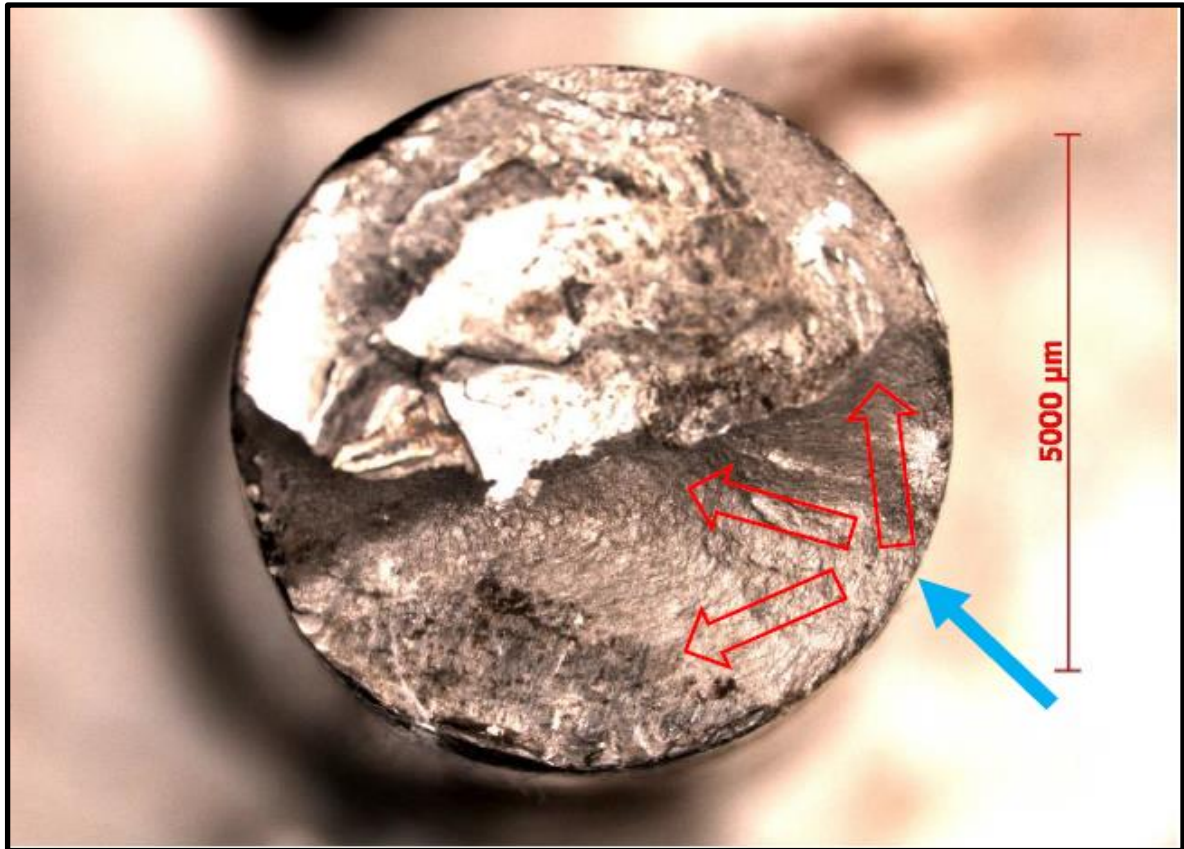
The visual inspection revealed a fracture within the shank section of the fork bolt at ± 59 mm from the bolt head base. (Blue arrow; Photo 1). The part number depicted on the bolt head corresponds to the required: 269A6092-3.

Figure 4 : Fracture surface morphology (Stereo).

The fracture surface revealed indications towards a predominant fatigue fracture mode with the initiation point (Figure 4, blue arrow; also refer to Fractography 1 and 3, blue arrows) and directions of progression as indicated with red arrows.

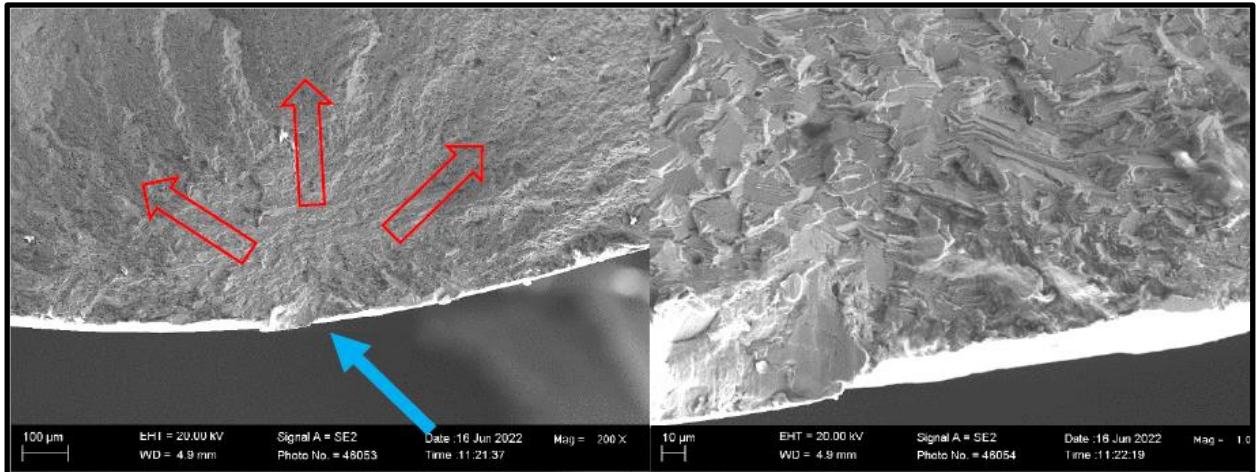
Fractograph 3: Fracture surface morphology (200-1000X, 20kV, SE, FEGSEM)

The fatigue mode of failure was confirmed at higher magnifications with the striation spacing (Fractography 3 and 4) suggesting a low stress/high frequency exposure.

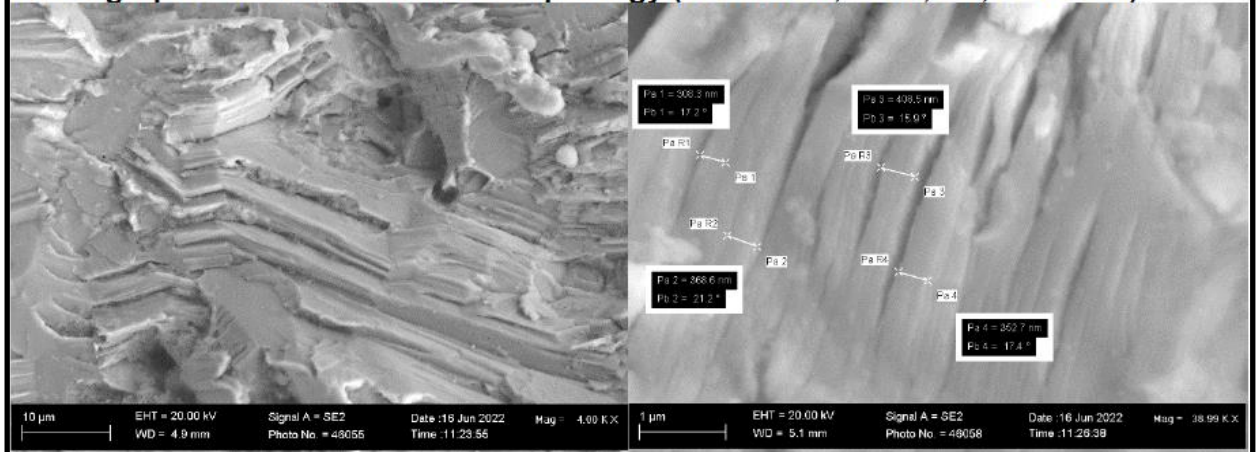
Fractograph 4: Fracture surface morphology (4000-38990X, 20kV, SE, FEGSEM)

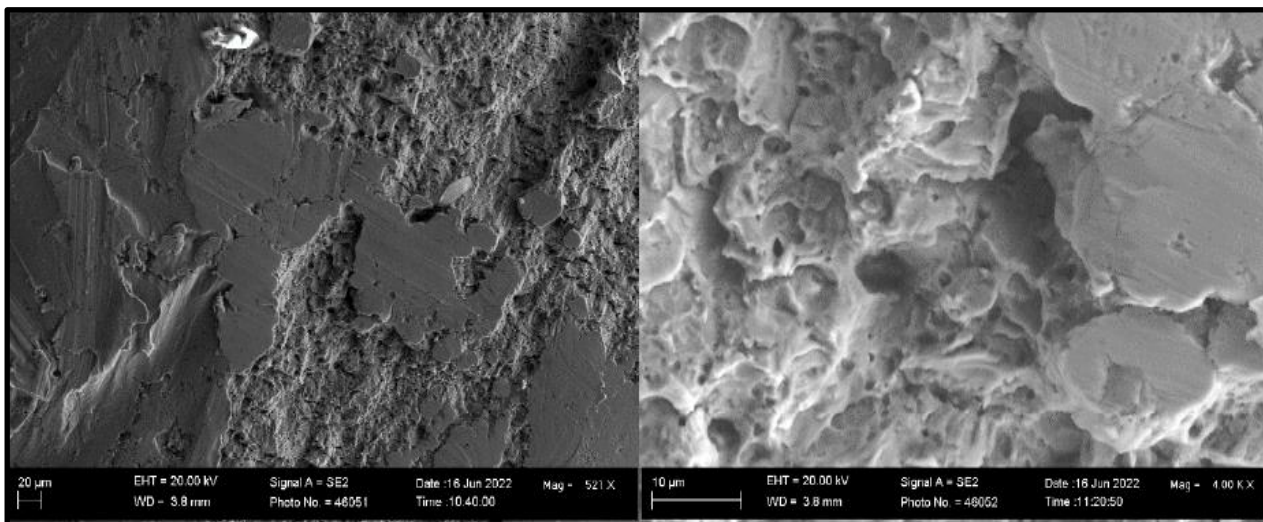
Fractograph 5: Fracture surface morphology (521-4000X, 20kV, SE, FEGSEM)

Remnants of the final fracture area revealed a ductile morphology (Fractography 5) within the mechanically damaged surface.

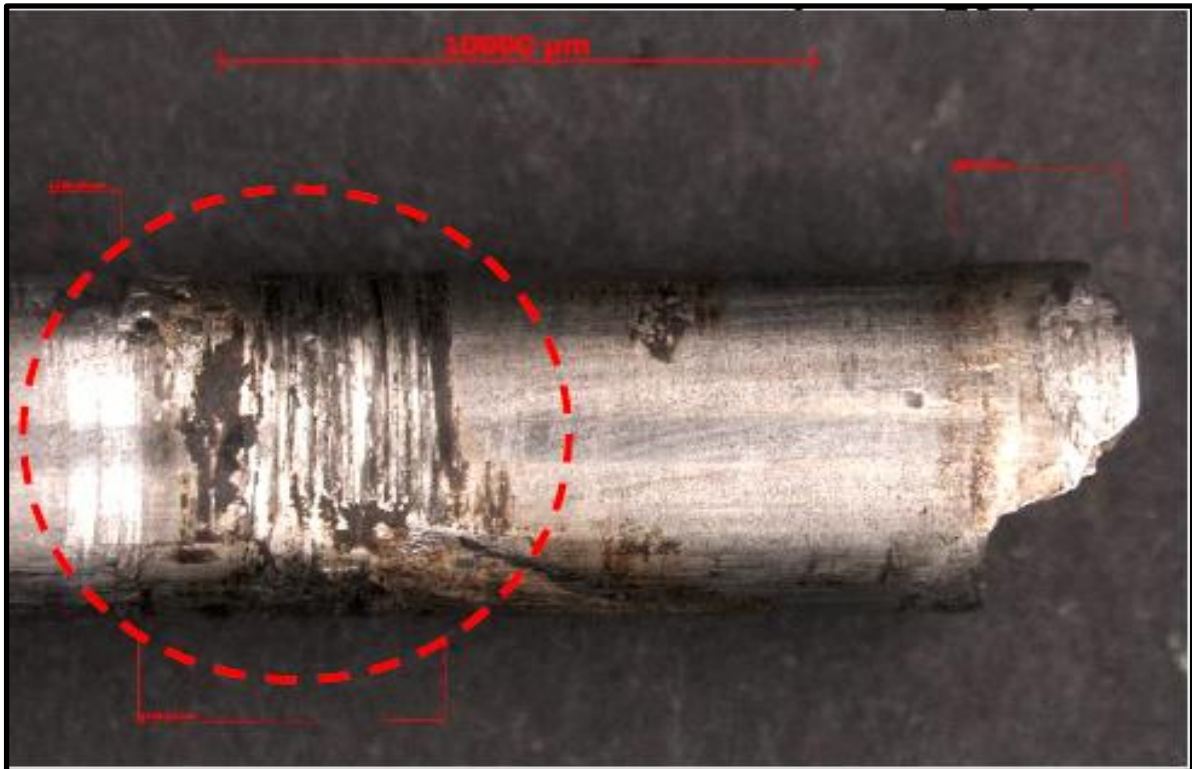
- The outer shank surface areas adjacent to the bolt head and the fracture locations revealed damages consistent with rotation of the bolt within the assembly during operation (Figures 5 and 6 below, red dashed circles above).

Figure 5: Bolt surface showing rotational damages, fracture end (Stereo).

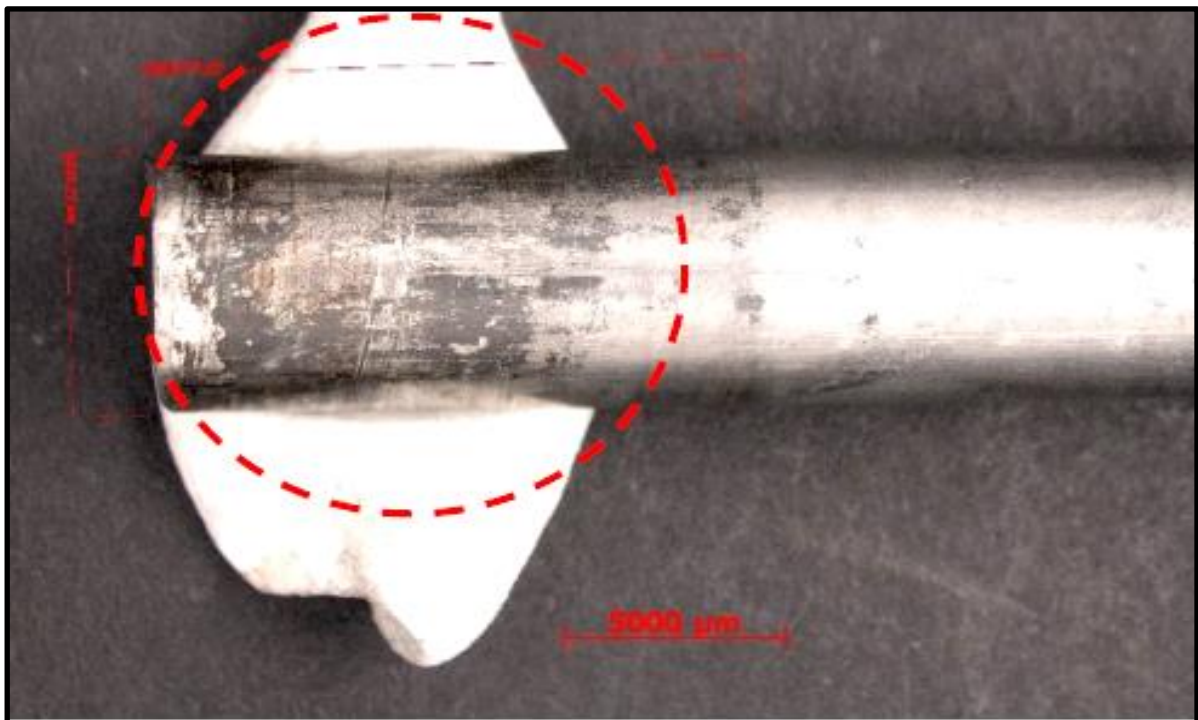
Photo 3: Bolt surface with rotational damages, bolt head end (Stereo).

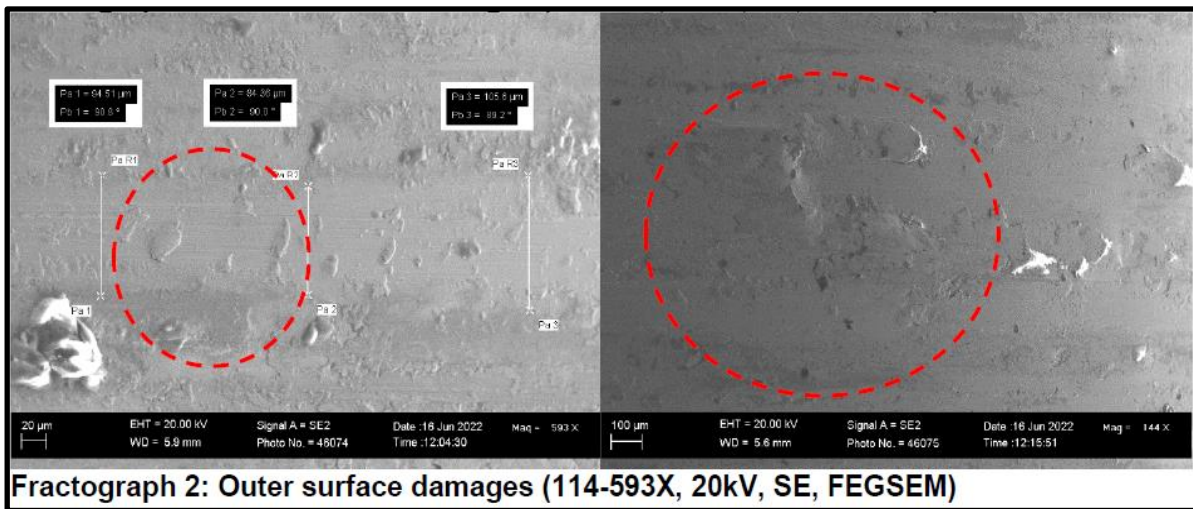
- Higher magnification revealed metal smearing and indications of fretting damages (Fractography 1 above and 2 below, red dashed circles) confirming the rotation of the bolt during operation. This is furthermore supported by the noted progression direction changes of the fatigue fracture.

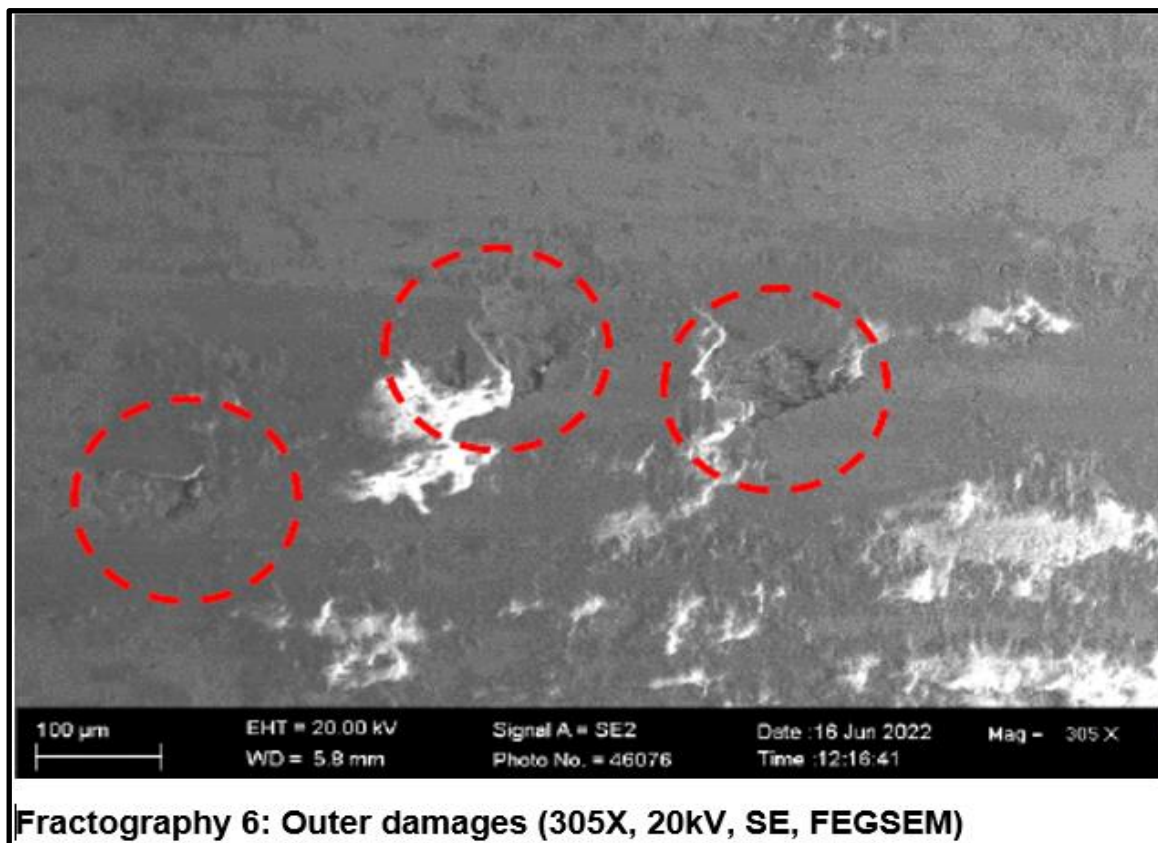
The fretting damages, due to the rotation, introduced multiple locations of surface damages (pitting) due to the mechanical fusion between the washers/supports and the bolt surface during operation (Fractography 6, red dashed circles). These surface damages will act as surface stress raisers and will be detrimental to the fatigue resistance of the component. The initiation of the fatigue fracture within the lower stressed shank- rather than the threaded section of the bolt supports this conception.
