LIMITED SERIOUS INCIDENT INVESTIGATION REPORT
--

Reference Number		CA18/3/2/1373					
Classification	Serious Incident	Date	20 September 2021	Time	0540Z		
Type of Operation		Private (Part 94)					
Location							
Place of Departure		Hoedspruit Civil Aerodrome (FAHT), Limpopo Province		Place of Intended Landing		Hoedspruit Civil Aerodrome (FAHT), Limpopo Province	
Place of Occurrence		Southern Cross private school rugby field, Limpopo Province					
GPS Co-ordinates	Latitude	S24° 21'.20"	Longitude	E30°57'.08"	Elevation	1712 feet	
Aircraft Information							
Registration		ZU-CZY					
Model/Make		Bantam B22J (Serial No: 03-0222)					
Damage to Aircraft		None		Total Aircraft Hours	821.3		
Pilot-in-command							
Licence Valid		Yes	Gender	Male	Age	31	
Licence Type		National Pilot Licence (NPL)					
Total Hours on Type		1339.3		Total Flying Hours	1866.8		
People On-board		1 + 0	Injuries	0	Fatalities	0	
Other (On Ground)		0					
What Happened							
<p>On Monday morning, 20 September 2021, a pilot on-board a Bantam B22J high-wing monoplane aircraft with registration ZU-CZY was conducting circuits at Hoedspruit Civil Aerodrome (FAHT) in Limpopo province when the incident occurred. Prior to

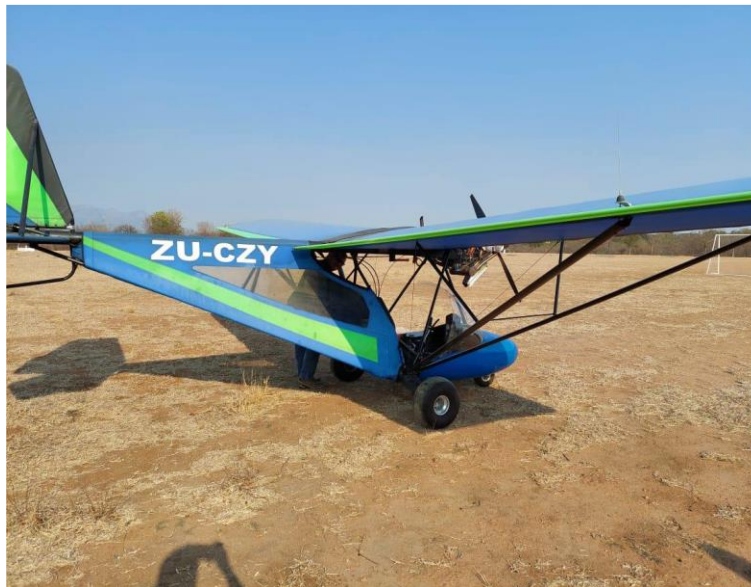
Figure 1: The aircraft on the school rugby field. (Source: Operator)

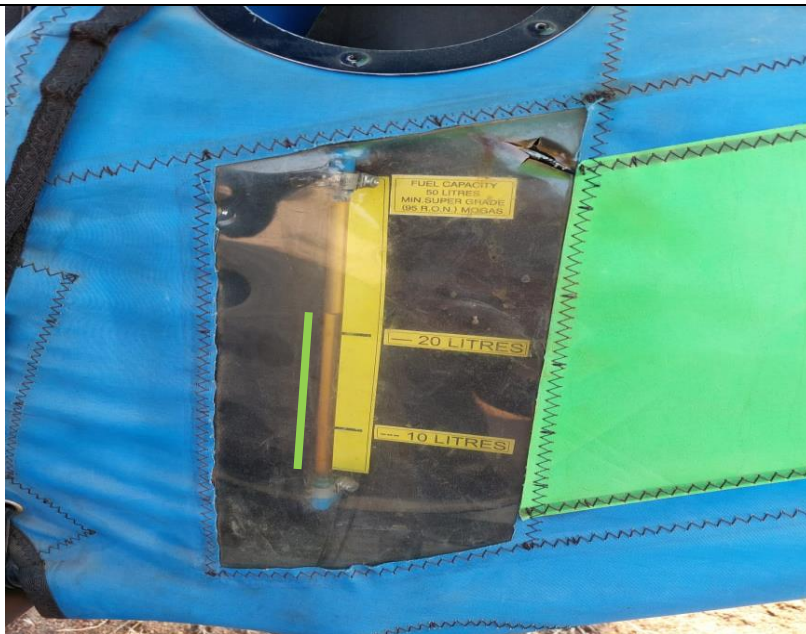
The aircraft was recovered to the South African Civil Aviation Authority (SACAA) approved aircraft maintenance organisation (AMO) in FAHT where it was examined by the approved person (AP). No evidence of oil or fuel leak was noted on any of the fuel and oil system components. The fuel tank had about 27 litres of fuel remaining. Fuel was observed in the fuel line, fuel filter and in the carburettor bowl. Fuel was of the correct grade (95 Octane unleaded) and green in colour. The security of the spark plugs on the engine, leads and electrical connections were checked and found satisfactory.

Figure 2: The fuel tank on the aircraft with fuel level visible. (Source: Operator)

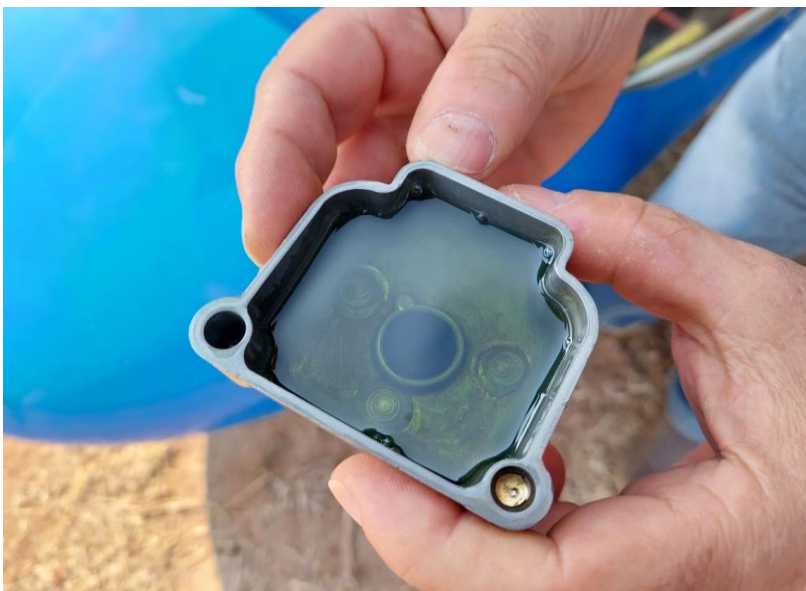
Figure 3: 95 Octane unleaded fuel found in the carburettor bowl. (Source: Operator)
