<b>LIMITED SERIOUS INCIDENT INVESTIGATION REPORT</b>
--

<b>Reference Number</b>	CA18/3/2/1374						
<b>Classification</b>	Serious Incident	<b>Date</b>	3 October 2021	<b>Time</b>	0530Z		
<b>Type of Operation</b>	Private (Part 91)						
<b>Location</b>							
Place of Departure	Eagles Creek, Gauteng Province	Place of Intended Landing	Eagles Creek, Gauteng Province				
Place of Incident	Magaliesburg General Flying Area						
GPS Co-ordinates	Longitude	S 25°53'47"	Latitude	E 028°01'55"	Elevation	4700 ft	
<b>Aircraft Information</b>							
Registration	ZS-SWX						
Model/Make	Grumman American AA-5 Traveler (Serial number: AA5-0040)						
Damage to Aircraft	Minor	Total Aircraft Hours	3201.2				
<b>Pilot-in-command</b>							
Licence Type	Private Pilot Licence (Aeroplane)	Gender	Male	Age	59		
Licence Valid	Yes						
Total Hours on Type	7.6	Total Flying Hours	736.8				
People On-board	1 + 1	Injuries	0	Fatalities	0	Other (on ground)	0
<b>What Happened</b>							
<p>On 3 October 2021 at about 0530Z, a pilot and a passenger on-board a Grumman American AA-5 Traveler aircraft with registration ZS-SWX were on a private flight from Eagles Creek Airport in Gauteng province, with the intention to

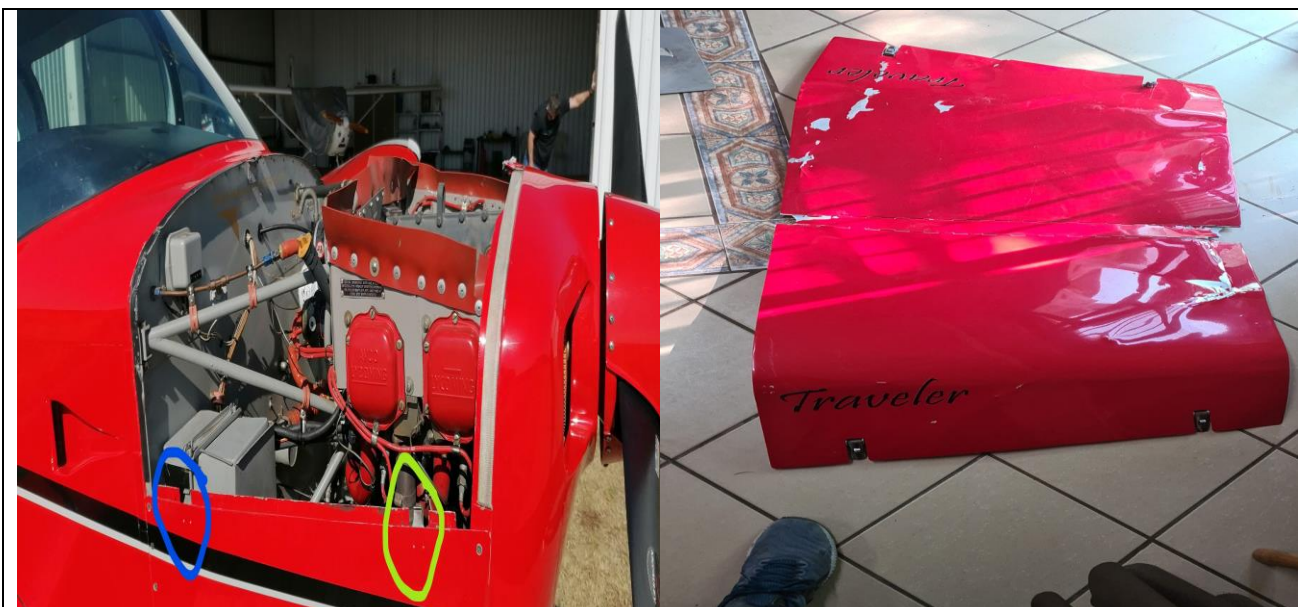
- 1) Following the incident, the pilot reported that he recalled the engine cowling being properly latched and secured when checked during pre-flight inspection, as this happened 30 minutes into the flight. During post-incident inspection, the pilot discovered that the port side bottom latch clip was bent, but he could not determine if this occurred before or during flight, considering the incident of the cowling detaching during flight. The cowling latch brackets on the lower cowling were found bent, indicating that the latches were fastened when the top cowling separated.

- 2) Part of the hinge bracket had sheared but it was still attached to the engine firewall bracket and nose cowl by the screws designed to hold it in place; and there was evidence that the screws did not shear. There was no other damage found on the airframe. Once the top cowling was located, the latches were inspected and found to be serviceable. Following the incident, the aircraft maintenance organisation (AMO) replaced the engine cowling and latches.

- 4) It is likely that the port side cowl latches were weakened and lost effectiveness/integrity over time during the flight when the cowling cover was raised by airflow from the starboard side. It is also likely that during pre-flight inspections, the pilot may have overlooked whether the port side cowl latches were properly secured. It is probable that during flight, with air flowing through the cowling, the latches further loosened, causing the cover to detach from the starboard side. Part of pre-flight inspection from the Pilot's Operating Handbook (POH) requires that the cowling be checked for security.

**Figures 1 and 2:** The engine bay and cowling cover that detached in-flight. The circle in blue indicates the starboard normal latch hook; and the circle in lime green shows the stretched hook. (Source: Pilot)

The engine cowling separated in-flight due to the starboard side engine cowl latches that were not properly secured.

Inadequate pre-flight inspection conducted prior to the flight.

Pilots are encouraged to ensure that they conduct a thorough and proper pre-flight inspection before each flight.
