**LIMITED SERIOUS INCIDENT INVESTIGATION REPORT**

<b>Reference Number</b>	CA18/3/2/1375					
<b>Classification</b>	Serious Incident	<b>Date</b>	5 October 2021	<b>Time</b>	1745Z	
<b>Type of Operation</b>	Training (Part 141)					
<b>Location</b>						
Place of Departure	Karoo Gateway (Beaufort West) Aerodrome (FABW), Western Cape Province		Place of Intended Landing	Karoo Gateway (Beaufort West) Aerodrome (FABW), Western Cape Province		
Place of Accident	Runway 08, Karoo Gateway (Beaufort West) Aerodrome (FABW), Western Cape Province					
GPS Co-ordinates	Latitude	32° 18' 16.3" South	Longitude	022° 39' 42.0" East	Elevation	2 929 feet
<b>Aircraft Information</b>						
Registration	ZS-SWP					
Model/Make	Piper Seminole 44-180					
Damage to Aircraft	Substantial		Total Aircraft Hours	3 398.6 hours		
<b>Pilot-in-command</b>						
Licence Type	Airline Transport Pilot Licence (ATPL) (Aeroplane)		Gender	Male	Age	29
Licence Valid	Yes					
Total Hours on Type	647.3		Total Flying Hours	2 426.3

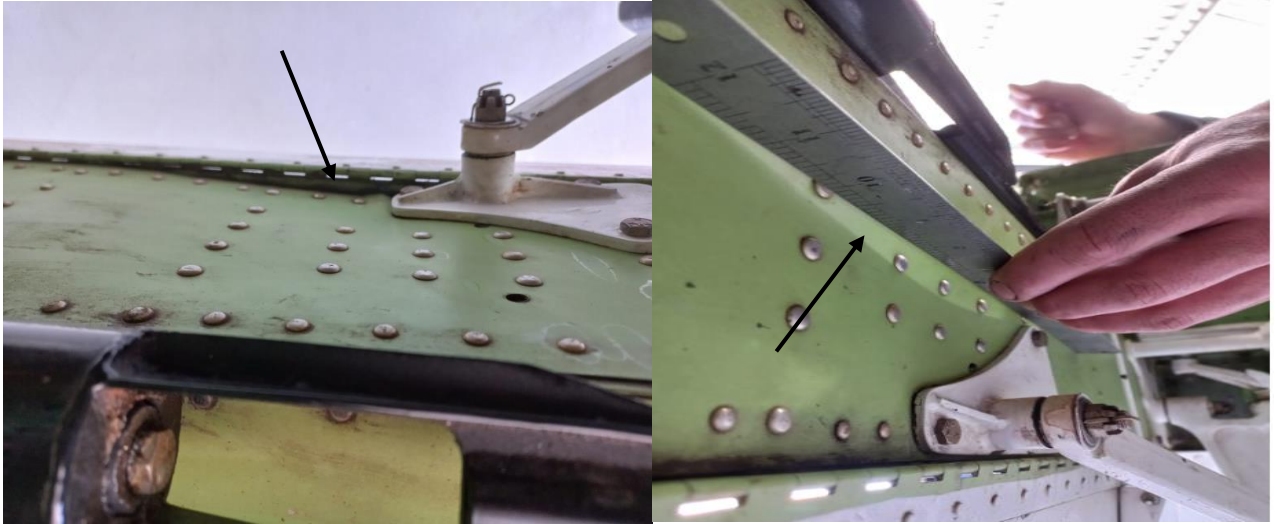
- The aircraft sustained substantial damage in the nose section area with aluminium extrusions along the lower spars, sheared bolt that attaches to the drag link, nose spar box structure that had flexed upwards and cracked lengthwise, bent ribs on the nose support, sheared rivets that attaches the spar box to the bottom skin, 'wrinkles'/buckles along the left- and right-side of the fuselage skin, cracked and flaking drag link assembly and cracked bushes that attaches the drag link to the arm assembly.

**Figures 1 and 2:** The arrows show a bend/dent on the nose spar box structure where a drag link assembly attach.  
(Source: AMO)

The aircraft's nose landing gear impacted an antelope during take-off rotation.

- Both the left- and the right-side engines along with the associated propeller were not damaged. The carbon fibre nose cone was also not damaged.
- The aircraft was issued a special flight permit with an expiry date of 9 November 2021 for repositioning for maintenance repairs at an aircraft maintenance organisation (AMO) facility in Nelspruit, Mpumalanga province.

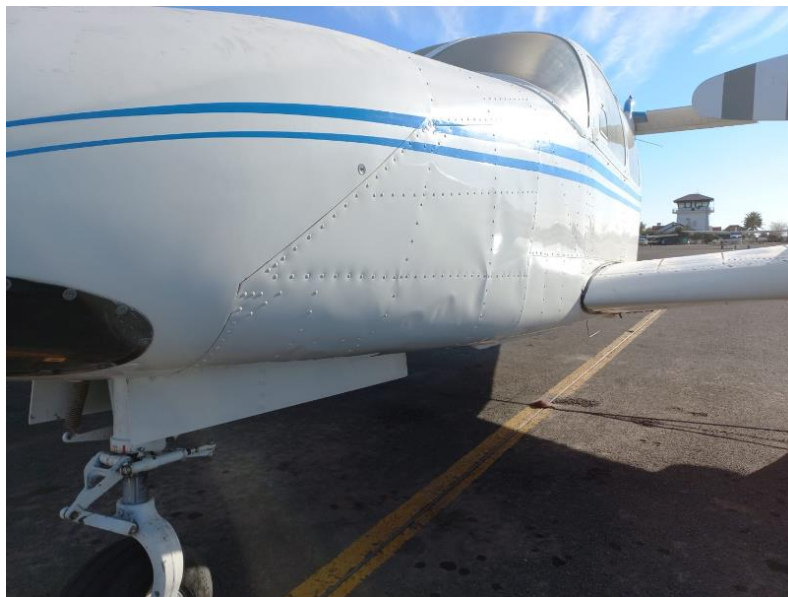
**Figure 3:** Wrinkles/buckles on the fuselage skin. (Source: AMO)

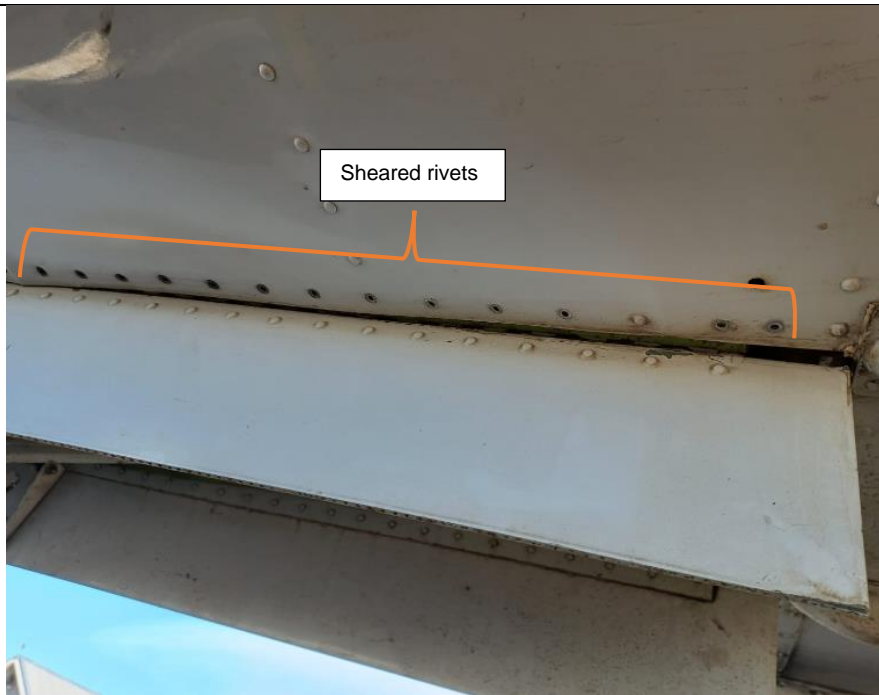
**Figure 4:** Sheared rivets that attach the skin to the nose spar box structure near the nose gear door. (Source: AMO)
