LIMITED SERIOUS INCIDENT INVESTIGATION REPORT
--

Reference Number		CA18/3/2/1376					
Classification	Serious Incident	Date	10 October 2021	Time	1200Z		
Type of Operation	Private (Part 91)						
Location							
Place of Departure	Bethlehem Airfield (FABM), Free State Province	Place of Intended Landing	El Mirador Airfield (FALQ), KwaZulu-Natal Province				
Place of Incident	Runway 06 at El Mirador Airfield (FALQ), Bergville in KwaZulu-Natal Province						
GPS Co-ordinates	Latitude	28°59'10.73" South	Longitude	029°28'34.12" East	Elevation	3924ft	
Aircraft Information							
Registration	ZT-GZG						
Model/Make	Motor Glider Stemme S-12						
Damage to Aircraft	Minor	Total Aircraft Hours	360				
Pilot-in-command							
Licence Valid	Yes	Gender	Male	Age	60		
Licence Type	Glider Pilot Licence (GPL)						
Total Hours on Type	532		Total Flying Hours	913			
People On-board	1+0	Injuries	0	Fatalities	0	Other (on ground)	0
What Happened							
<p>On 10 October 2021, the pilot on-board a Motor Glider Stemme S-12 with registration ZT-GZG took off from Bethlehem Airfield (FABM) in the Free State Province with the intention to land at El Mirador Airfield (FALQ) in Bergville, KwaZulu-Natal Province

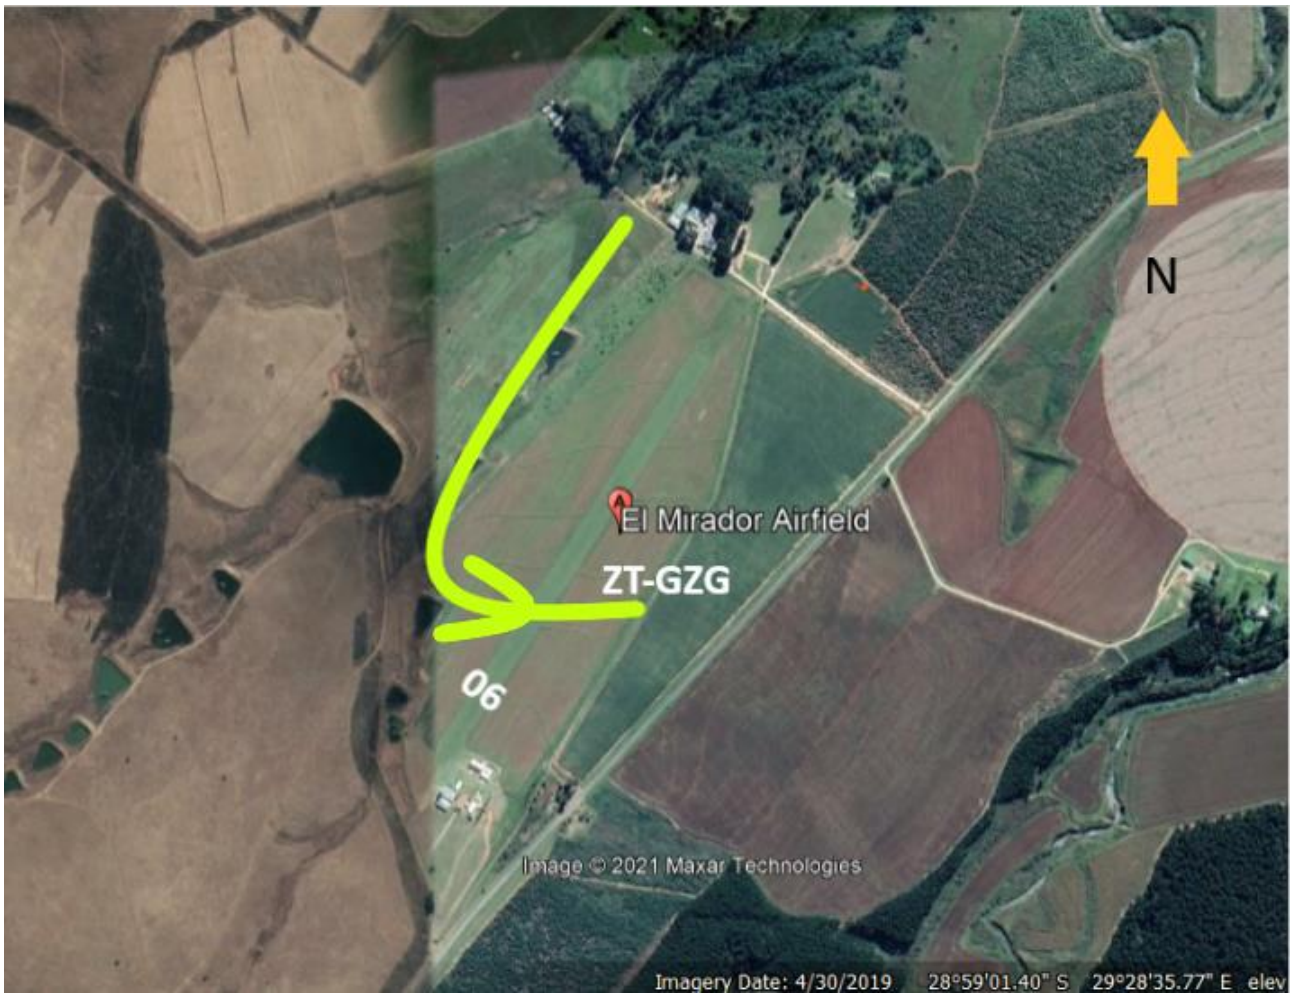
Figure 1: The approach which the pilot followed leading to the incident. (Source: Google Map)

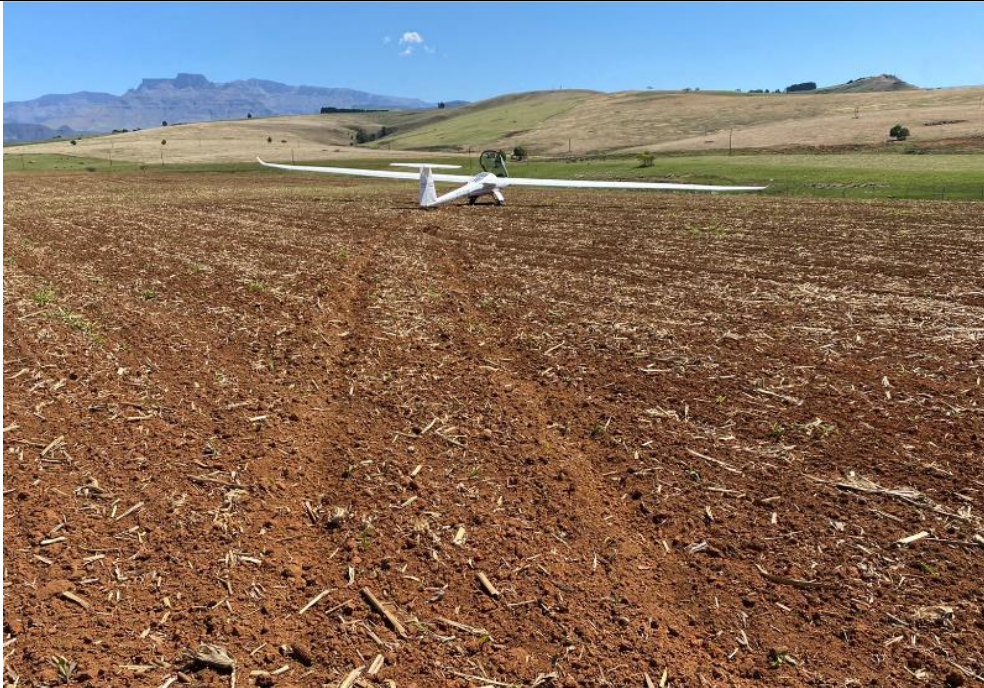
Figure 2: Final resting position of the glider post-incident. (Source: Pilot)

Unstable approach which resulted in loss of control of the glider during the landing roll, causing the glider to veer off the runway.

Operators and pilots are reminded of the dangers associated with not following procedures when joining circuits. Moreover, operators and pilots should conduct runway inspections before final approach for landing at aerodromes.
