**LIMITED SERIOUS INCIDENT INVESTIGATION REPORT**

<b>Reference Number</b>	CA18/3/2/1377						
<b>Classification</b>	Serious Incident	<b>Date</b>	24 October 2021	<b>Time</b>	0800Z		
<b>Type of Operation</b>	Training (Part 141)						
<b>Location</b>							
<b>Place of Departure</b>	Wonderboom Aerodrome (FAWB), Gauteng Province			<b>Place of Intended Landing</b>	Wonderboom Aerodrome (FAWB), Gauteng Province		
<b>Place of Accident</b>	Wonderboom Aerodrome, Runway 11						
<b>GPS Co-ordinates</b>	<b>Latitude</b>	S25°39'12.6"	<b>Longitude</b>	E 28°13'25.19"	<b>Elevation</b>	5280ft	
<b>Aircraft Information</b>							
<b>Registration</b>	ZS-KNG						
<b>Model/Make</b>	Cessna 402C II, Cessna Aircraft Company						
<b>Damage to Aircraft</b>	Substantial			<b>Total Aircraft Hours</b>	1468.7		
<b>Pilot-in-command</b>							
<b>Licence Type</b>	Airline Transport Pilot Licence (ATPL)		<b>Gender</b>	Male		<b>Age</b>	63
<b>Licence Valid</b>	Yes						
<b>Total Hours on Type</b>	277.7			<b>Total Flying Hours</b>	23678.4

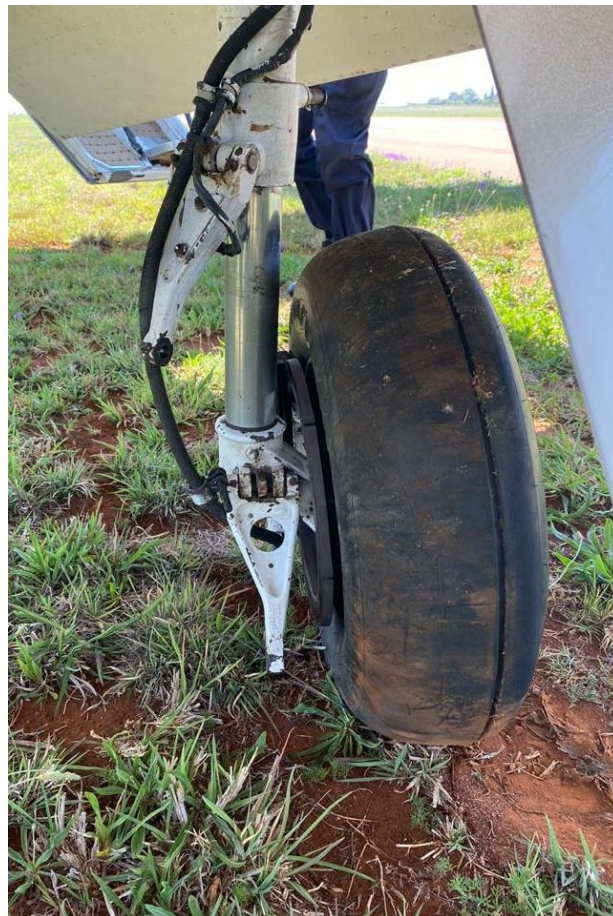
gear due to a separated torque link. The aircraft skidded and came to a stop on the left edge of RWY 11.

**Figure 1:** The left main gear torque link had separated. (Source: Pilot)

The pilot lost control of the aircraft and veered off the runway during the landing roll due to the separation of the bolt and the castellated nut which connect to the torque link. Landing gear failure and improper maintenance/servicing.

Over torque during maintenance.

It is recommended that the AMO adheres to all manufacturer’s technical specifications, especially torque measurements, to avoid similar incidents.

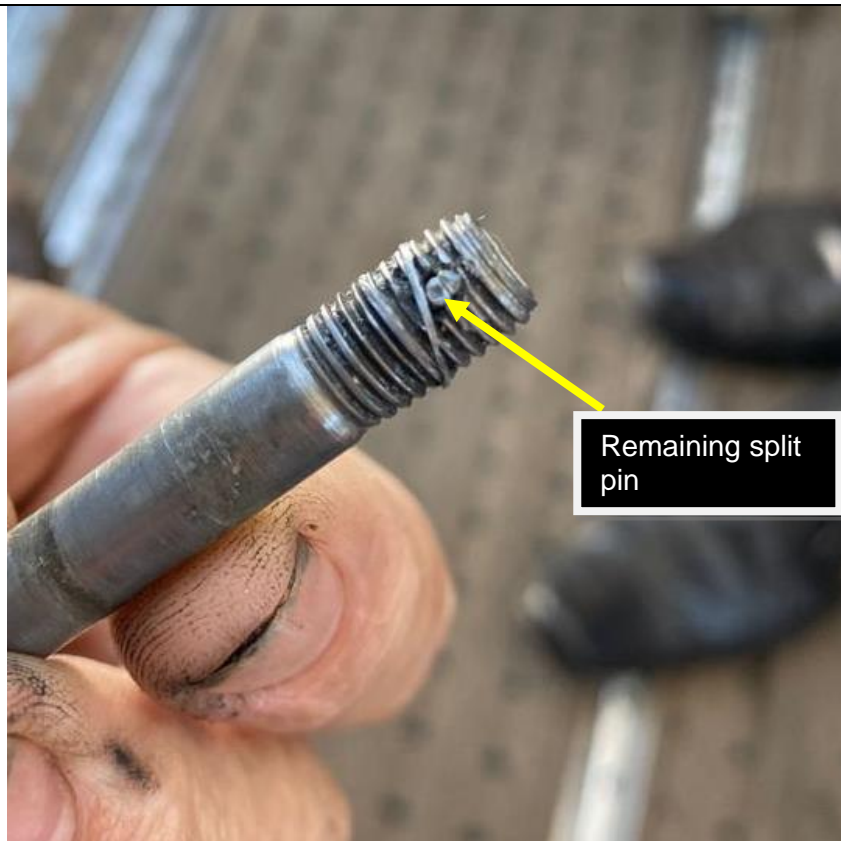
- The 100-hour mandatory periodic inspection (MPI) was completed on 21 October 2021 at 1463.4 Hobbs hours and 10231 airframe hours. The aircraft had flown 5.3 hours since the said MPI.
- According to the aircraft maintenance engineer (AME), the torque link, bolt and castellated nut are on-condition items which are inspected at every inspection, including the MPI.
- Examination of the bolts suggested that during the touch-and-go circuits, the left main gear castellated nut was stripped off and the split pin was sheared. Only the bolt was found at FAWB (see Figure 2).

**Figure 2:** The split pin is contained in the bolt hole. The nut was never found. (Source: Pilot)
