LIMITED SERIOUS INCIDENT INVESTIGATION REPORT

Reference Number	CA18/3/2/1378					
Classification	Serious Incident	Date	13 October 2021	Time	0515Z	
Type of Operation	Training (Part 141)					
Location						
Place of Departure	Port Elizabeth International Airport (FAPE), Eastern Cape Province		Place of Intended Landing	Port Elizabeth International Airport (FAPE), Eastern Cape Province		
Place of Occurrence	Threshold of Runway 35 at Port Elizabeth International Airport (FAPE)					
GPS Co-ordinates	Latitude	33°59'47.21" S	Longitude	25°37'34.90" E	Elevation	229 feet
Aircraft Information						
Registration	ZS-RNH					
Model/Make	Robinson 22 Beta II					
Damage to Aircraft	None		Total Aircraft Hours	4 683.3		
Pilot-in-command						
Licence Type	Commercial Pilot License (CPL)		Gender	Female	Age	32
Licence Valid	Yes					
Total Hours on Type	297.5		Total Flying Hours	531.5		
People On-board	1 + 1	Injuries	0	Fatalities	0	Other (on ground) 0
What Happened						
<p>On 13 October 2021 at about 0436Z, a student pilot (SP) accompanied by a flight instructor (FI) on-board a Robinson 22 Beta II helicopter with registration ZS-RNH was conducting hover training exercises on the threshold of Runway (RW

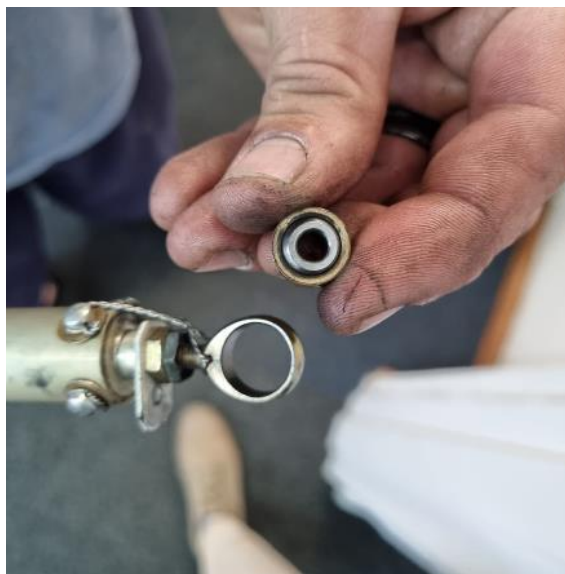
- During post-incident inspection, the engineers found that the insert which houses the ball in the rod end of the overtravel spring had become loose and had separated from the rod end.

- According to the airframe logbook, there was no record of the failed insert rod end being changed since the aircraft came into the country on 27 November 2008 at 3132.8 airframe hours. The rod end seemed to be a Robinson originally supplied part. The rod end is an on-condition part and not a life-limited part.

Figure 1: The rod end with the failed insert. (Source: AMO)

Loss of engine power during hover exercises as a result of a loose insert which houses the ball in the rod end on the throttle control overtravel spring.

- Post-incident, the rod end with the failed insert was removed and replaced with a serviceable part (Part number: A933-3) in accordance with Robinson R22 Maintenance Manual Revision November 2020 paragraph 6.710. Thereafter, the helicopter was tested and found serviceable.

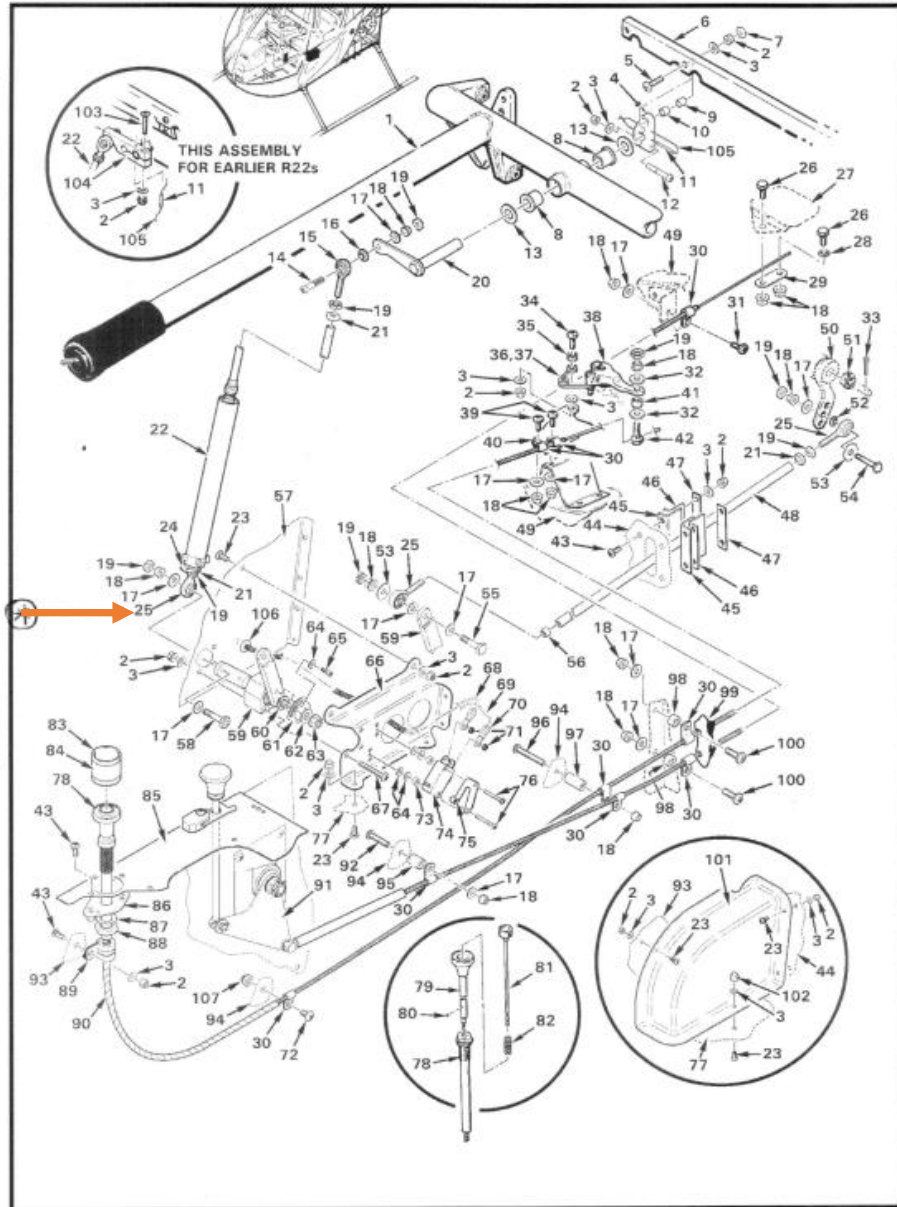
FIGURE 76-1 ENGINE CONTROLS

Diagram 1: The schematic diagram of the engine controls. (Source: Illustrated Parts Catalogue)

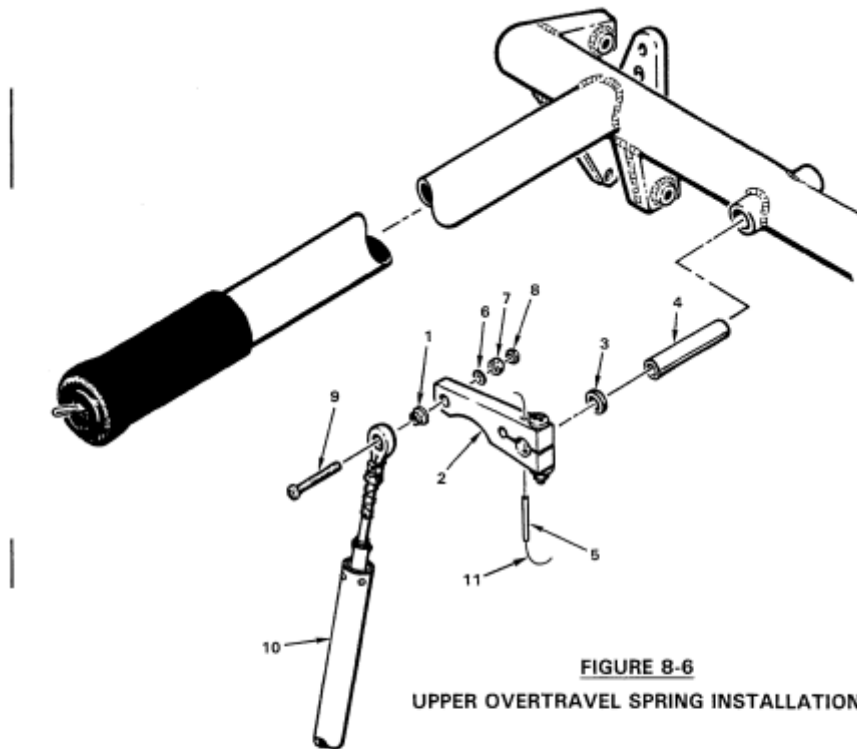
FIGURE 8-6
UPPER OVERTRAVEL SPRING INSTALLATION

- According to the last mandatory periodic inspection (MPI) which was conducted on 25 October 2021 at 15874.81 airframe hours, there was no work done on the rod end with the failed insert prior to the flight. During the last MPI, a collective overtravel spring was changed in accordance with maintenance manual Revision November 2020 paragraph 6.710. The helicopter flew a further 36.34 hours before the incident occurred.

Diagram 2: Overtravel spring diagram. (Source: Robinson Maintenance Manual)
