LIMITED SERIOUS INCIDENT INVESTIGATION REPORT
--

Reference Number	CA18/3/2/1379						
Classification	Serious Incident	Date	13 October 2021	Time	1144Z		
Type of Operation	Training (Part 141)						
Location							
Place of Departure	Virginia Aerodrome (FAVG), KwaZulu-Natal Province	Place of Intended Landing	Virginia Aerodrome (FAVG), KwaZulu-Natal Province				
Place on Incident	Durban South, Old Durban International Aerodrome						
GPS Co-ordinates	Latitude	S 29°57'52.6"	Longitude	E 030°57'12.6"	Elevation	33 feet (ft)	
Aircraft Information							
Registration	ZS-PUR						
Model/Make	C152, Cessna Aircraft Company						
Damage to Aircraft	Minor	Total Aircraft Hours	5810.9				
Pilot-in-command							
Licence Type	Commercial Pilot Licence (CPL)	Gender	Male	Age	28		
Licence Valid	Yes						
Total Hours on Type	397.6		Total Flying Hours	896.9			
People On-board	1 + 1	Injuries	0	Fatalities	0	Other (on ground)	0
What Happened							
<p>On 13 October 2021, a flight instructor and a student pilot on-board a Cessna 152 aircraft with registration mark ZS-PUR were on a training flight from Virginia Aerodrome (FAVG) to Durban general flying area (GFA) to practice forced landing exercises. The flig

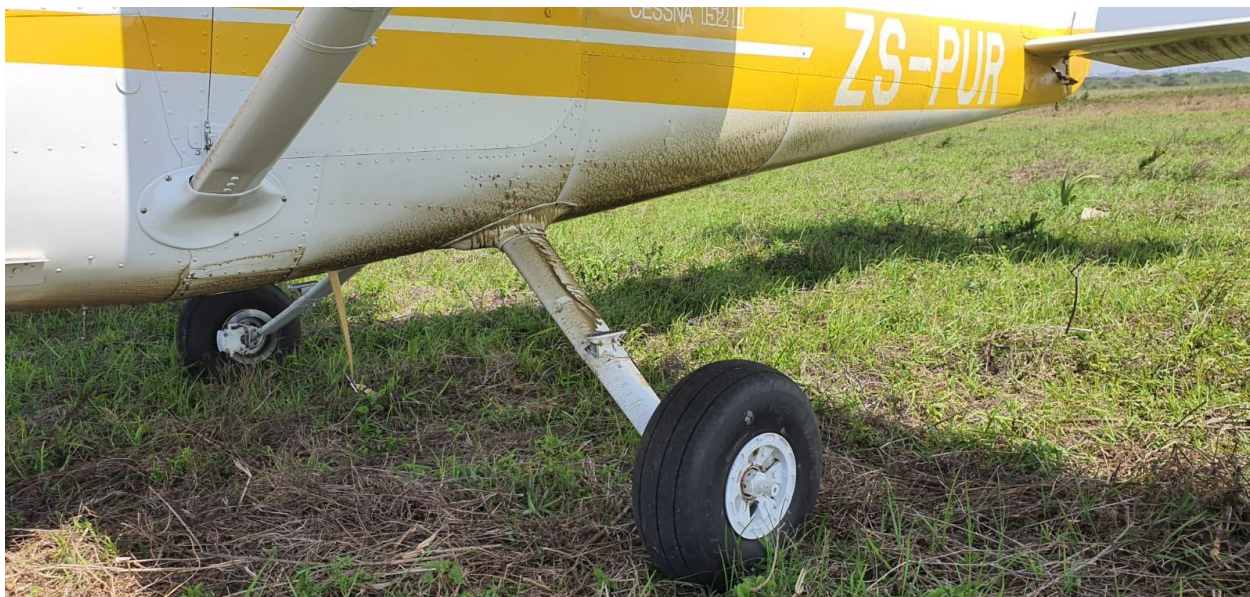
Figure 1: The airframe covered in leaked oil. (Source Pilot)

- The aircraft was released to service following a 100-hour mandatory periodic inspection (MPI) on 5 October 2021 at 5792.2 Tachometer hours and had completed 18.8 hours before the incident.
- According to the aircraft maintenance organisation (AMO), a crankshaft seal was damaged, which led to oil leakage, oil pressure drop and engine seizure. The crankshaft seal was fitted during engine overhaul on 5 February 2018 at 4798.7 airframe hours.
- The crankshaft seal comes in a kit and is fitted according to service instruction (SI) 1324C of 26 May 2009 and it is replaced on condition.
- There were no oil pressure or oil quantity snags entered in the last five pages of the flight folio prior to the incident flight; the only entry that was in the flight folio was the release to service after the MPI.

Engine stoppage in-flight due to oil leakage which resulted in a drop in oil pressure because of a damaged crankshaft seal, causing the pilot to execute a successful forced landing; engine failure.
