LIMITED SERIOUS INCIDENT INVESTIGATION REPORT

Reference Number	CA18/3/2/1380						
Classification	Serious Incident	Date	14 October 2021	Time	1540Z		
Type of Operation	Private (Part 91)						
Location							
Place of Departure	Skukuza Airport (FASZ), Mpumalanga Province			Place of Intended Landing	Rand Airport (FAGM), Gauteng Province		
Place of Accident	Semi-prepared field, 3 nautical miles south of FAGM						
GPS Co-ordinates	Latitude	26°17'17.1" S	Longitude	28°10'37.8" E	Elevation	5 438 feet	
Aircraft Information							
Registration	ZS-IOP						
Model/Make	Cessna A150L (Serial Number: A150-0326)						
Damage to Aircraft	None			Total Aircraft Hours	10 030.7		
Pilot-in-command							
Licence Type	Commercial Pilot Licence (CPL)		Gender	Male		Age 62	
Licence Valid	Yes						
Total Hours on Type	325.6			Total Flying Hours	2 225.3		
People On-board	1+1	Injuries	0	Fatalities	0	Other (on ground)	0
What Happened							
<p>On 14 October 2021, a pilot and a passenger on-board a Cessna A150L with registration ZS-IOP took off on a private flight from the Rand Airport (FAGM) in Gauteng province to Kruger Mpumalanga International Airport (FAKN) and, later, to Skukuza Airport (FASZ) in Mpumalang

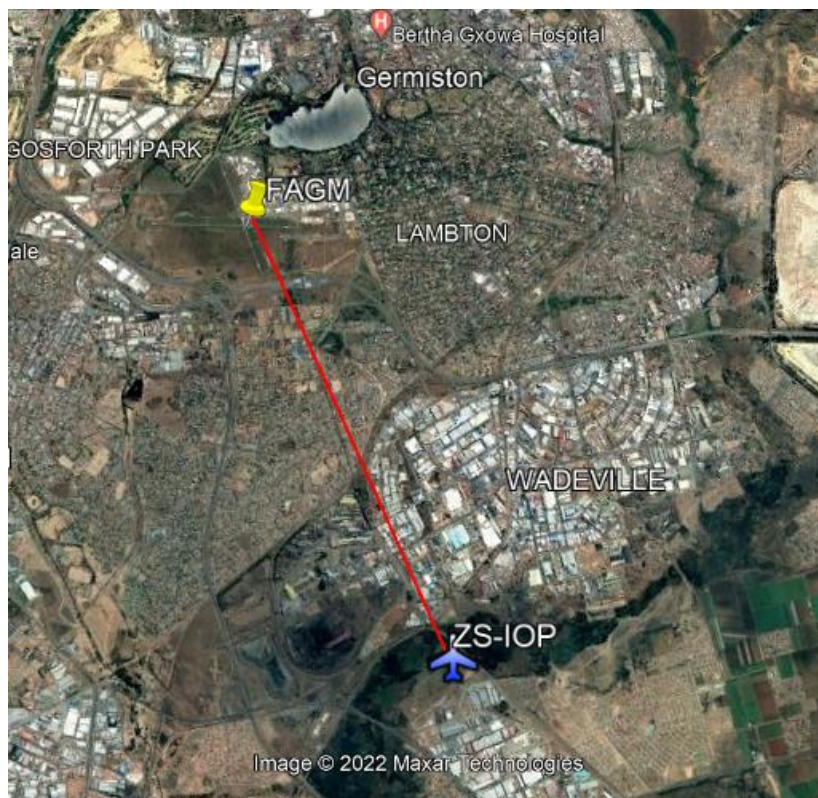
forced landing on a semi-prepared field approximately 3 nautical miles (nm) south-east (SE) of FAGM; the aircraft landed safely.

The aircraft was not damaged, and both occupants were not injured during the serious incident.

Figure 1: The approximate landing site of the aircraft. (Source: Google Earth)
