LIMITED SERIOUS INCIDENT INVESTIGATION REPORT

Reference Number	CA18/3/2/1381						
Classification	Serious Incident	Date	20 October 2021	Time	1100Z		
Type of Operation	General Aviation and Operating Flight Rules (Part 91)						
Location							
Place of Departure	Upington International Airport (FAUP), Northern Cape province		Place of Intended Landing	Oranjemund International Airport (FYOG), Namibia			
Place of Accident	17 nautical miles (nm) west of FAUP, Northern Cape Province						
GPS Co-ordinates	Latitude	S 28° 25' 20"	Longitude	E 20° 56' 33"	Elevation	3525 ft	
Aircraft Information							
Registration	ZS-HNB						
Make/Model	Bell 412 EP (Serial Number: 36317)						
Damage to Aircraft	None		Total Aircraft Hours	13 008.2			
Pilot-in-command							
Licence Valid	Yes		Gender	Male		Age	31
Licence Type	Airline Transport Pilot Licence (Helicopter)						
Total Hours on Type	145.0		Total Flying Hours	6 345.0			
People On-board	1 + 2	Injuries	0	Fatalities	0	Other (On Ground)	0

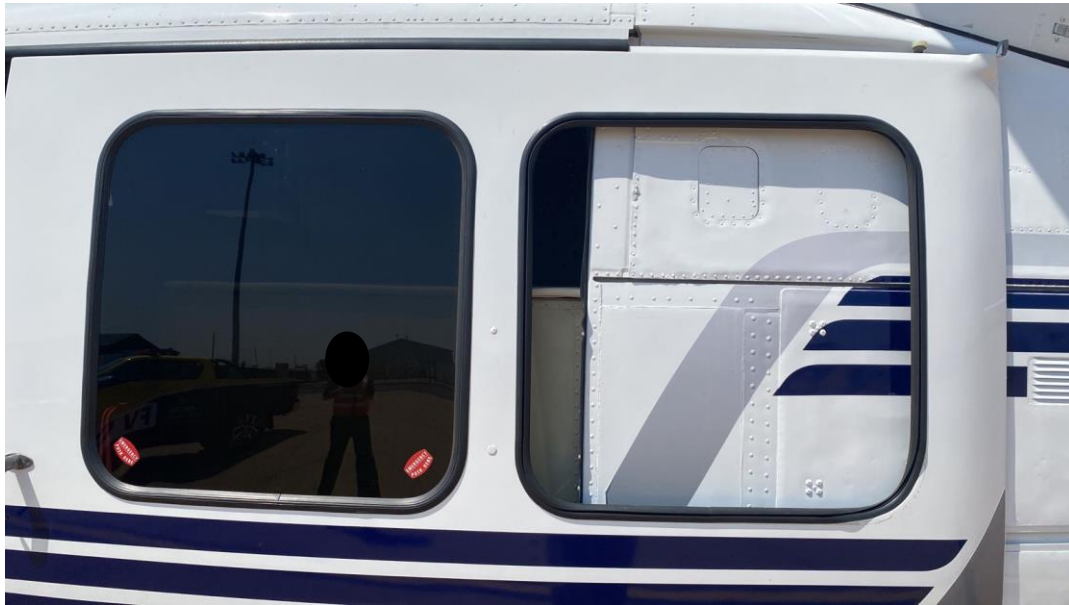
The pilot stated that they were 10 minutes into the flight with all doors closed when the aft left cargo door window detached from its frame. The pilot further stated that it was a sudden event, with no pre-warning indication to the crew. The pilot immediately descended to the approximate area where the window had fallen to see if they can locate it, but they were unable to locate it. They then returned to FAUP. The helicopter landed back at FAUP without any further damage. The

Figure 1: The left rear cargo door with no window. (Source: Operator)

- The helicopter had flown 4.5 hours since the installation of the window.
- The window frame was inspected, and the retainer seal and filler seal had remained in place; not due to improper bonding.
- The PMA window that was installed was thinner and more flexible than the Original Equipment Manufacturer (OEM) window. The OEM windows were 0.150 inch thick whilst the PMA window was 0.125 inch thick.
- Technical Bulletin No. 412-86-54 states:

- The window that was installed was within the minimum thickness specifications but was thinner than the OEM windows.

It is likely that the installed window was thinner and more flexible than the OEM part and, most probably, detached from the door structure during cruise due to helicopter vibration.

The operator had since taken a decision to install all the windows for their entire fleet with OEM approved parts.
