LIMITED SERIOUS INCIDENT INVESTIGATION REPORT
--

Reference Number	CA18/3/2/1382						
Classification	Serious Incident	Date	14 October 2021	Time	1630Z		
Type of Operation	Parachute (Part 105)						
Location							
Place of Departure	Mossel Bay Aerodrome (FAMO), Western Cape	Place of Intended Landing	Mossel Bay Aerodrome (FAMO), Western Cape				
Place of Incident	Mossel Bay						
GPS Co-ordinates	Latitude	S 34°09'25"	Longitude	E 022°03'41"	Altitude	16500 feet (ft)	
Aircraft Information							
Registration	ZS-OHB						
Model/Make	Beechcraft Aircraft, King Air B90 (Serial Number: LJ-431)						
Damage to Aircraft	None		Total Aircraft Hours	10950.6			
Pilot-in-command							
Licence Type	Private Pilot Licence (PPL)	Gender	Male	Age	55		
Licence Valid	Yes						
Total Hours on Type	530		Total Flying Hours	1150			
People On-board	1+15	Injuries	0	Fatalities	0	Other (on ground)	0
What Happened							
<p>On 14 October 2021 at 1606Z, a pilot and 15 parajumpers on-board a King Air B90 aircraft with registration mark ZS-OHB took off from Mossel Bay Aerodrome (FAMO) on a paradropping exercise overhead the aerodrome with the intention to land at the same aerodrome. The flight was conducted during d

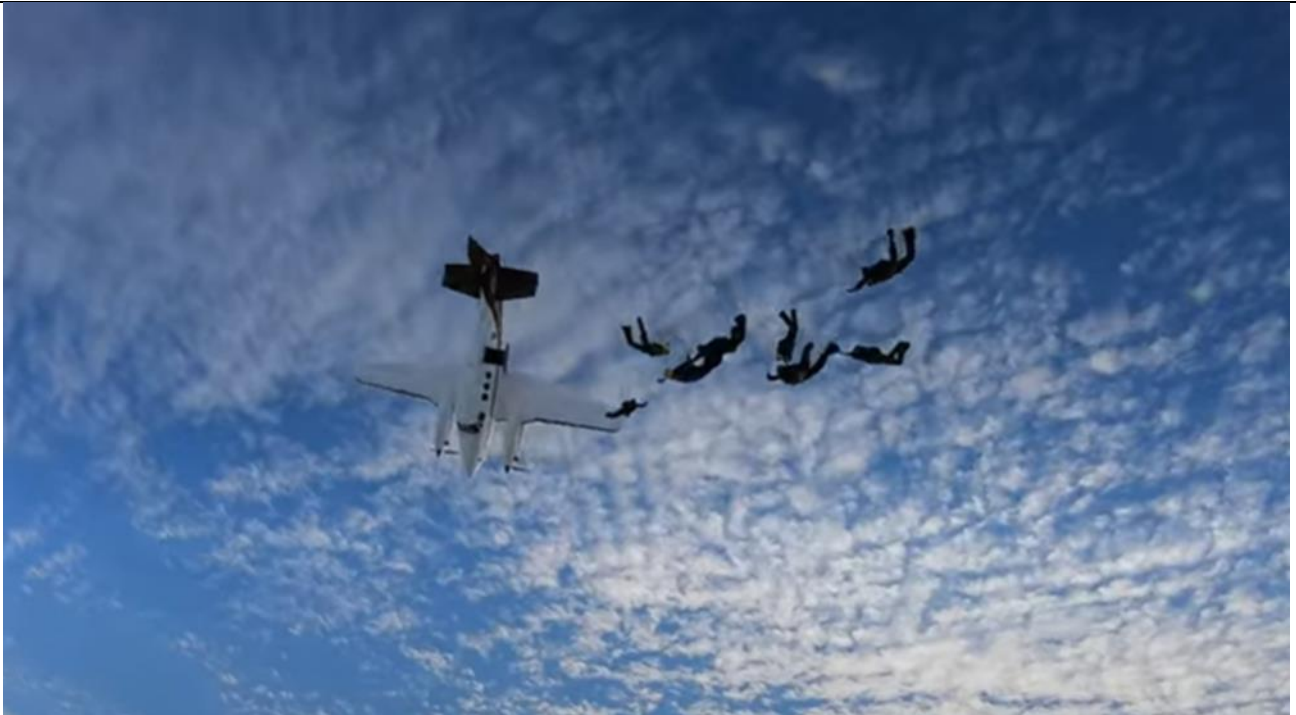
- Weather: visibility 9999m; wind: light and variable; clouds broken at 1800ft; overcast at 3700ft, QNH: 1013. The weather did not contribute to the incident.
- When the sixth jumper exited and joined the group outside of the aircraft, the aircraft started to pitch up and entered a stall from which the pilot recovered after two spins.

Figure 2: The aircraft as it enters the two spins before recovery. (Source: www.youtube.com)

During a paradropping exercise while the jumpers were preparing to launch, a change in-flight configuration caused the centre of gravity (CoG) to shift aft, resulting in the aircraft stalling and entering a left-side spin. The aircraft completed two spins before the pilot recovered and landed safely.

- The operator stated that in future, a maximum of five jumpers will be allowed on the outside step.
- The operator will brief the big formations to be wary/observant of the pitch movement of the nose of the aircraft.
- This information will be placated inside the aircraft and will be part of the briefing before departure.

- It is recommended to the operator to review/include the procedure that will ensure that the jump master monitors all jumps and that he/she be the last one to jump out.
- It is recommended to the Director of Civil Aviation that the SACAA should consider evaluating the effectiveness of its Part 105 operation oversight programme, as well as ensure that Part 105 operations are conducted at the same level of safety as Part 121 and 135 operations.
