| LIMITED SERIOUS INCIDENT INVESTIGATION REPORT |

| Reference Number | CA18/3/2/1384 | | | | | | |
| Registration | ZU-NDP | | | | | | |
| Make/Model | Jabiru J430 (Serial Number: 353) | | | | | | |

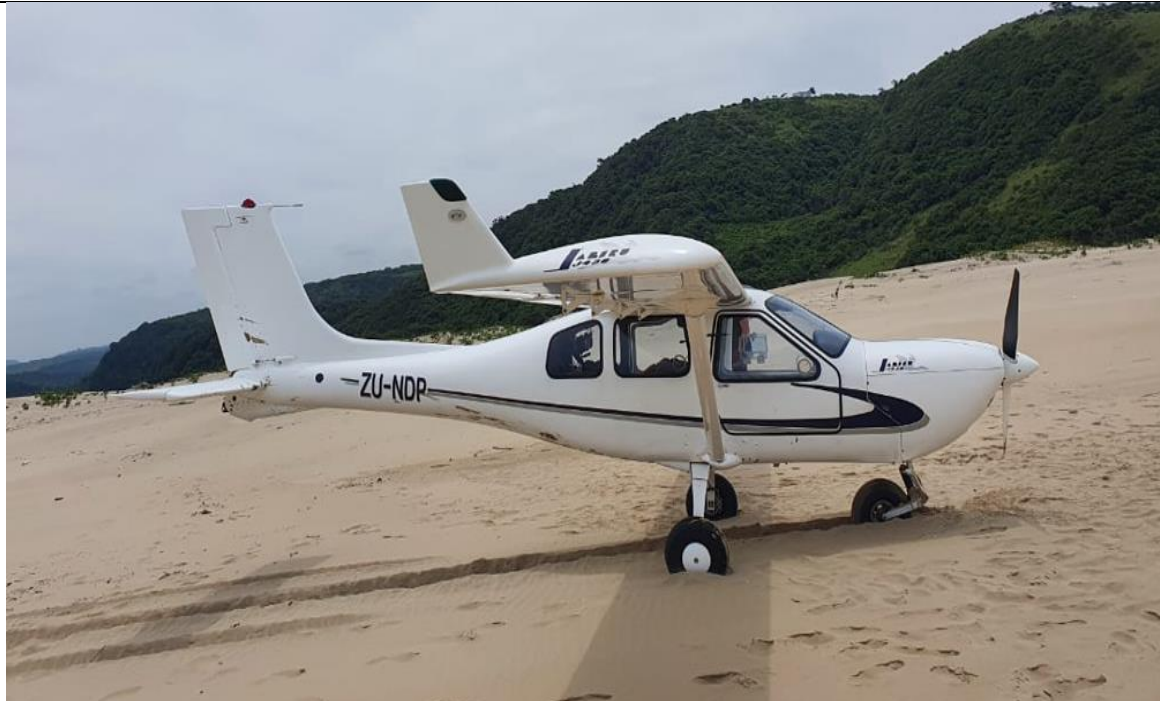
| <p>On Thursday morning, 9 December 2021, a pilot and a passenger on-board a Jabiru J430 aircraft with registration ZU-NDP took off on a private flight from Wings Park Aerodrome, near East London in the Eastern Cape province, to Virginia Aerodrome (FAVG) in KwaZulu-Natal province. The flight was conducted under visual flight rules (VFR) by day and under the provisions of Part 94 of the Civil Aviation Regulations (CAR) 2011 as amended.</p> <p>Approximately one hour into the flight and 140 nautical miles (nm) from FAVG in proximity to Port St Johns, the engine suddenly lost power and, shortly thereafter, it stopped. The pilot then scanned the area for a suitable place to execute a forced landing, and decided on the beach at Port St Johns. During the forced landing, the nose gear dug into the soft sand, bringing the aircraft to a stop.</p> | | | | | | | |

Post-incident examination of the aircraft indicated no visible damage to the nose gear and the propeller. The two occupants were not injured.

Figure 2: The aircraft as it came to rest. (Source: Pilot)

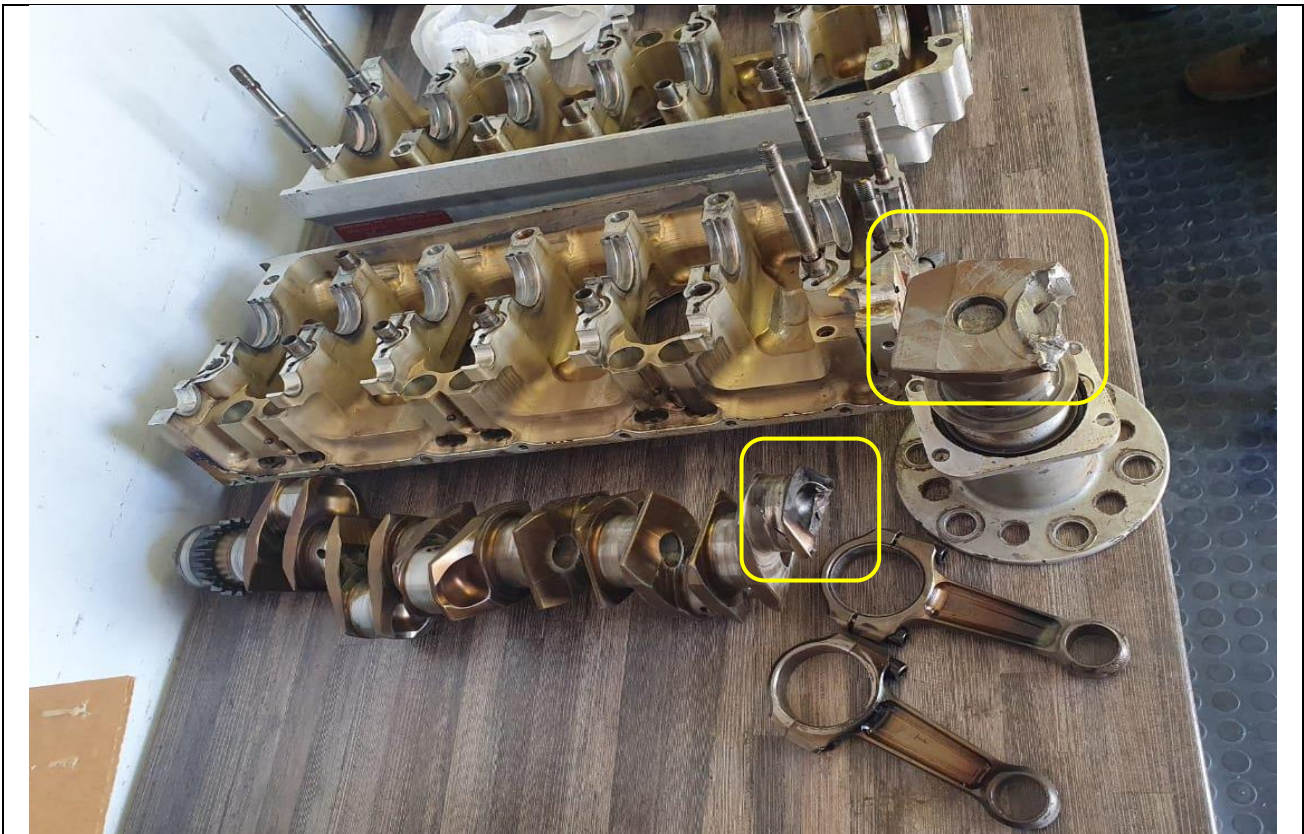
Figure 3: The dismantled engine with the fractured crankshaft. (Source: Manufacturer)

- (vii) The engine was removed from the airframe because the engine ground test run could not be performed as it was not possible to turn the engine. During a teardown inspection of the engine, it was found that the crankshaft had sheared. It is likely that the engine could have been overfilled at some point of its operational life.

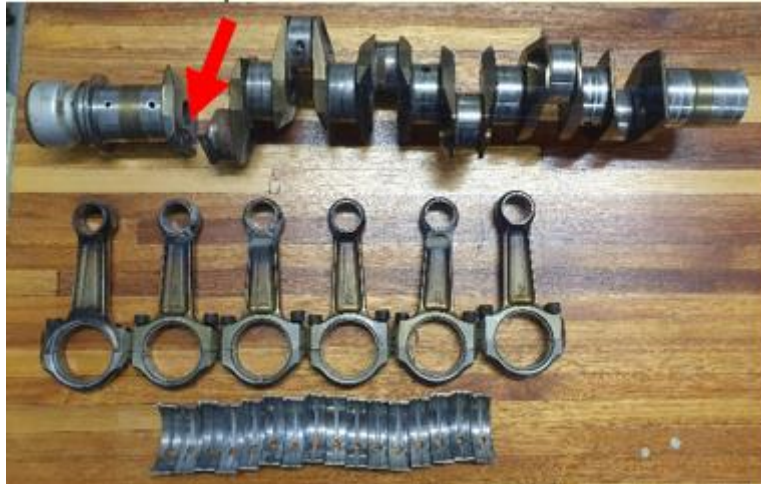
Photo 2: Fractured crankshaft assembly (digital).

The visual inspection revealed a fractured crank shaft at the No. 1 Conrod Big End (BE) position (Photos 2 and 3, red arrows; Diagrams 1 and 2, red arrow).

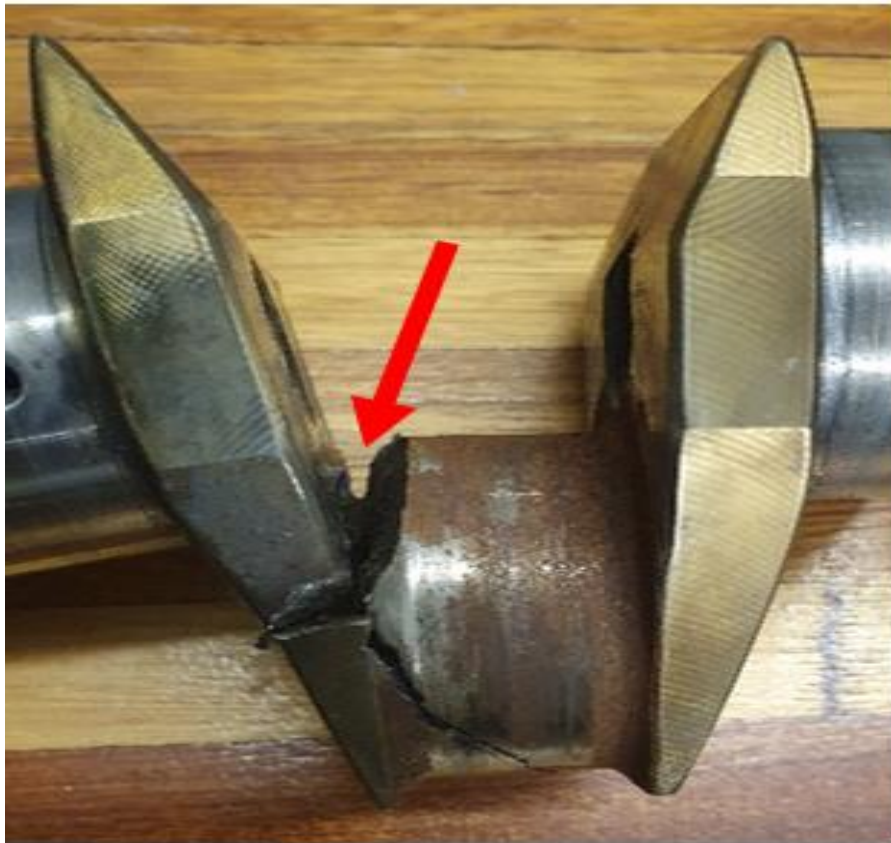
The No. 1 BE journal revealed extensive post-failure corrosion that is inductive of high temperature exposure (Photo 3).

Photo 3: Conrod fracture position (digital).

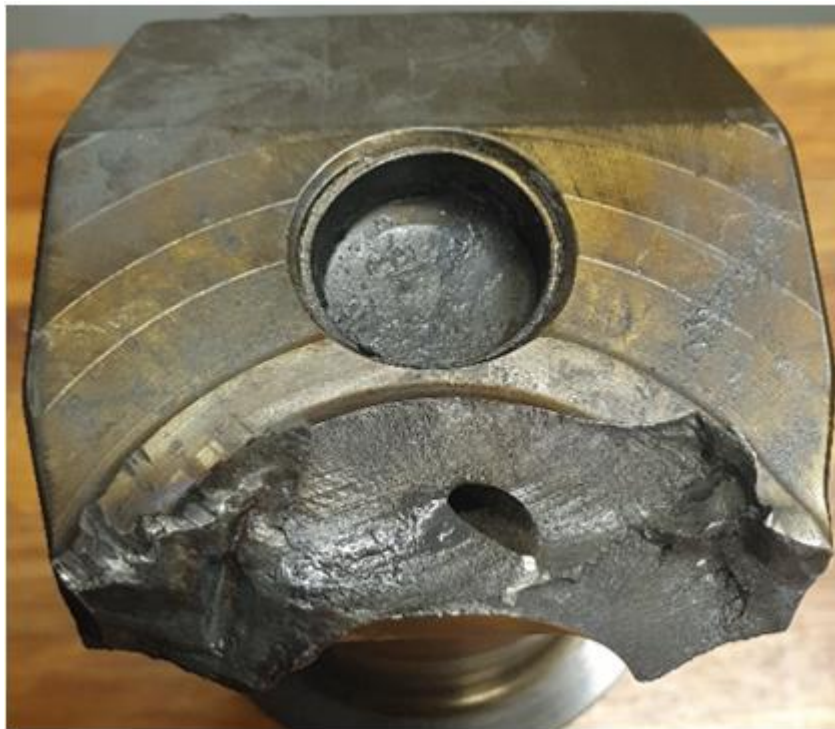
The fracture surface revealed indications towards a fatigue failure mode (Photo 4) originating at two locations within radii with progression directions as indicated (Photo 5, red arrows).

Photo 4: Fractured surface morphology (digital).

The Investigation results revealed the crankshaft fractured at the No. 1 Conrod BE position within the radii with **fatigue** as the primary failure mode. The most probable causational factor/s towards the originating of the fatigue failure could be one, or a combination of the following:

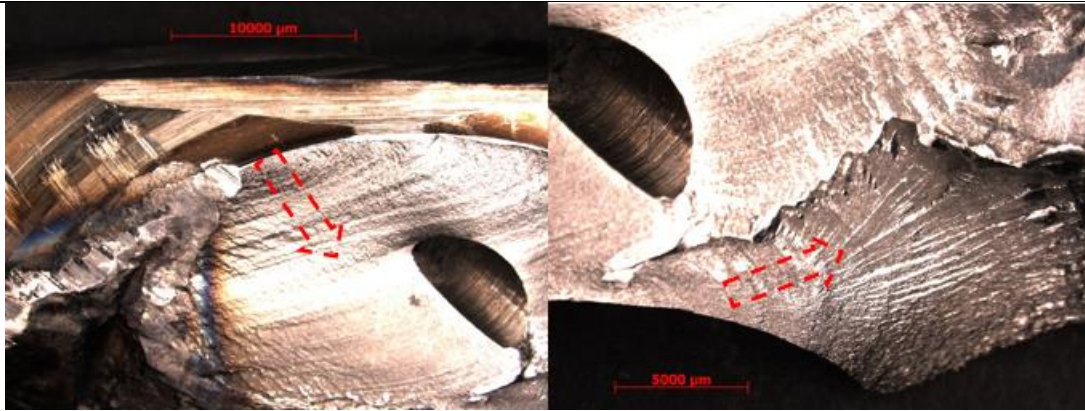
Photo 5: Fractured surface morphology (stereo).

The Main Journal/Crankcase Bearings revealed indications of significant wear and metal impregnation (Photo 5). The former could be considered within limits considering the Total Time Since New (TTSN) while the latter is supportive towards oil pressure/quantity during operation.

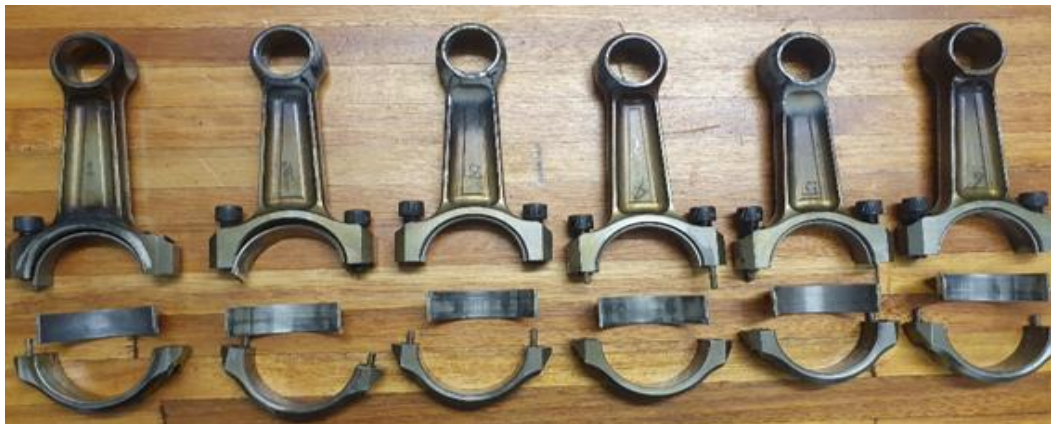
The conrod assembly inspection revealed high temperature exposures to the SEs, excessive wear to the moving parts of the No 1 Conrod assembly and significant wear to the 2-6 BE bearings (Photo 7) - the latter could be considered within limits considering the TTSN.

Photo 7: Conrod and BE Bearing conditions (digital).

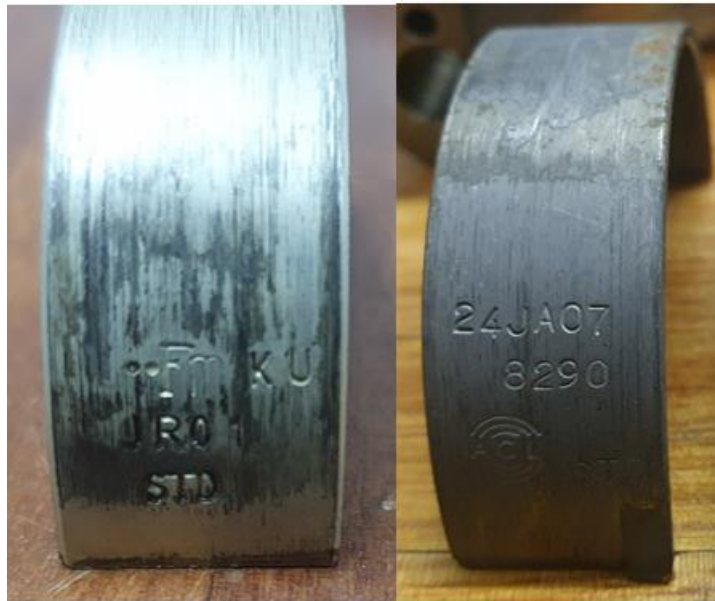
A discrepancy was noted between the No. 1 Conrod BE and the remaining BE bearing Part Numbers (Photo 8; Table 1).

Photo 8: Variation in part numbers – Conrod BEs 2-5 (left) and Conrod BE 1 (right) (digital).

- (viii) According to available information, the No.1 Conrod BE bearing (Part number: FM KU JR01 STD) was replaced on 10 May 2017 with Part Number 24JA07 8290, which was not recognised by the manufacturer, therefore, the investigation concluded that the No1. Conrod bearing was not a manufacturer-approved part.

The No.1 conrod bearing which was fitted prior to the accident flight was not a manufacturer-approved part.

| <ol style="list-style-type: none"> 1. It is recommended to the operators/AMOs to always ensure the fitment of the manufacturer-approved components or part/s in their engines or aircraft to avoid incidents such as this one. 2. It is recommended that the Regulator (SACAA) conducts an audit of the AMO and operator to ensure conformance to their issued approvals and ensure that there are established methods within the operator and the AMO to prevent incidents such as these from occurring. | |

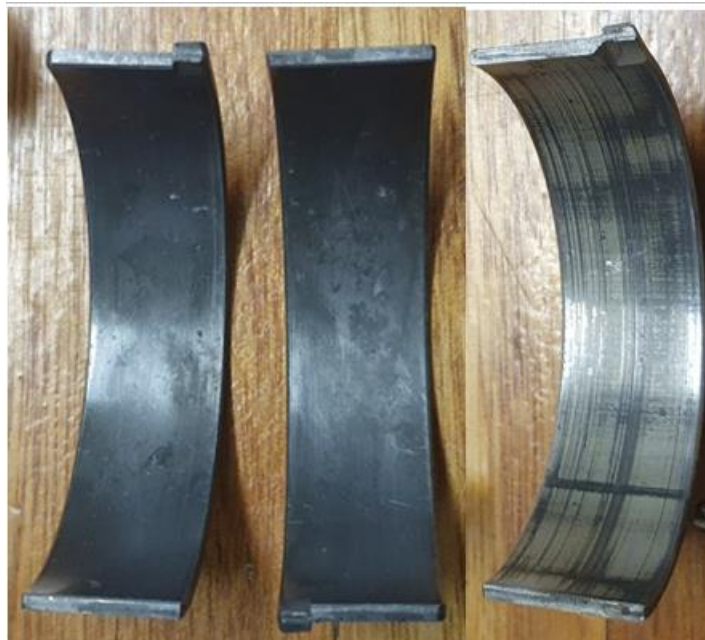
Excessive wear of the No. 1 Conrod BE bearing was noted in contrast with the remaining BE bearings (Photo 9; Fractograph 3).

Photo 9: Variation in surface wear – No 1 Conrod BE bearings (left), remaining BE bearing (right) (Digital)

EDS results from the No. 1 BE bearing revealed that the greater part of the top Sn-layer was removed during operation while the remaining No 2-6 BE Bearings revealed the opposite (EDS 3 and 4).

The variation in wear-rates between the No. 1 and the remaining BE bearings could result in similar dimensional (thickness) variations over a period of operational time.

Incorrect Conrod BE bearing fitted at the No. 1 position: Although the reason/s for the noted discrepancy between the No. 1 and the remaining BE bearing Part Numbers could not be affirmed by this investigation, the variations in wear-rate between the bearings were noticeable. The latter could result in dimensional (thickness) variations during operation that will be detrimental to the applied stress at the crankshaft No. 1 Conrod BE journal position. Although the relevant aircraft logbook revealed no indication of an overhaul procedure due to the remaining Time Between Overhaul (TBO) of 122.4 hours, there is an inscription towards inspection/maintenance surrounding the crankshaft assembly dated 10 May 2017
