LIMITED SERIOUS INCIDENT INVESTIGATION REPORT

| Reference Number | CA18/3/2/1387 | | | | | | |
| Registration | ZS-HHJ | | | | | | |
| Make/Model | Tamarack Helicopters Inc / UH-1H (Serial Number: 65-09637) | | | | | | |

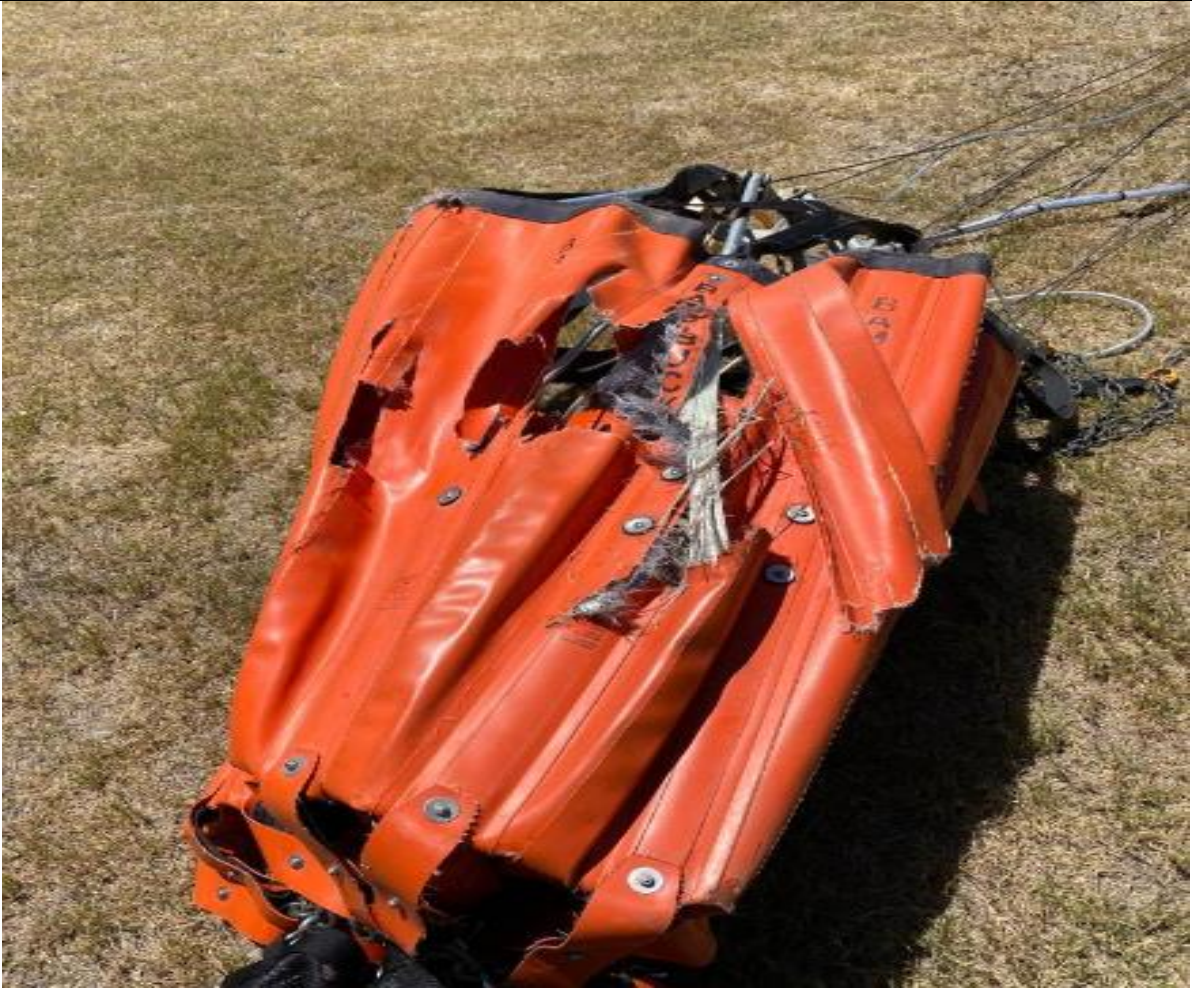
Figure 1: The damaged Bambi bucket. (Source: Operator)

The Bambi bucket got entangled on the tail rotor guard as well as made contact with the tail rotor blades after it disappeared from the pilot's helicopter mirror view in-flight.

- It is recommended to the operator to amend the Operation Manual and include water filling procedure and limitation as it currently does not address and/or clearly define water filling/upliftment from a shallow water source and mitigation procedure that must be taken when the bucket cables are snagged as a result of filling water from a shallow water source.
- It is recommended that the operator reviews and amends the Operation Manual Chapter 15.6 General Rules and Limitations for the tail rotor clearance calculation to be in line with the Bambi Bucket Operations Manual.
- It is recommended that pilots who operate sling loads land as soon as practical when the load or sling is out of sight or out of the inspection/monitoring mirror.

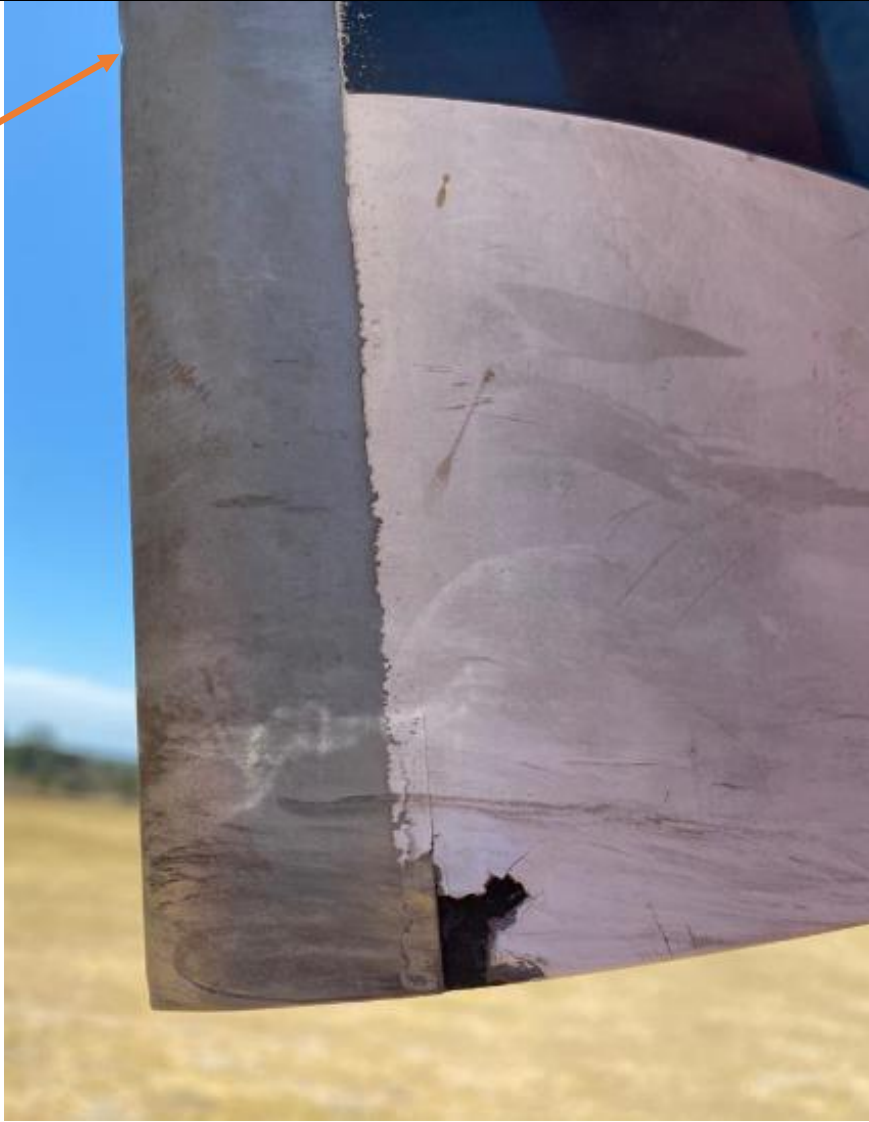
As the Bambi bucket was not visible in the pilot's mirror field of vision (these mirrors are used by the pilot to monitor the sling load below the helicopter), the pilot assumed that it had either detached and fell off or had gotten entangled on an external part of the helicopter (the skid gear). The flight controls were tested by the pilot for any damage whilst still on the descent phase to the landing zone, flying at 30 knots with minimum control inputs (pilot induced). There was no vibration felt by the pilot, or loss of tail rotor authority experienced during the approach for landing. The helicopter landed on the sports field. After shutdown and during the walk-around inspection, the pilot noticed that the Bambi bucket was still suspended by two of the suspension cables from the helicopter's tail rotor guard. Further inspection revealed that the Bambi bucket was damaged, which appeared to have been caused during contact with the tail rotor blades. The helicopter sustained damage to both tail rotor blades. No person was injured during the incident.

Figure 2: The damaged tail rotor blade with a nick on the leading edge.
(Source: Operator)

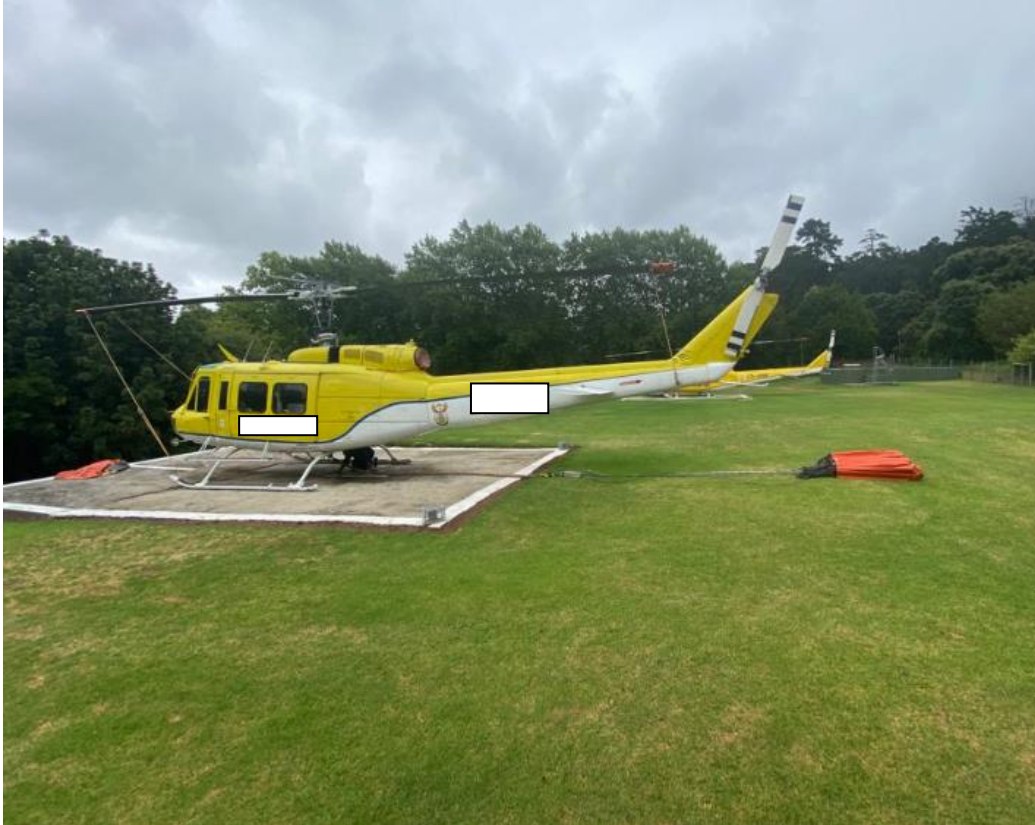
Figure 3: A similar helicopter fitted with a 5m synthetic sling line. (Source: Operator)
