LIMITED SERIOUS INCIDENT INVESTIGATION REPORT

Reference Number		CA18/3/2/1388					
Classification	Serious Incident	Date	23 January 2022	Time	0900Z		
Type of Operation		Private (Part 91)					
Location							
Place of Departure		The Coves Aerodrome, Gauteng Province		Place of Intended Landing		The Coves Aerodrome, Gauteng Province	
Place of Accident		The Coves Aerodrome Gauteng Province					
GPS Co-ordinates		Latitude	25°46'38"S	Longitude	027°47'35.0" E	Elevation	3885 feet
Aircraft Information							
Registration		ZS-BDE					
Model/Make		Extra Flugzeugbau GmbH, EA-300L (Serial Number: 153)					
Damage to Aircraft		Minor		Total Aircraft Hours		1185.1	
Pilot-in-command							
Licence Valid		Yes		Gender		Male	
						Age	
						51	
Licence Type		Commercial Pilot Licence (CPL)					
Total Hours on Type		325.7		Total Flying Hours		2984.2	
People On-board		1+0		Injuries		0	
				Fatalities		0	
				Other (on ground)		0	
What Happened							
<p>On 23 January 2022, a pilot on-board an Extra Flugzeugbau aircraft with registration mark ZS-BDE took off from The Coves Aerodrome in Gauteng Province with the intention to land at the same aerodrome. This was a private flight conducted under the provis

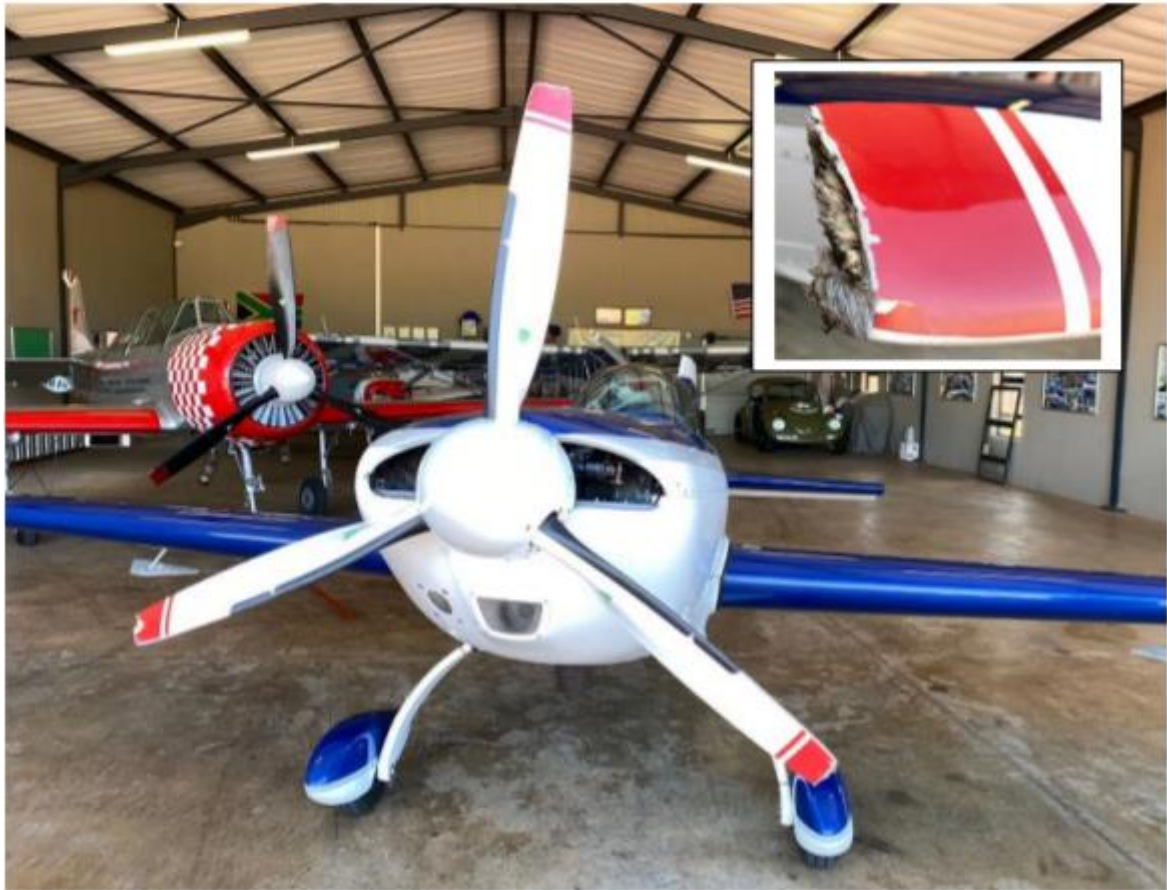
Figure 1: Damaged propeller blade tips. (Source: AME)

It is likely that the canopy was not secured during the pre-take-off check or the pre-take-off checklist was not used, resulting in the canopy opening during the take-off roll. In an attempt to abort take-off roll, the pilot applied maximum brakes which resulted in the propeller blade tips scraping the ground.

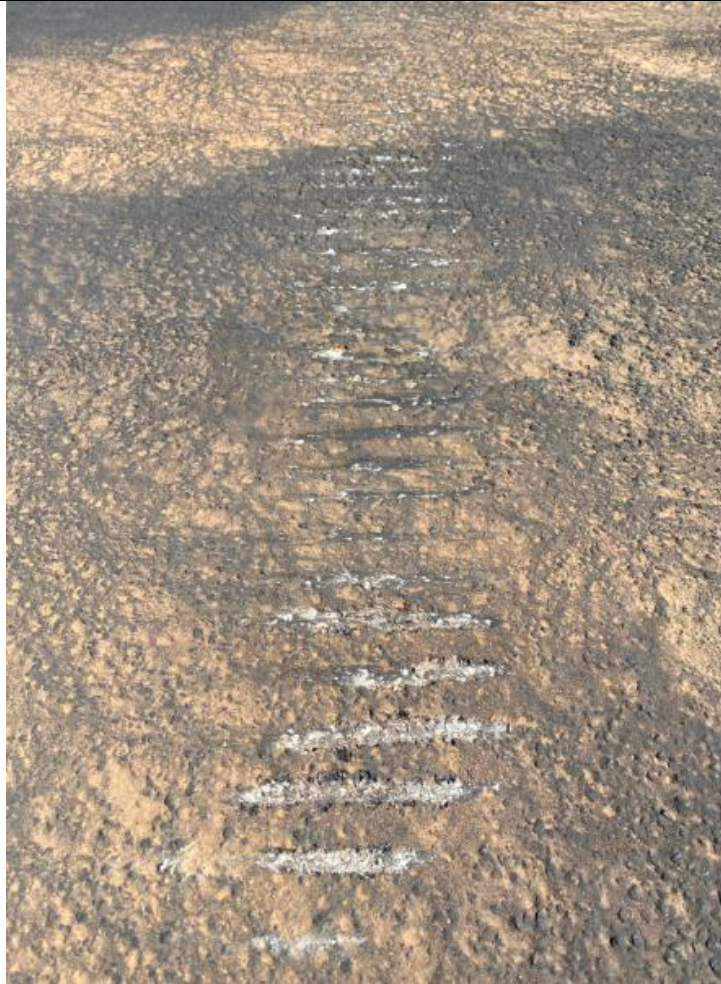
Figure 2: Scrape marks made by propeller blade tips. (Source: AME)

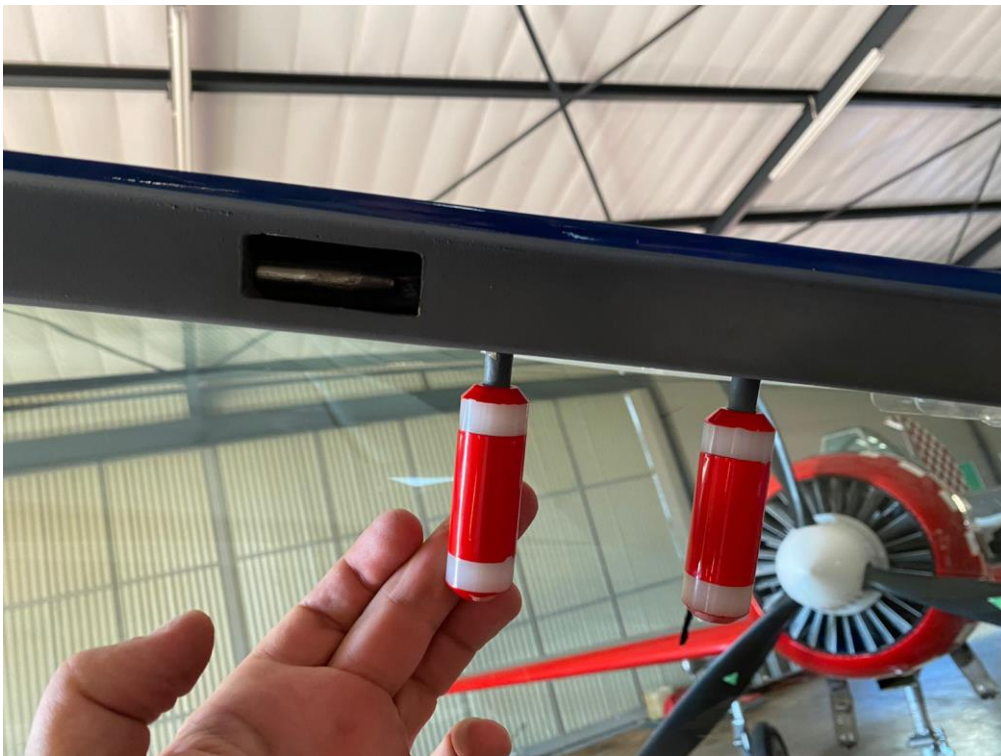
Figure 3: Latches of the canopy door on the aircraft. (Source: AME)

Post-accident inspection conducted by an aircraft maintenance organisation (AMO) revealed that the canopy was not latched properly following the pre-take-off checklist, hence, it blew open during the take-off roll. The latch mechanism was found to be serviceable. The aircraft maintenance records were up to date and revealed that the aircraft was maintained in accordance with (IAW) the manufacturer's specifications and existing procedures. The aircraft had undergone a mandatory periodic inspection (MPI) on 15 July 2021 at 1152.2 airframe hours. The aircraft was flown for a further 32.9 hours since the last MPI. Maintenance conducted on the canopy included: *clean and lubricate canopy hinge and latching mechanism*. The pilot was initially issued a Commercial Pilot

Safety message: Pilots are encouraged to ensure that they conduct a thorough and proper pre-take-off check using a checklist or POH.

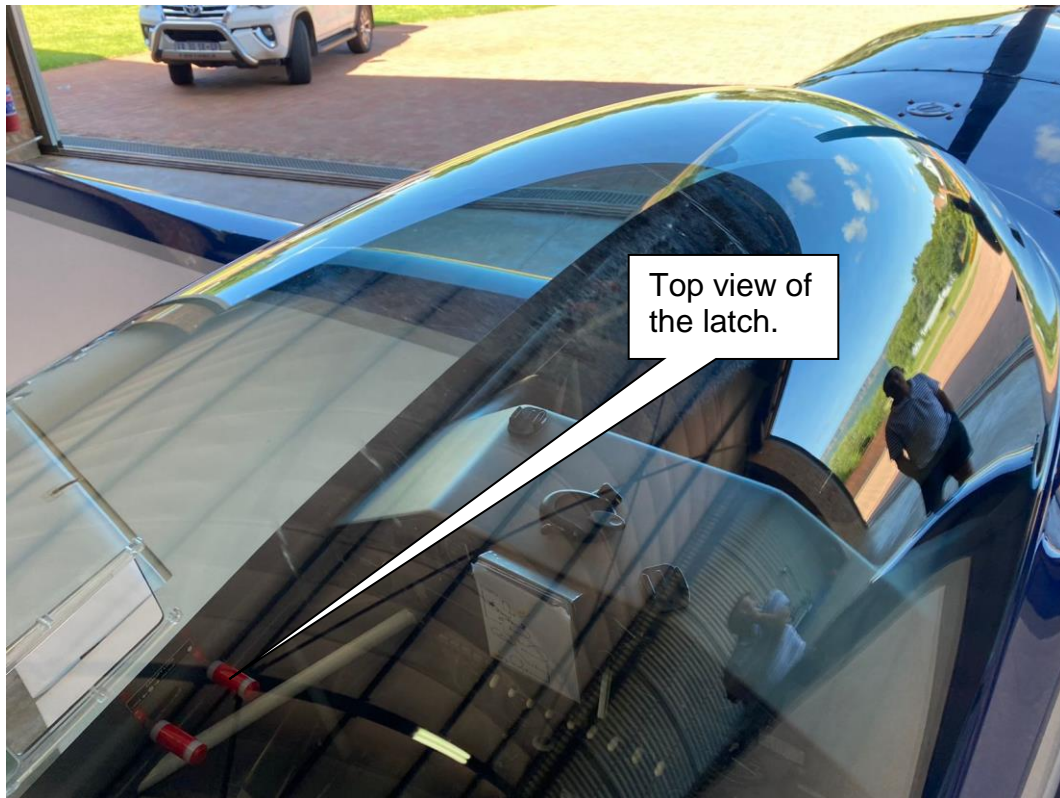
Figure 4: Top view of the canopy latches. (Source: AME)
