**LIMITED SERIOUS INCIDENT INVESTIGATION REPORT**

<b>Reference Number</b>	CA18/3/2/1389						
<b>Classification</b>	Serious Incident	<b>Date</b>	3 February 2022	<b>Time</b>	1510Z		
<b>Type of Operation</b>	Private (Part 91)						
<b>Location</b>							
Place of Departure	Brits Aerodrome (FABS), North West Province		Place of Intended Landing	Grand Central Aerodrome (FAGC), Gauteng Province			
Place of Occurrence	Runway 35 at FAGC, Gauteng Province						
GPS Co-ordinates	Latitude	S25° 59'.13.44"	Longitude	E28°08'.25.97"	Elevation	5327 feet	
<b>Aircraft Information</b>							
Registration	ZS-IIZ						
Make/Model	Cessna 177RG Cardinal (Serial Number: 177RG-0134)						
Damage to Aircraft	Substantial		Total Aircraft Hours	3433.1			
<b>Pilot-in-command</b>							
Licence Valid	Yes	Gender	Male	Age	30		
Licence Type	Commercial Pilot Licence (CPL)						
Total Hours on Type	192.3		Total Flying Hours	824.8			
People On-board	1 + 1	Injuries	0	Fatalities	0	Other (On Ground)	0

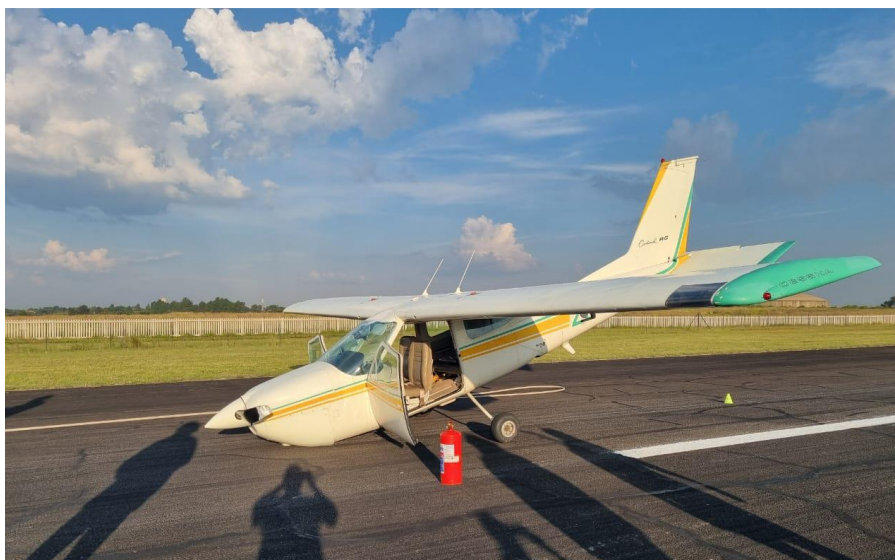
The pilot reported that after joining FAGC circuit, he communicated with air traffic control (ATC) requesting permission to perform a few circuits before making a full-stop landing on Runway 35. The ATC granted him permission and he performed two successful touch-and-go landings. The pilot intended to perform a full-stop landing following his third circuit. He followed the pre-landing checks as conducted during the previous landings and made sure the landing gear was down and in the locked position with the green light illuminating in the cockpit; he also selected 30° (degrees) flaps for landing. The pilot also used the mirror to check the position of the nose gear, which he confirmed to have been in the down position. However, after touchdown on Runway 35 at approximately 75 knots ground speed and as the aircraft decelerated, the nose pitched down and the propeller struck the runway surface. The aircraft slid on the runway surface for approximately 40 metres (m) before coming to a stop in a nose-down attitude. The two occupants were not injured but the aircraft was substantially damaged. The duration of the flight was 2.0 hours.

**Figure 1:** The aircraft as it came to rest. (Source: Pilot)

The aircraft's nose landing gear collapsed during the landing roll on Runway 35 at FAGC.

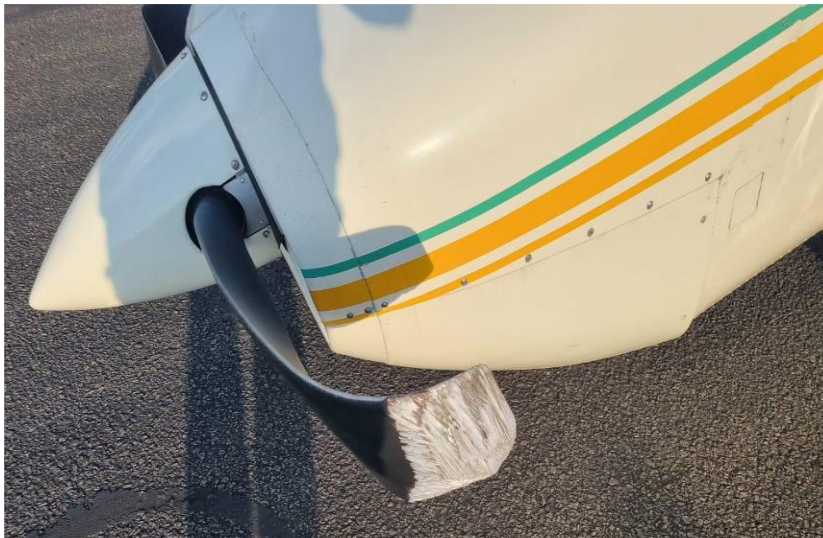
The ATC activated the aerodrome crash alarm and the aerodrome rescue and fire-fighting (ARFF) personnel responded swiftly to the scene. Post-incident visual inspection of the aircraft showed that the propeller blades had bent backward, consistent with the engine producing power; the landing gear lever was in the down position and the flaps extended to 30°.

**Figure 2:** A bent propeller blade tip. (Source: Pilot)

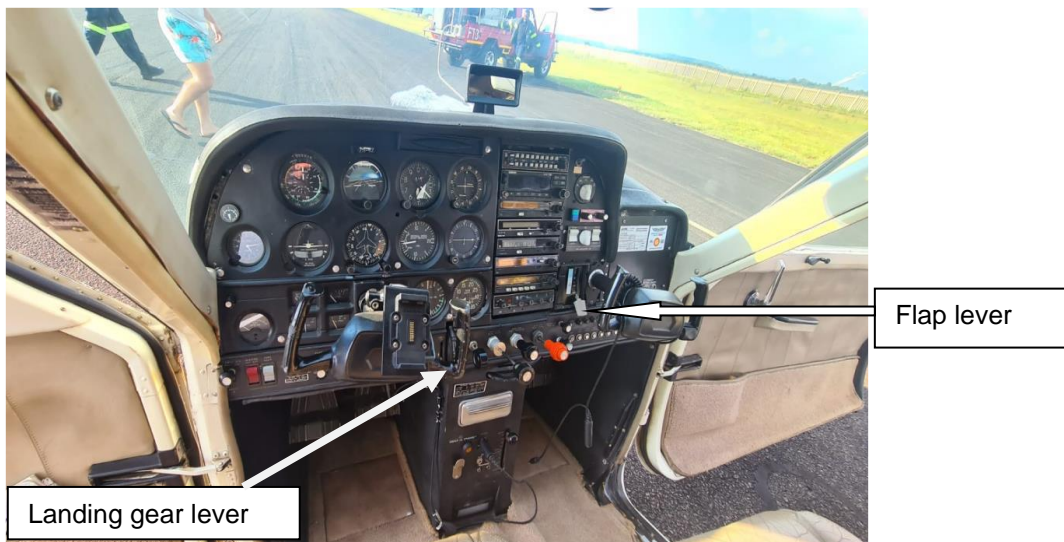
**Figure 3:** A view of the cockpit with the landing gear lever and flap lever in the down position.

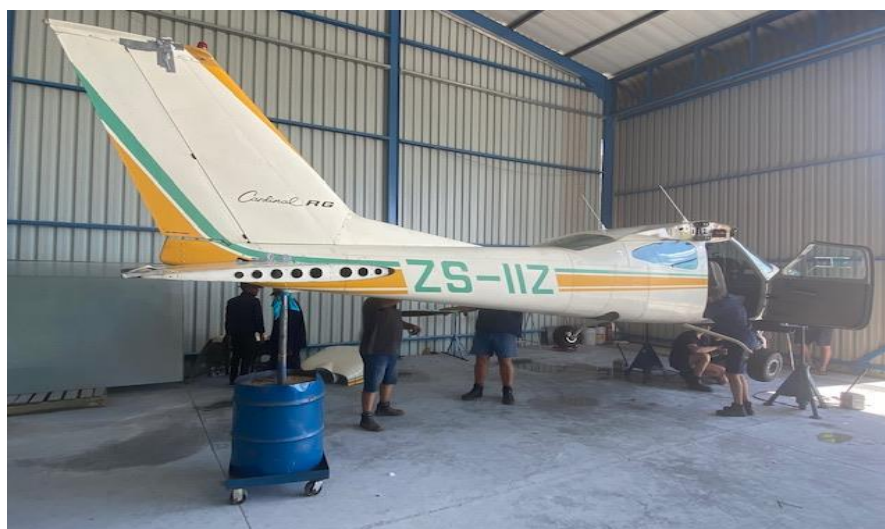
The aircraft was recovered to an aircraft maintenance organisation (AMO) at Wonderboom Aerodrome (FAWB) in Gauteng province for engineering investigation. The aircraft was placed on jacks in the hangar and external power was connected. The landing gear's unsafe warning horn was tested, and it operated normally. The pilot stated that during finals, the green landing gear down and locked indication light illuminated in the cockpit and at no time did the unsafe gear warning horn sound prior to touch down on the asphalt Runway 35.

The aircraft had adequate MIL-H-5606 hydraulic fluid in the reservoir and none of the circuit breakers (CB) had popped. The damaged nose gear doors were removed to facilitate the landing gear retraction and extension tests. The nose gear and wheel-well were inspected, and nothing abnormal was noticed. The nose gear microswitch was intact and it was also not faulty. The hydraulic system indicated 1500 pounds per square inch (psi) pressure which was adequate, according to the POH. The landing gear retraction and extension tests were carried out using the normal procedure and only the main landing gears extended and locked into position every time it was extended; the nose landing gear did not lock into position. The nose landing gear hydraulic lines and actuating cylinder were inspected, and no obvious signs of hydraulic leak were observed; all fasteners were in place and properly secured. The emergency landing gear extension procedure was conducted, and all three landing gears extended and locked into position with the green lights illuminating.

**Figure 4:** A view of the aircraft on jacks during the landing gear examination.

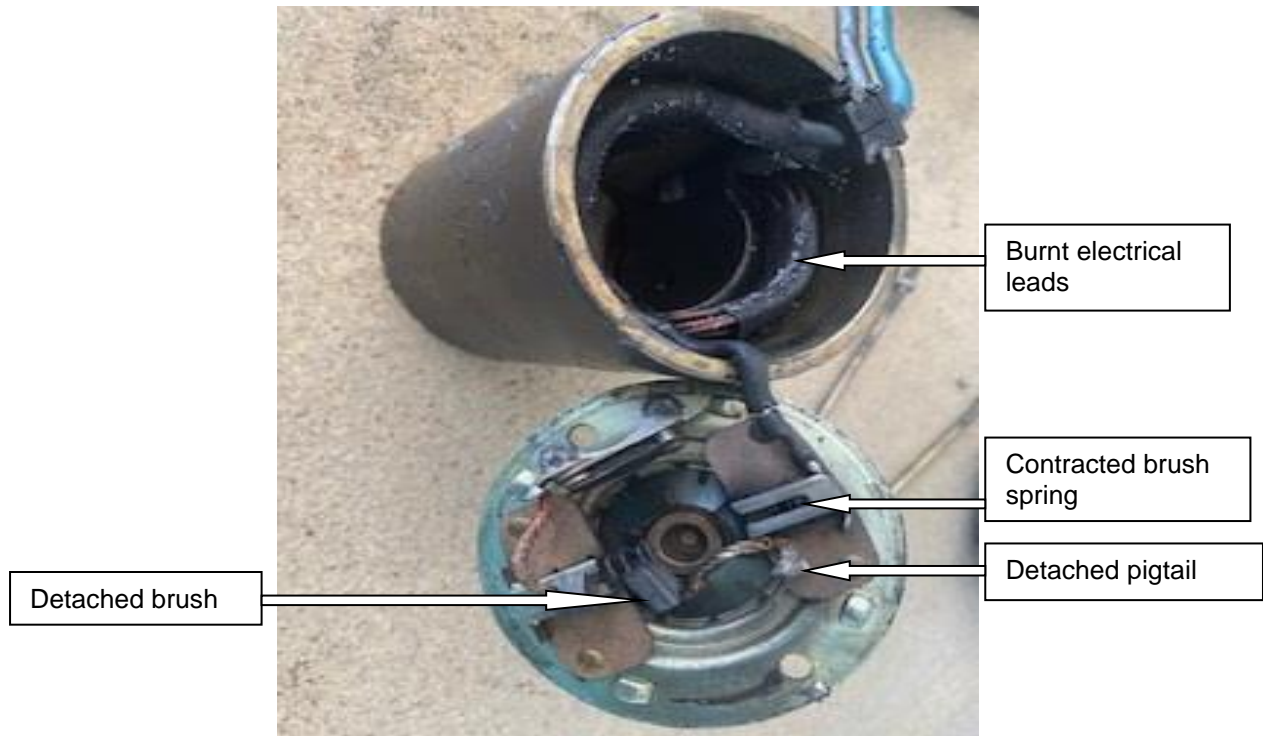
A decision was made to inspect the landing gear pump motor bearing Part Number 105932E and Serial Number 9832, located on the aft fuselages' left-side. After dismantling the pump motor, signs of excessive heat were observed on the electrical leads and the armature (see Figures 5 and 6). The bonding on the pigtails had melted due to excessive heat caused by the continuous running of the gear pump motor and had, eventually, detached. One of the tiny brush springs had contracted due to excessive heat and the brush had also detached. The burnt electric leads and

armature were an indication that the landing gear pump motor was operational at the time of the accident.

**Figure 5:** The landing gear pump motor after it was opened.

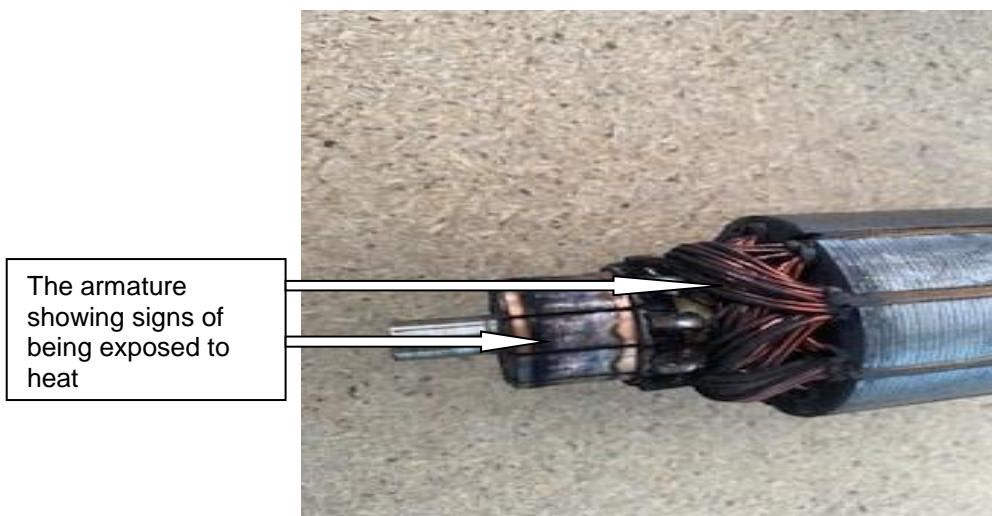
**Figure 6:** Heat signs on the armature.

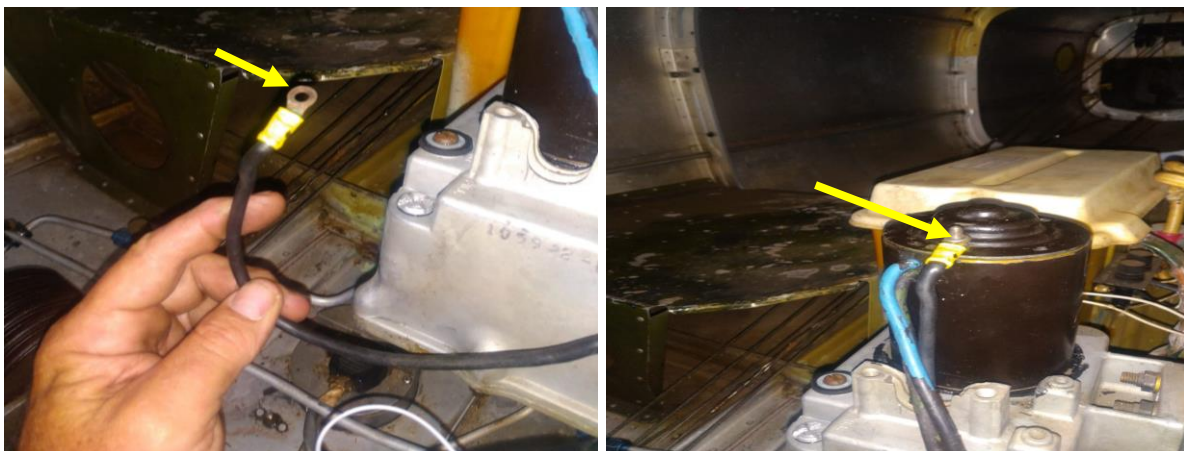
The AMO at FALA stated that the pilot could not wait until the replacement parts were available. The aircraft, however, was not relocated to FAWB as indicated. On 14 October 2021, the pilot flew to Zebula Lodge in Bela-Bela, Limpopo province, with the landing gear still in an extended position. The flight folio entries indicated that from Zebula Lodge, the aircraft was flown to multiple aerodromes and had accumulated approximately 36.2 airframe hours before it was flown back to the AMO at FAWB. On 25 November 2021, the last 100-hour mandatory periodic inspection (MPI) was certified on the aircraft at 3347.3 airframe hours. During this maintenance, a detailed examination of the landing gear was carried out and the engineers noted the voltage and current flow degradation on the landing gear pump motor, which was caused by a corroded cable lug. The lug was replaced, and the landing gear pump motor tested normal.

**Figures 7 and 8:** A disconnected gear pump motor cable (left picture); and a connected gear pump motor cable after maintenance (right picture).
