LIMITED SERIOUS INCIDENT INVESTIGATION REPORT
--

Reference Number		CA18/3/2/1390					
Classification	Serious Incident	Date	5 February 2022	Time	0615Z		
Type of Operation	Private (Part 94)						
Location							
Place of Departure	Potchefstroom Aerodrome (FAPS), North West Province		Place of Intended Landing	Potchefstroom Aerodrome (FAPS), North West Province			
Place of Occurrence	Runway 03, Potchefstroom Aerodrome (FAPS), North West Province						
GPS Co-ordinates	Latitude	26° 40' 38.37" S	Longitude	027° 04' 50.24" E	Elevation	4 511ft	
Aircraft Information							
Registration	ZS-GYK						
Make/Model	Scheibe Flugzeugbau GmbH SF-25C Falke (Serial Number: 44154)						
Damage to Aircraft	Substantial		Total Aircraft Hours	1 600 hours			
Pilot-in-command							
Licence Valid	Yes		Gender	Male	Age	25	
Licence Type	Glider Pilot Licence (GPL)						
Total Hours on Type	66.9 hours		Total Flying Hours	111.7 hours			
People On-board	1 + 0	Injuries	0	Fatalities	0	Other (on ground)	0

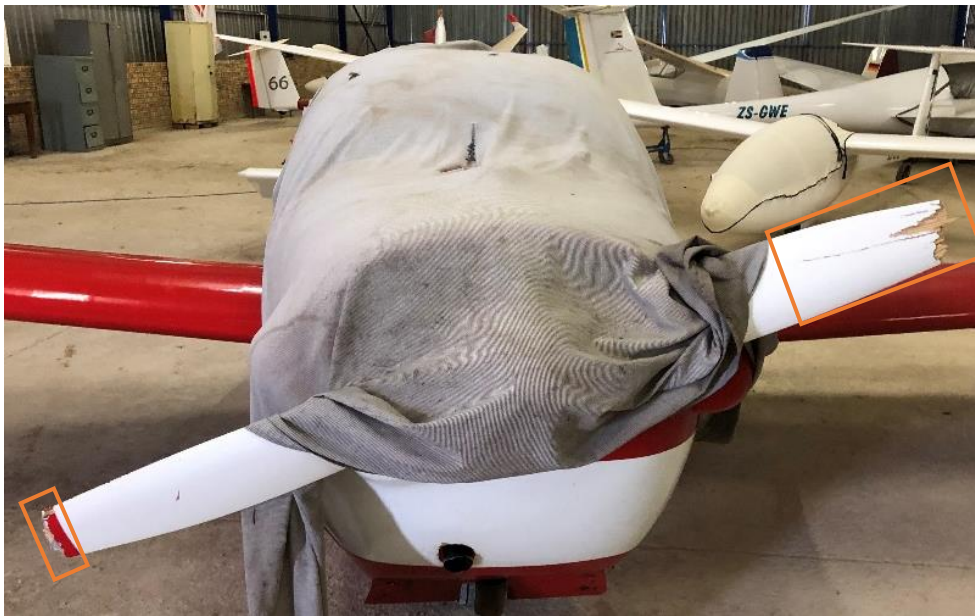
What Happened							
<p>On Saturday morning, 5 February 2022 at about 0515Z, a pilot on-board a Scheibe SF-25C Falke motorised glider with registration ZS-GYK took off on a local flight from Runway (RWY) 03 at Potchefstroom Aerodrome (FAPS), North West province, with the intention to land back at FAPS. Fine weather conditions prevailed at the time of the flight. No flight plan was filed for the flight. The flight was conducted under the provisions of Part 94 of the Civil Aviation Regulations 2011 as amended.</p> <p>According to the pilot, prior to touchdown, the propeller struck the runway's threshold edge, but the pilot was able to maintain control of the glider during the landing roll. The glider sustained substantial damage to the wooden propeller blades, and its tail wheel broke off. The pilot was not injured during the incident.</p>

Figure 1: Damage to the propeller blades. (Source: Google Earth)

- According to the pilot, the glider stalled due to speed being 10 to 20km/h slower than required for landing in a crosswind condition. This caused the glider to stall just above the ground before hitting the runway with the propeller.

The glider was unstable on approach (being low) and it undershot the runway, resulting in the propeller striking the runway's threshold edge.
