LIMITED SERIOUS INCIDENT INVESTIGATION

Reference Number	CA18/2/3/1396					
Classification	Serious Incident	Date	13 April 2022	Time	1538Z	
Type of Operation	Training (Part 141)					
Location						
Place of Departure	Wonderboom Aerodrome (FAWB), Gauteng Province		Place of Intended Landing	Wonderboom Aerodrome (FAWB), Gauteng Province		
Place of Incident	Wonderboom Aerodrome (FAWB) on the apron outside the operator's hangar					
GPS Co-ordinates	Latitude	25°39'.00" S	Longitude	028°13'.00" E	Elevation	4095 feet
Aircraft Information						
Registration	ZS-SCE					
Model/Make	Cessna 172M (Serial Number: 17263043)					
Damage to Aircraft	Substantial		Total Aircraft Hours	3536.2		
Pilot-in-command						
Licence Type	Commercial Pilot Licence (CPL)	Gender	Male	Age: 23		
Licence Valid	Yes					
Total Hours on Type	600		Total Flying Hours	1209.2		
People On-board	2 + 0	Injuries	0	Fatalities	0	Other (on ground) 0
What Happened						
<p>On 13 April 2022, a Cessna 172M aircraft with registration ZS-SCE, operated by Eagle Air Flying School, was scheduled for a night flight training when the incident occurred at Wonderboom Aerodrome, Gauteng province. On-board the aircraft were the instructor and th

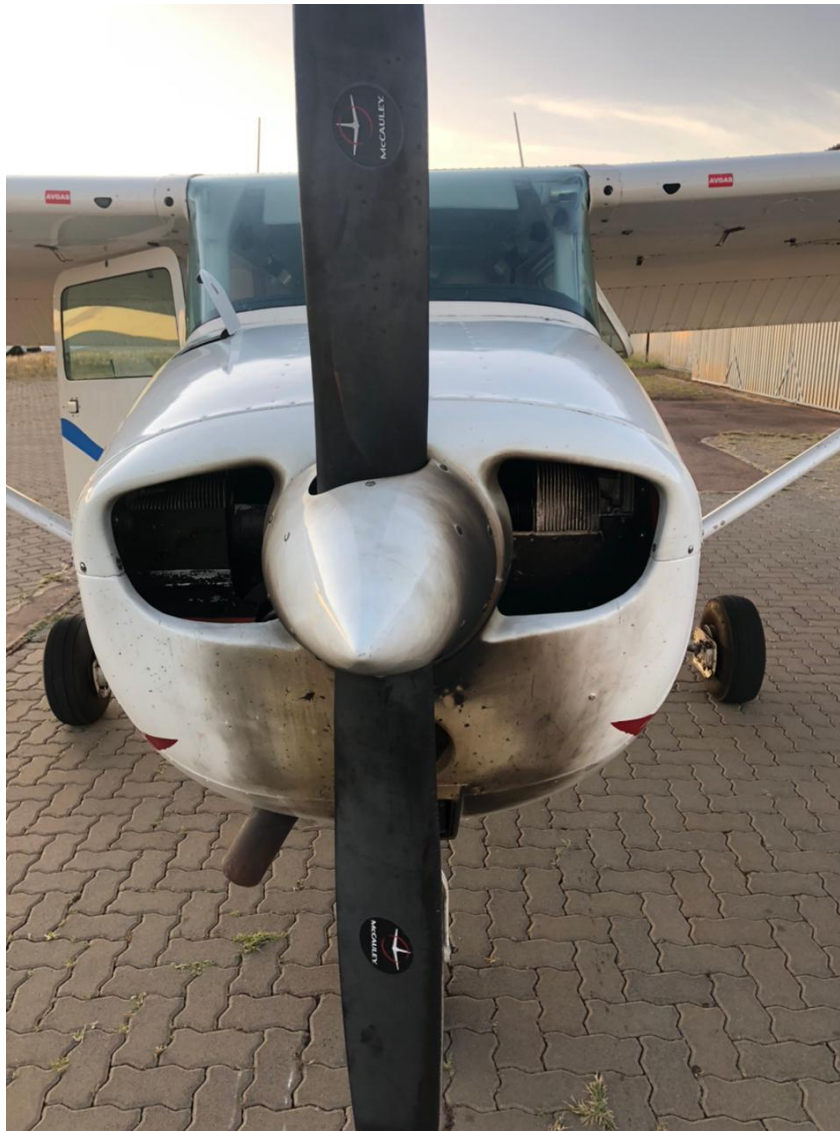
unharmred. The fire extinguisher was used to extinguish the fire. The aircraft sustained fire damage to the engine compartment.

Figure 1: The aircraft after the fire was put out. (Source: Pilot)

The engine was over-primed during start-up, resulting in excess fuel catching fire and damaging the engine compartment.

After the incident, all damaged parts were replaced with new parts — the carb heat box baffle rubbers were replaced, and the carb heat box was inspected to ensure it operated as expected; the cowling and spinner were repaired and re-painted; the carburettor was re-installed with new gaskets and the carb heat box was refitted with a new air filter; the aircraft was ground-run and all systems were within the parameters.

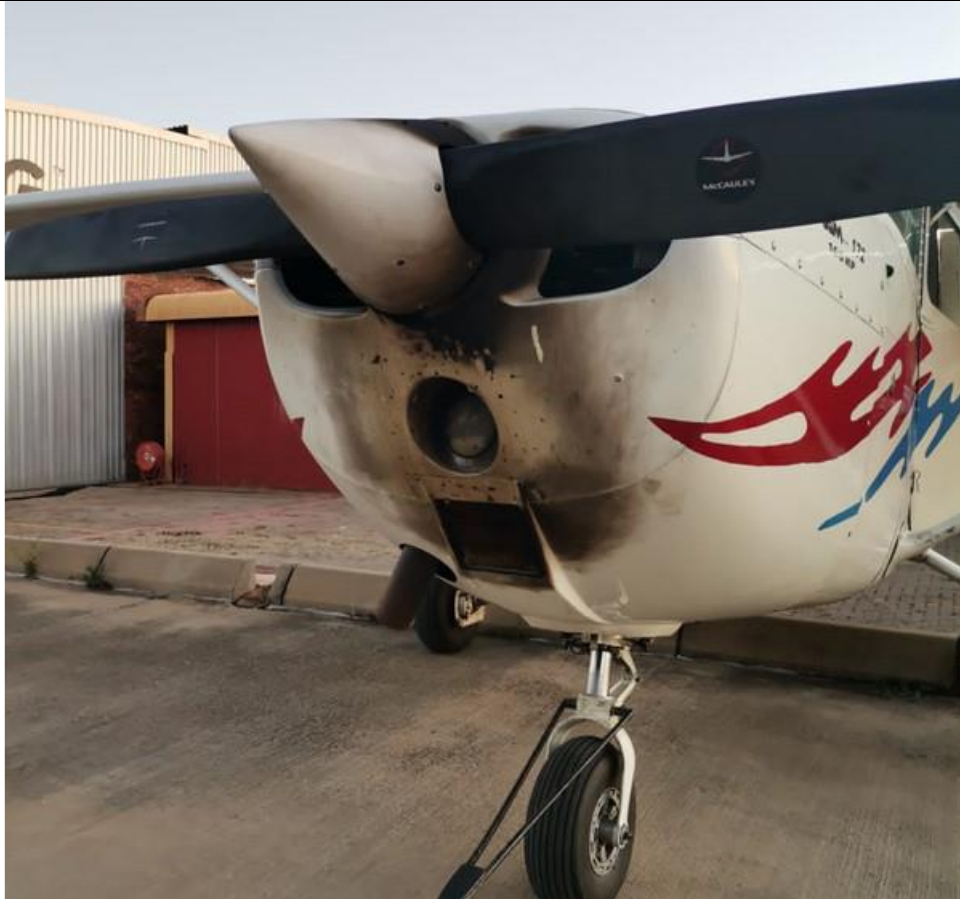
Figure 2: A close-up picture showing the black residue caused by the fire. (Source: Pilot)

- The nose engine cowlings, spinner paint and landing light were damaged.
- The gaskets and plunger were damaged due to heat from the fire.
- The air-filter and the front baffle rubbers on the carb heat box were damaged.
- The carburettor was removed and inspected by the aircraft maintenance organisation (AMO), and it was found undamaged.
- The aircraft's maintenance records were up to date; they revealed that the aircraft was maintained in accordance with (IAW) the manufacturer's specifications and existing procedures.
- The aircraft had a Certificate of Release to Service which was issued on 23 February 2022 with an expiry date of 23 February 2023 or at 7184.20 hours, whichever occurs first.
- The aircraft had a valid Certificate of Registration which was issued to the current owner on 29 July 2021.
