<b>LIMITED SERIOUS INCIDENT INVESTIGATION REPORT</b>
--

<b>Reference Number</b>		CA18/3/2/1397					
<b>Classification</b>	Serious Incident	<b>Date</b>	15 April 2022		<b>Time</b>	0545Z	
<b>Type of Operation</b>		Charter (Part 135)					
<b>Location</b>							
Place of Departure		Lanseria International Airport (FALA), Gauteng Province		Place of Intended Landing		Alldays Aerodrome (FAAL), Limpopo Province	
Place of Serious Incident		Runway 07 (RWY07) at Lanseria International Airport (FALA)					
GPS Co-ordinates	Latitude	S 25°56'23"	Longitude	E 027°55'28.8"	Elevation	4517 ft	
<b>Aircraft Information</b>							
Registration		ZS-WRI					
Model/Make		Cessna C402 C (Serial Number: 402C0610)					
Damage to Aircraft		None		Total Aircraft Hours		1112.7	
<b>Pilot-in-command</b>							
Licence Valid		Yes	Gender	Male	Age	27	
Licence Type		Commercial Pilot Licence (Aeroplane)					
Total Hours on Type		370		Total Flying Hours		936	
People On-board	1 + 2	Injuries	0	Fatalities	0	Other (On Ground)	0

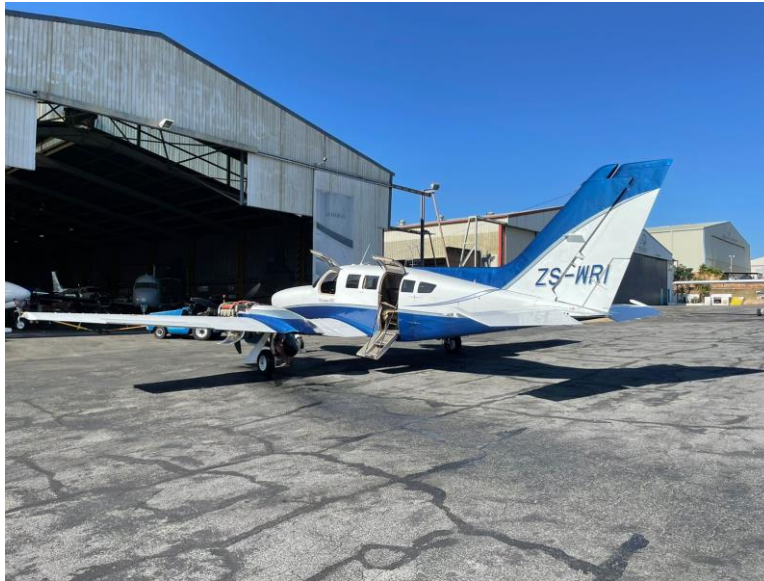
**Figure 1:** The aircraft at the aircraft maintenance organisation (AMO) facility after the incident. (Source: Pilot)

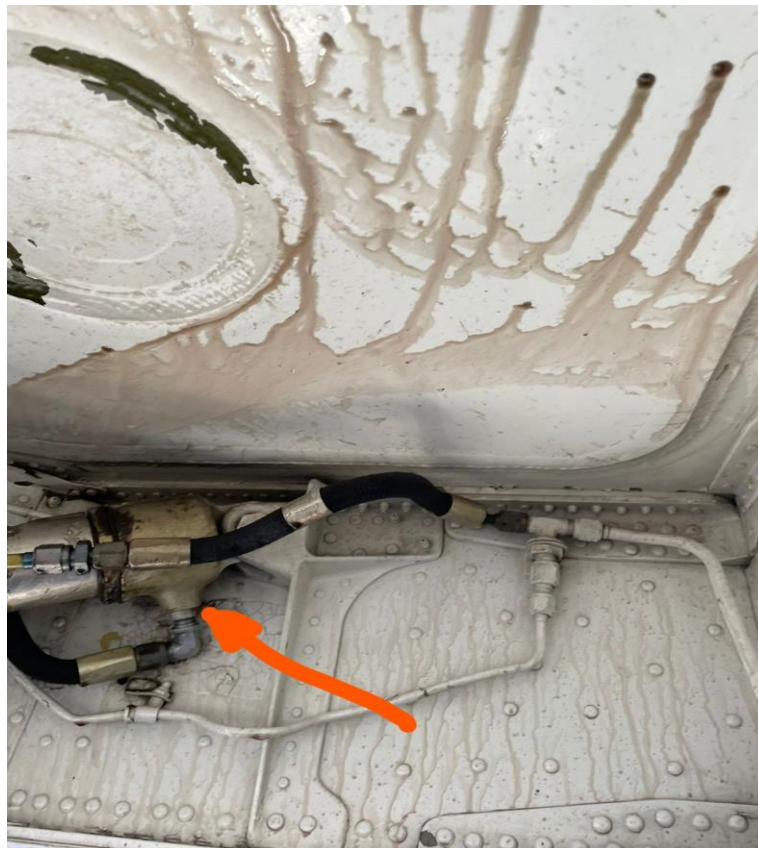
Post-flight inspection of the main landing gear wheel well revealed that a rubber seal on the nut that connects to the left gear hydraulic loaner pump actuator was well-worn. This caused the hydraulic fluid to leak (squirt) when under pressure.

**Figure 2:** Position of the hydraulic fluid seal in the left main gear wheel well. (Source: Operator)

- The operator had an aircraft operating certificate (AOC) which was issued on 27 September 2021 with an expiry date of 30 September 2022.
- A hydraulic hose seal, which is an on-condition item, on the left-side main gear wheel well area had failed. This caused the hydraulic fluid to leak when under pressure during operation, hence, the gear indication failure. The left air filter was removed, cleaned and

A failed hydraulic fluid hose seal on the loaner pump led to an 'unlocked gear indication' light illuminating at take-off.

refitted, whilst the failed hydraulic hose seal was replaced with a new one. The engine bay was washed, and the hydraulic levels were topped up before a test flight was conducted. The aircraft operated satisfactorily during the test flight.
