**LIMITED SERIOUS INCIDENT INVESTIGATION REPORT**

<b>Reference Number</b>		CA18/3/2/1399					
<b>Classification</b>	Serious Incident	<b>Date</b>	25 April 2022	<b>Time</b>	1140Z		
<b>Type of Operation</b>		Private (Part 94)					
<b>Location</b>							
<b>Place of Departure</b>		Diemerskraal Aerodrome, Western Cape Province		<b>Place of Intended Landing</b>		Springbok Aerodrome (FASB), Northern Cape Province	
<b>Place of Occurrence</b>		Private Farm, 2nm north-east of Moorreesburg, Western Cape Province					
<b>GPS Co-ordinates</b>	<b>Latitude</b>	33°07'03.62" S	<b>Longitude</b>	18°41'53.27" E	<b>Elevation</b>	629 feet	
<b>Aircraft Information</b>							
<b>Registration</b>		ZU-DND					
<b>Model/Make</b>		Team Rocket F1 (TRF1) (Serial Number: 38)					
<b>Damage to Aircraft</b>		None		<b>Total Aircraft Hours</b>		448.5	
<b>Pilot-in-command</b>							
<b>Licence Type</b>		Private Pilot Licence (PPL) Aeroplane		<b>Gender</b>	Male	<b>Age</b>	58
<b>Licence Valid</b>		Yes

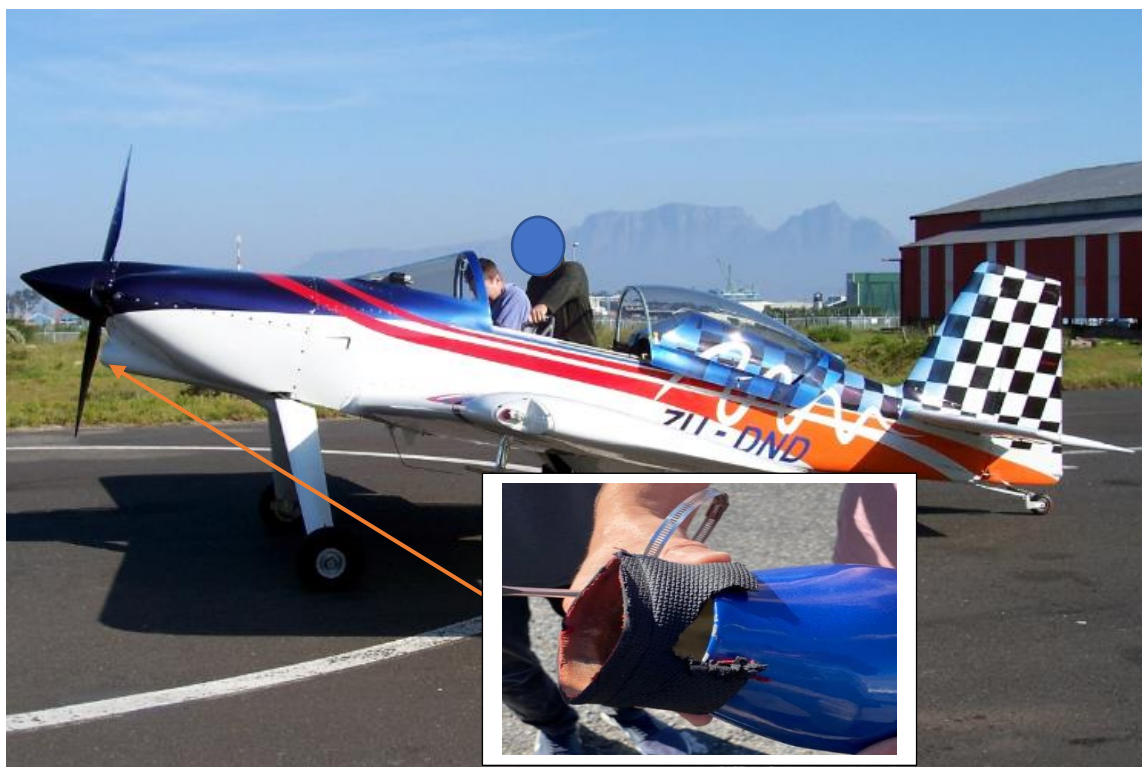
**Figure 1:** The baffle seal of the engine induction filter housing. (Source: Pilot)

- After the (current) emergency landing incident, the pilot inspected the aircraft and noticed that the air passage on the inlet scoop was partially blocked by the baffle seal which was sucked in and restricting normal passage of air into the engine. (The baffle seal is located between the cowling and the engine induction filter housing.) The air filter was also unsteady in its housing. The pilot contacted the AP to inspect the aircraft, whereafter, a temporary repair was carried out by removing the seal to bring the aircraft into a serviceable state so it could be flown out of the private farm. A ground-run was carried out and the aircraft was declared safe to fly back to the departure airfield. The baffle seal was installed on 1 July 2005 when the aircraft was manufactured, and it is an on-condition item.

A dislodged baffle seal blocked the air passage on the inlet scoop, restricting air flow to the engine for proper combustion. This resulted in loss of engine power, followed by a successful emergency landing.

- A day after the incident, the aircraft was flown to an aircraft maintenance organisation (AMO) in Cape Town for permanent repairs to be carried out. It was determined that the baffle seal be removed permanently as it did not have any effect on the engine's performance. The misalignment of the filter was also rectified. The defects were duly signed off on the airframe logbook and the aircraft was released back to service. The AMO was issued an AMO certificate on 30 May 2021 with an expiry date of 30 April 2022

As a safety action, the AMO determined that the absence of the baffle seal did not have any impact on the engine's performance, therefore, a decision was made to remove it permanently. The removal of the baffle seal was approved by the original builder, according to the AMO.
