<b>AIRCRAFT ACCIDENT SHORT REPORT</b>
---------------------------------------

CA18/2/3/9651, ZU-RCA, AutoGyro Calidus, unsuccessful recovery with high-speed blade flap on take-off

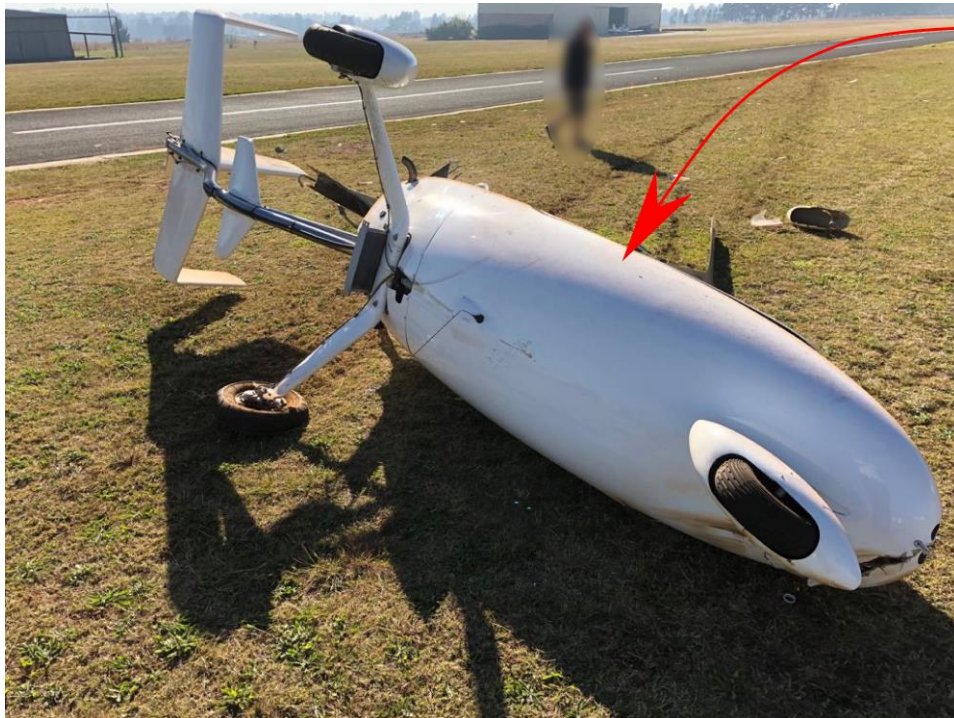
- 2.4 The aircraft then flipped onto its left-hand side and began to skid; it skidded for a distance of 25 m.
- 2.5 The aircraft experienced substantial damage during the accident sequence, to the main rotor blades, propellers, canopy and landing gears.

Figure 4: The arrow indicates the path that the autogyro slid after the high-speed blade flap.

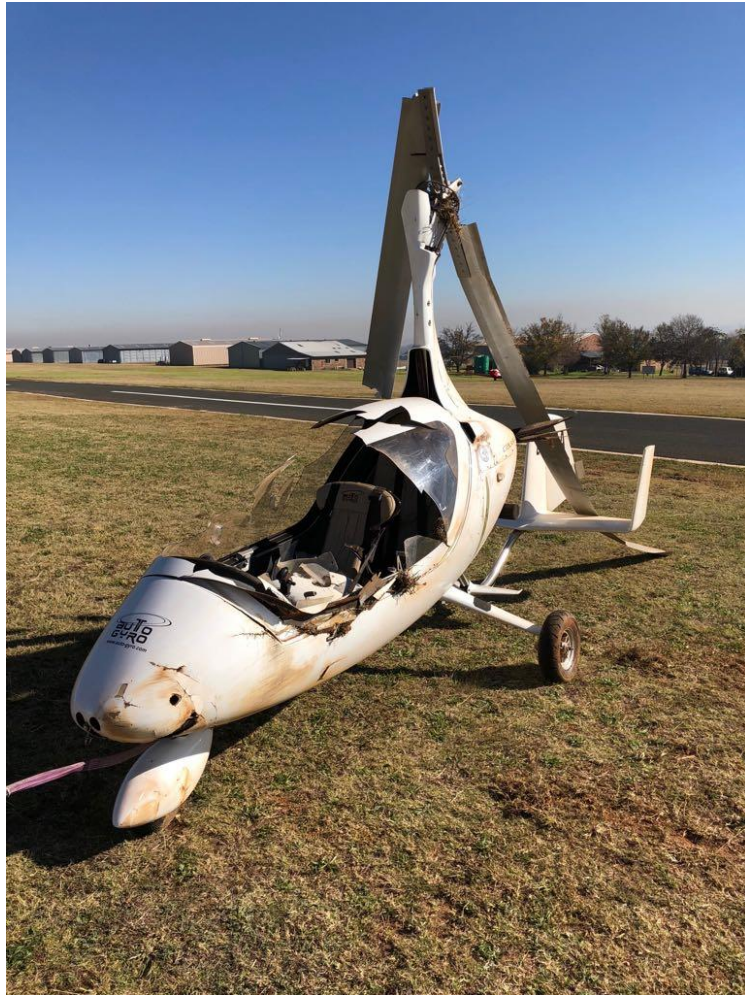
**Figure 5:** The damage to the autogyro due to the high-speed blade flap

- 3.10 The aircraft was substantially damaged during the accident sequence, namely to the main rotor blades, propellers, canopy and landing gear.

- 4.1 It is likely that on take-off, the pilot applied throttle and releasing the brake, building up forward speed on the runway and forgotten to pull the control stick back, and then doing this late. The torque caused by the sudden increase in lift of the advancing blade against the retreating blade threw the gyro onto its left side.
