AIRCRAFT ACCIDENT SHORT REPORT

CA18/2/3/9681: ZS-SWS Student lost control during touch and go

Date and time : 12 January 2018 1820Z
Location : Runway 26, Beaufort West (FABW)
Occurrence category : CAT 2
Occurrence type : Accident
Aircraft registration : ZS-SWS
Aircraft manufacturer and model : Piper Aircraft Corporation PA44-180
Last Point of departure : FABW
Next point of intended landing : FABW
Location of accident site with reference to easily defined geographical points (GPS readings if possible) : Runway 26 FABW (GPS S 32° 21'10.30" E 022° 35' 02.79")
Meteorological Information : Wind: 180°/10 kts, CAVOK, temperature: 20 °C
Type of operation : Training (Part 91)
Persons on board : 2+0
Injuries : 0
Damage to aircraft : Left wing leading edge, right main gear and right flap

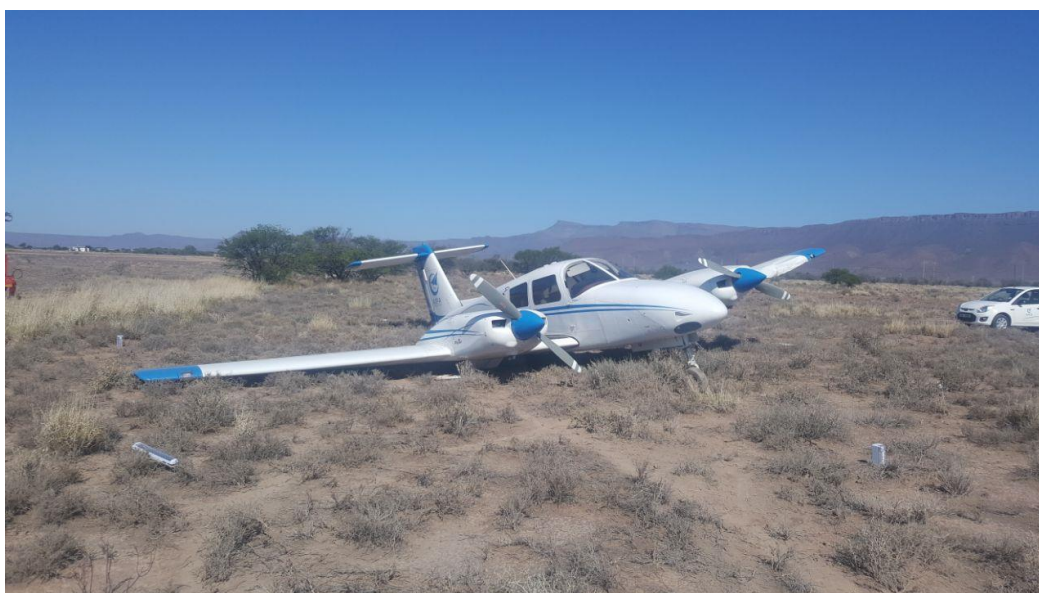
2.2 The instructor and student were not injured. The aircraft sustained damage to the leading edge of the left wing, right main gear and right flap.

Figure 1: The aircraft on the day after the accident (Photo courtesy of the instructor)

- 4.1 The student pilot lost control of the aircraft during touch and go.
- 4.2 Loss of directional control
- 4.3 Poor technique
