<b>AIRCRAFT ACCIDENT REPORT AND EXECUTIVE SUMMARY</b>
---

Reference:	CA18/2/3/9682	
<b>Aircraft Registration</b>	ZU-TEF	<b>Date of Accident</b>	23 January 2018		<b>Time of Accident</b>	11:10Z
<b>Type of Aircraft</b>	Savannah S		<b>Type of Operation</b>	Test Flight		
<b>Pilot-in-command Licence Type</b>	National Pilot		<b>Age</b>	59	<b>Licence Valid</b>	Yes
<b>Pilot-in-command Flying Experience</b>	Total Flying Hours	1580.5		Hours on Type	1266.6	
<b>Last point of departure</b>	Robertsvale Aerodrome, Gonubie (Eastern Cape)					
<b>Next point of intended landing</b>	Robertsvale Aerodrome, Gonubie (Eastern Cape)					
<b>Location of the accident site with reference to easily defined geographical points (GPS readings if possible)</b>						
Private farm 3nm West of Kei Mouth at the GPS: S32° 41'33.67" E028° 19'30.59" Elevation: 40 feet						
<b>Meteorological Information</b>	Surface wind: 220° at 17 knots. Temperature 24°C. Visibility: 9999m					
<b>Number of people on board</b>	1 + 1	<b>No. of people injured</b>	0	<b>No. of people killed</b>	2

## AIRCRAFT ACCIDENT REPORT

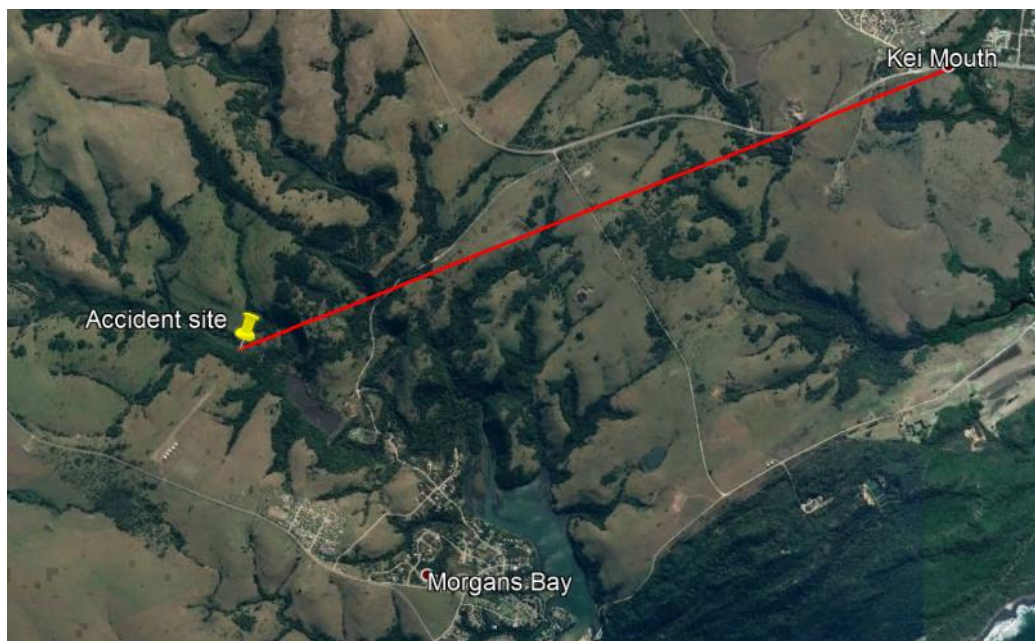
1.1.3. The aircraft was found at the GPS position: S32°41'33.67" E028°19'30.59 elevation 40ft" above sea level. The aircraft collided with a tree with its right wing first followed by the nose.

Figure 3: Accident site was approximately 3nm south west of Kei Mouth.

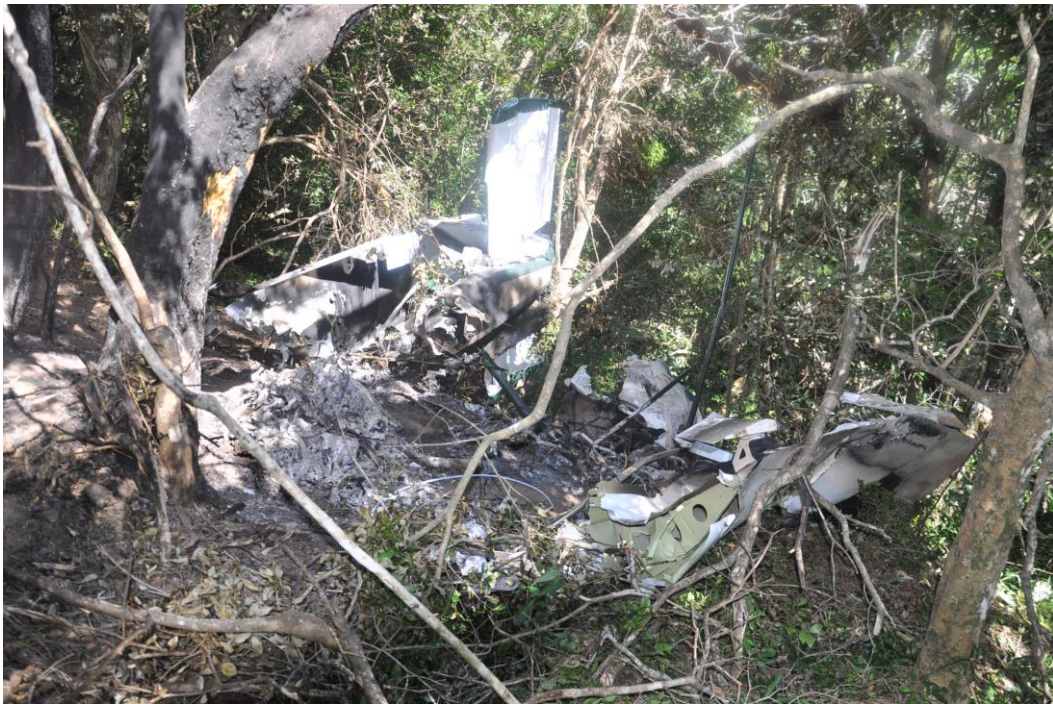
1.12.1 The aircraft collided with a tree with its right wing before it hit the ground followed by the post impact fire.

Figure 4: The tail section resting on its right hand side
