Accident and Incident Investigations Division

AIRCRAFT ACCIDENT REPORT AND EXECUTIVE SUMMARY

Reference:	CA18/2/3/9684	
Aircraft registration	ZU-EFY	Date of accident	25 January 2018		Time of accident	1500Z
Type of aircraft	Bantam B22J (conventionally controlled microlight)		Type of operation		Private (Part 94)	
Pilot-in-command licence type		National	Age	58	Licence valid	Yes
Pilot-in-command flying experience		Total flying hours	220.0		Hours on type	113.7
Last point of departure		Pyramid Aerodrome near Barberton, Mpumalanga Province				
Next point of intended landing		Pyramid Aerodrome near Barberton, Mpumalanga Province				
Location of the accident site with reference to easily defined geographical points (GPS readings if possible)						
Aylestone Private Reserve (GPS position: 25°39'49.52" South 030°57'01.91" East), elevation 2 830 ft. above mean sea level (AMSL)						
Meteorological information		Surface wind: 045° to 060° at 5 kts, Temperature: 27°C, Dew point: 17°C				
Number of people on board	1 + 0	No. of people injured	1	No. of people killed	0

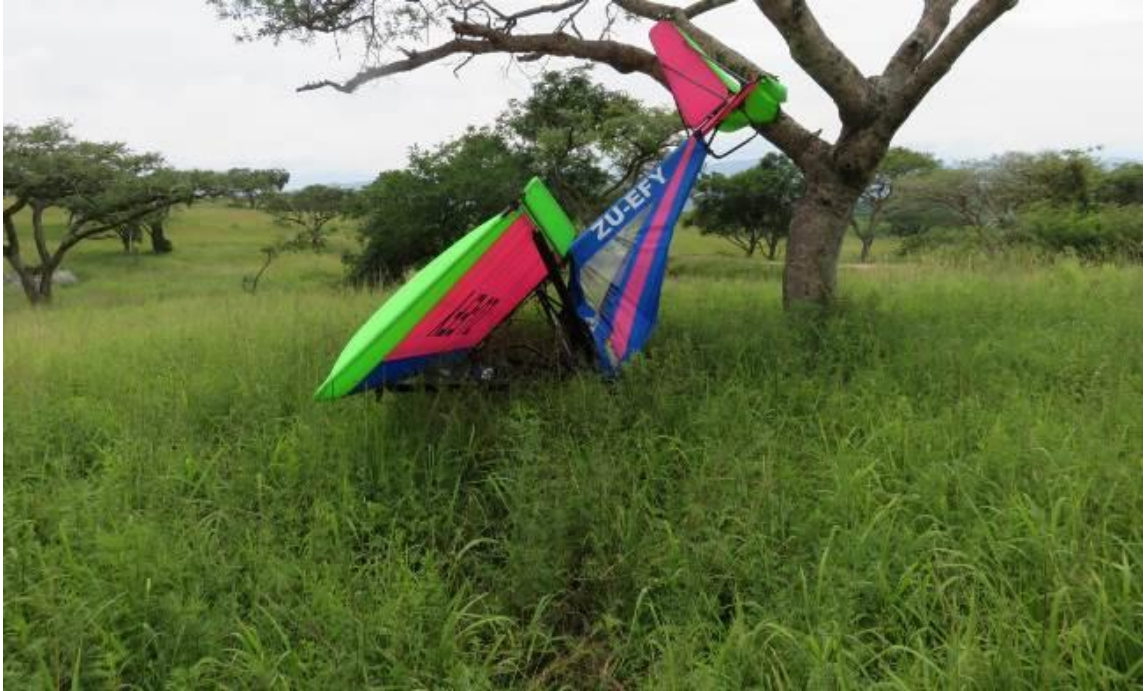
1.12.3 The area had experienced a large amount of rainfall in the prior week, therefore a large amount of grassy vegetation had begun to regrow, obscuring the ground scarring prior to the commencement of the on-site investigation.

Figure 3: Ground scarring leading up to the final resting position of the aircraft

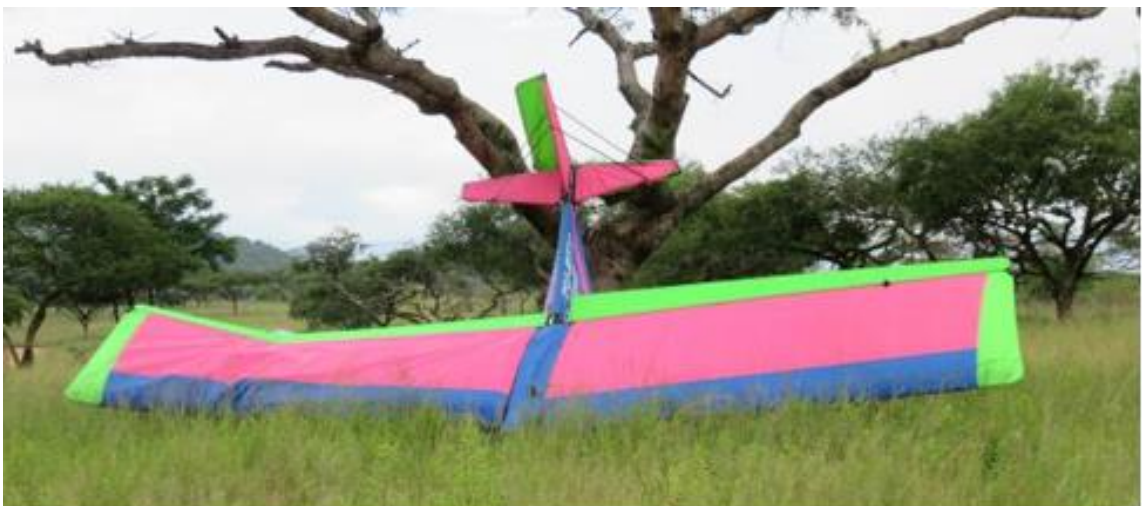
1.12.1 The microlight aircraft impacted with the savannah-type terrain in a steep nose-down attitude, in a north-easterly (030°M) direction. The distance from the first point of impact to the final position was approximately 5 m.

Figure 4: The final resting position of the aircraft

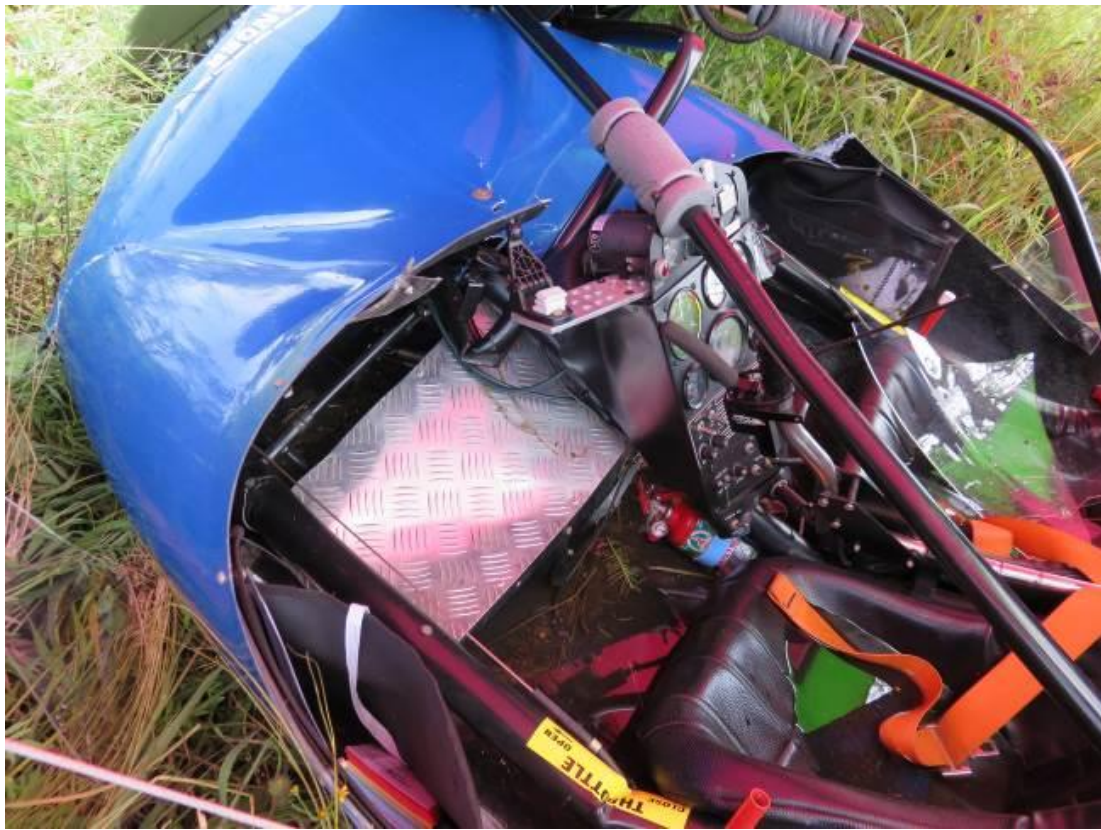
Figure 5: Damage to the controls and cabin area. The Plexiglas window completely shattered and the fibre glass area around the pilot's legs collapsed due to the impact and fuselage distortion.

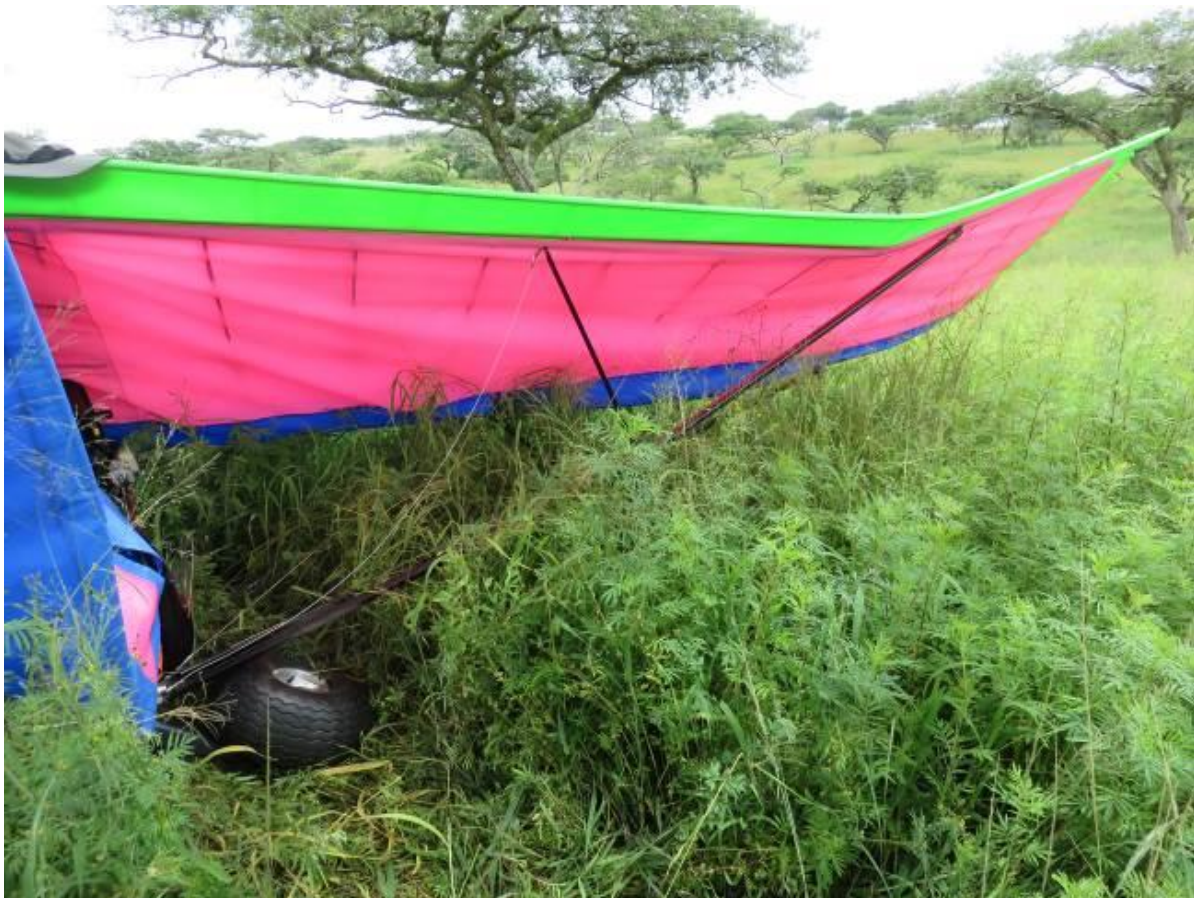
Figure 6: Distortion to the right wing and the collapsed right main gear

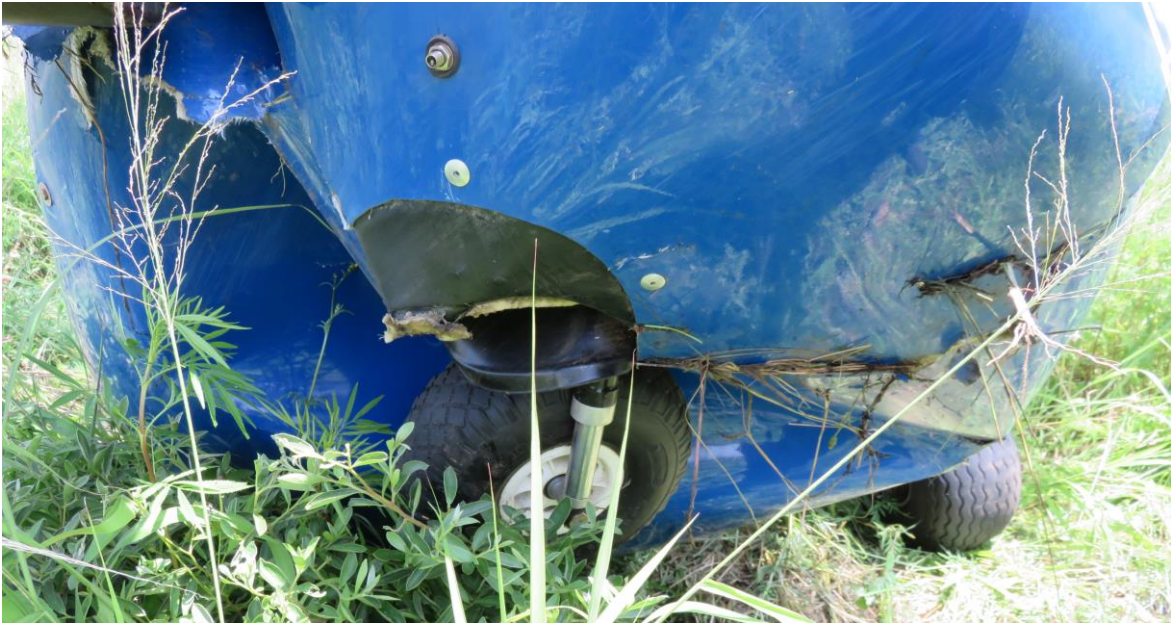
Figure 7: Collapse nose gear due to excessive impact forces

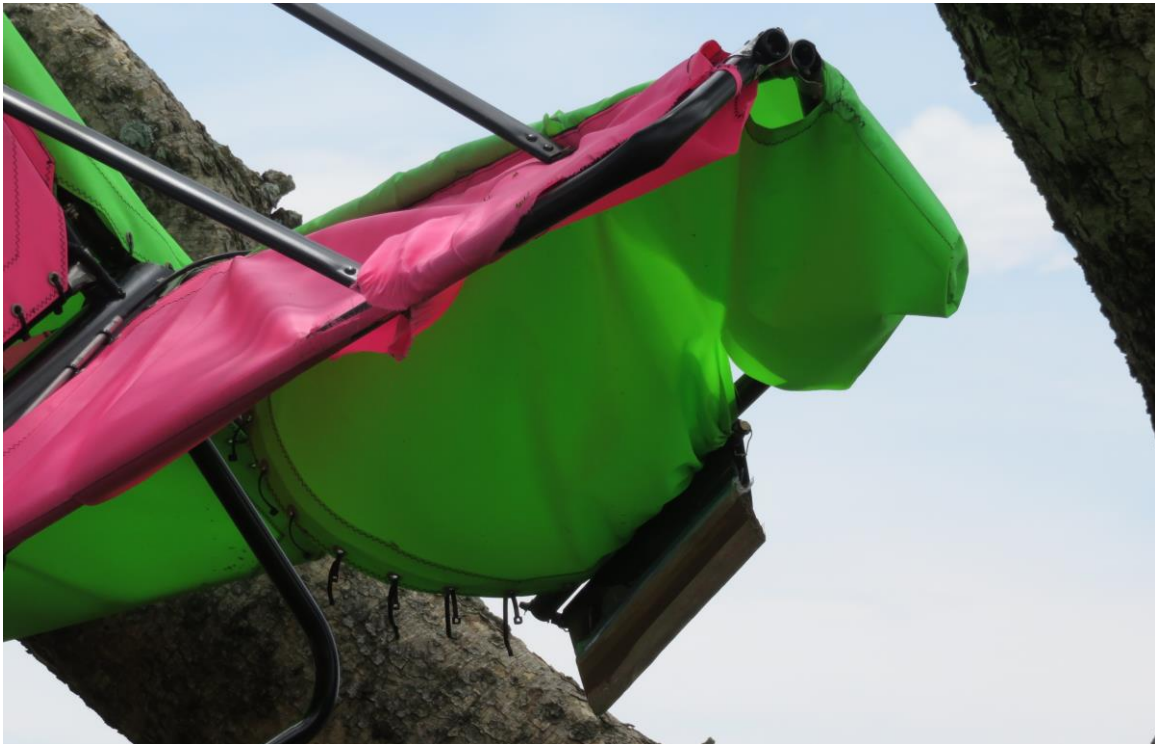
Figure 8: Damage to the empennage area, and the unapproved trim tab modification

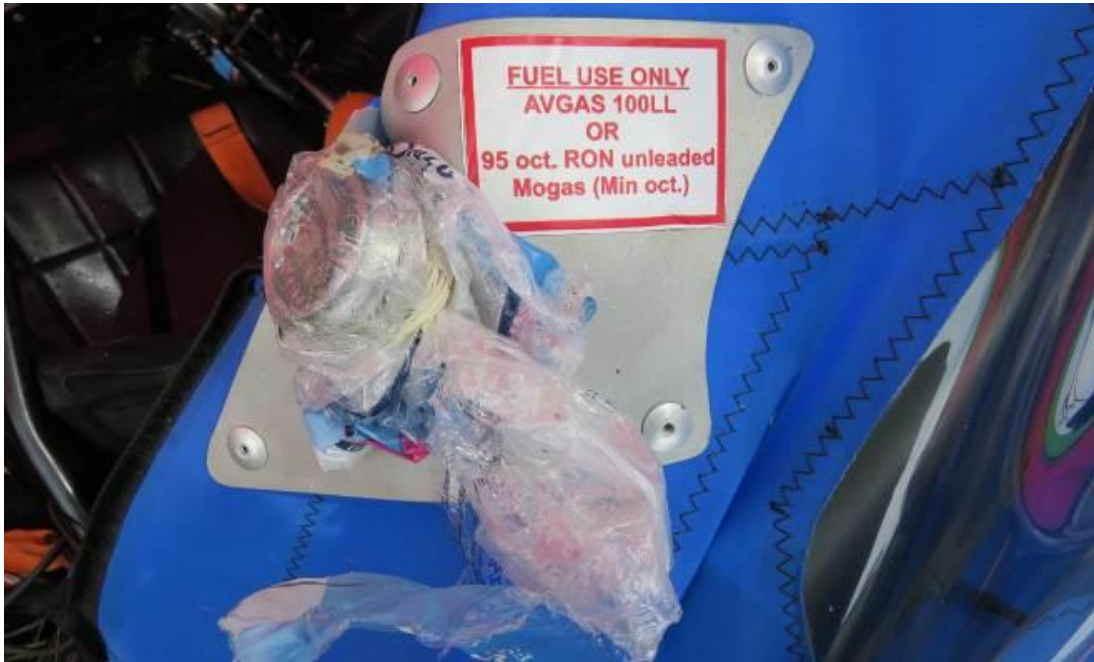
Figure 9: Plastic bag covering in place of the fuel cap

3.1.10 The pilot stated that he dropped the fuel tank filler cap during refuelling prior to the accident flight and was unable to retrieve it. He then covered the fuel tank filler point with a plastic bag as shown in Figure 9.

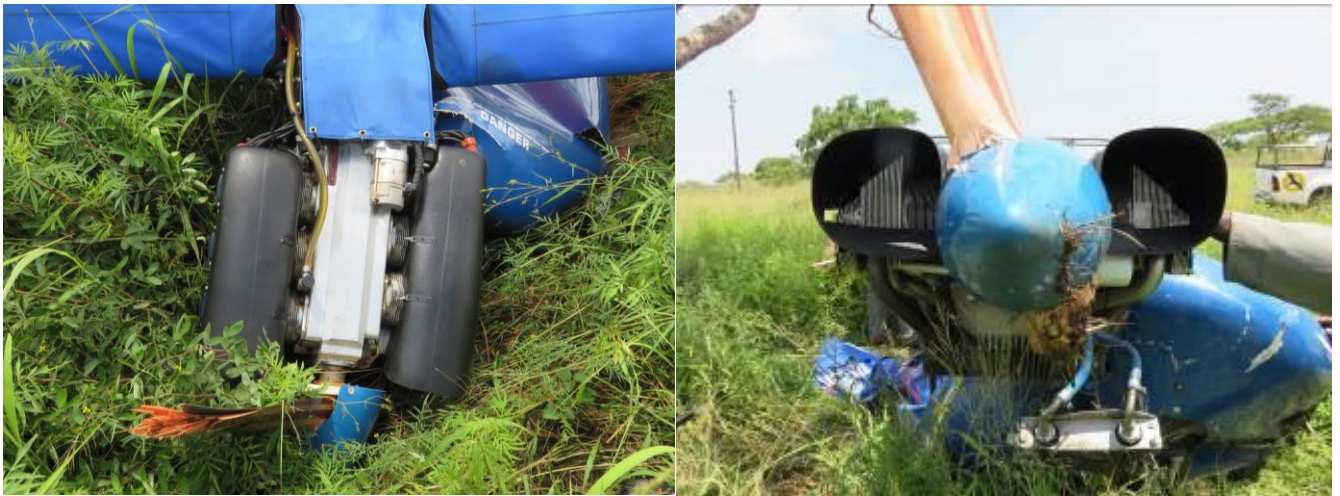
1.12.2 At the point of impact, debris from the wooden propeller and the Plexiglas windscreen were evident. Due to the distortion of the fuselage on impact, the microlight aircraft came to rest in a tail-high attitude against a tree. The cockpit/cabin area was substantially distorted, with the nose landing gear pushed up into the floor structure of the cockpit/cabin area. It was noted that the pilot did not make use of the aircraft-equipped shoulder harnesses, as these were still secured. It was also noted that the elevator trim tab had been subjected to an unapproved modification. One propeller blade completely shattered on impact and the second blade partially shattered, indicating that the engine was delivering power on impact.

Figure 10: The engine and propeller before recovery on the left and post recovery on the right

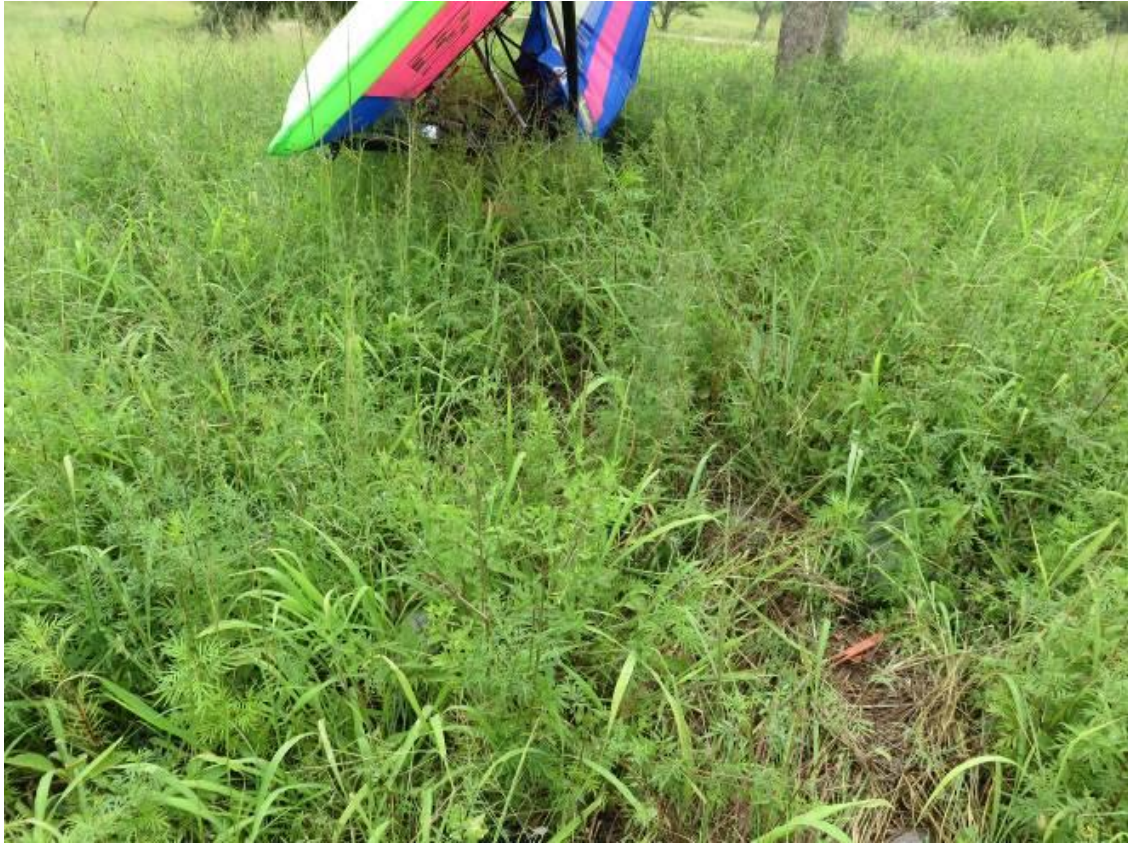
Figure 11: Propeller fragments and ground scarring

The aircraft had recently been subjected to repairs after it was involved in its third accident on 12 November 2017. During the on-site investigation, flight control continuity as well as the structural integrity was ensured. However, it was found that an unapproved modification had been installed on the elevator trim tab by the pilot/owner. He stated that he had flown with the unapproved modification for several flights. There was no documented evidence to prove that this information was indeed accurate, and this might have been the first flight with this extended elevator trim tab. No engine malfunction was reported by the pilot and the engine displayed evidence of normal operation, with one of the blades found to be shattered up to the hub assembly and the second blade shattered approximately midway.

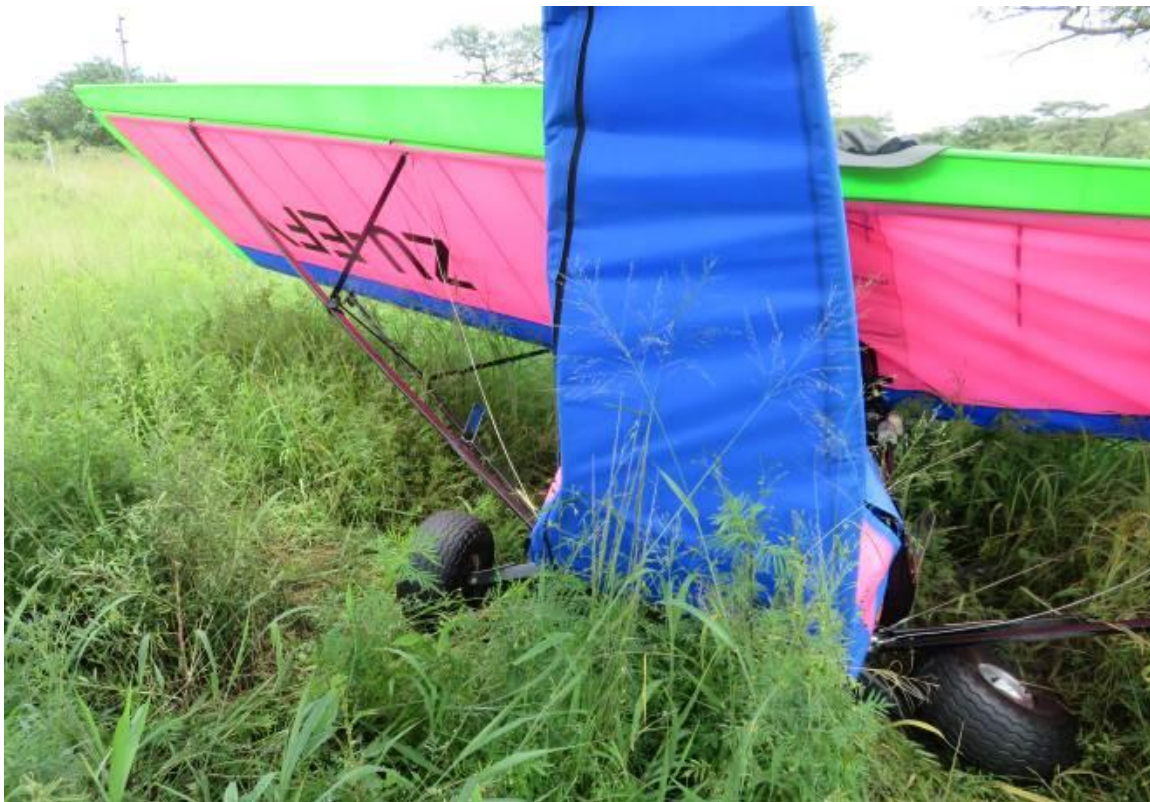
Figure 12: High tail attitude due to the distorted fuselage

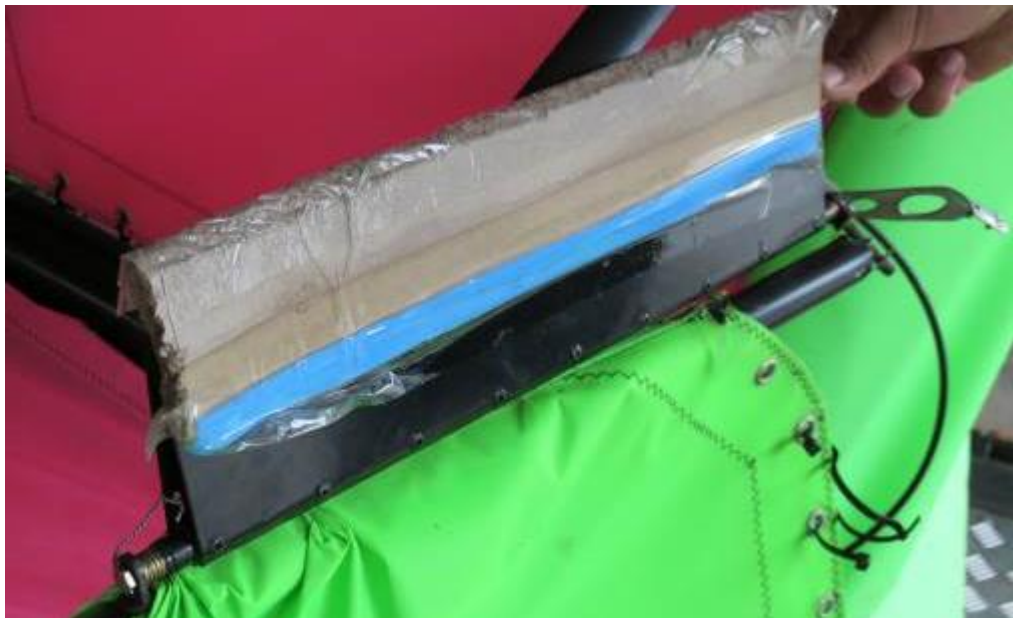
1.18.2 During the on-site investigation, it was noted that there was a modification to the elevator trim tab. During an interview with the pilot/owner, he stated that he had done the modification as he had difficulty during flight trimming the aircraft; he had to keep pulling back on the control stick. He extended the trim tab profile by extending the trim tab surface, by sticking a piece of cardboard to it. He indicated that he had flown several hours with the aircraft after performing the modification and that it had produced the desired effect.

This was found to be an unauthorised modification, as the pilot/owner did not comply with the requirements as stipulated in Part 44.01.10 of the CARs of 2011 as amended, attached to this report under Annexure A.

Figure 13: The elevator trim tab modification as it was found

- 3.1.9 The pilot, who was also the owner of the aircraft, performed an unapproved modification, namely he extended the elevator trim tab by means of sticking a

cardboard type of material to it. This was found to be in contravention of Part 44.01.10 of the CARs of 2011 as amended.
