AIRCRAFT ACCIDENT REPORT AND EXECUTIVE SUMMARY

Reference:	CA18/2/3/9687	
Aircraft registration	ZS-KOM	Date of accident	24 February 2018		Time of accident	1047Z
Type of aircraft	Cessna T210N (Aeroplane)		Type of operation		Private (Part 91)	
Pilot-in-command licence type		Student pilot	Age	73	Licence valid	Yes
Pilot-in-command flying experience		Total flying hours	Unknown		Hours on type	Unknown
Last point of departure		Mossel Bay Aerodrome (FAMO), Western Cape Province				
Next point of intended landing		Graaff-Reinet Aerodrome (FAGR), Eastern Cape Province				
Location of the accident site with reference to easily defined geographical points (GPS readings if possible)						
Oudtshoorn Military Area (GPS position; 33°30.748' South 022°10.893' East), Elevation 1 922 feet AMSL						
Meteorological information		Surface wind: 060°/5 kts, Temperature: 27°C, overcast with light rain visibility: 4000m				
Number of people on-board	1 + 1	No. of people injured	0	No. of people killed	2

Name of Owner : Jangen Air Investments (Pty) Ltd
Name of Operator : Private (Part 91)
Manufacturer : Cessna Aircraft Company
Model : T210N
Nationality : South African
Registration markings : ZS-KOM
Place : Ou

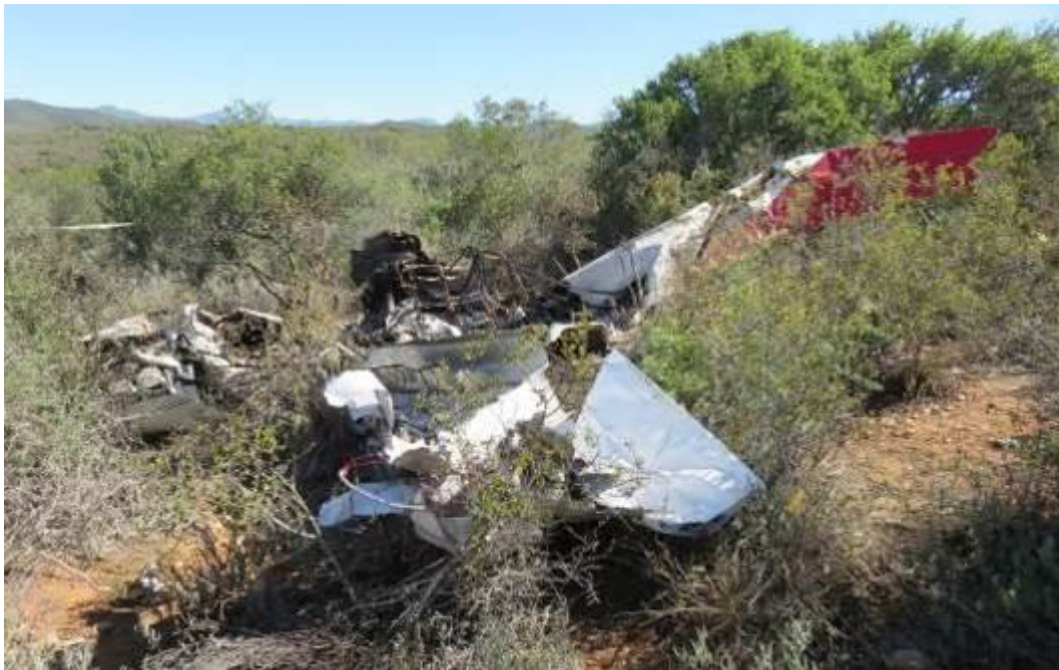
Figure 3: The main wreckage as it came to rest in an inverted attitude

1.12.1 The main wreckage of the aircraft was found in an inverted attitude, with the nose of the aircraft facing a south-westerly direction. The propeller was found to have fractured at the crankshaft flange and was located approximately 3m in front of the engine, which was still secured inside the airframe. The three propeller blades were still attached to the hub assembly and did not display any rotational evidence. The spinner was still attached to the propeller hub assembly and did not display any evidence of rotation that could be associated with normal engine operation.

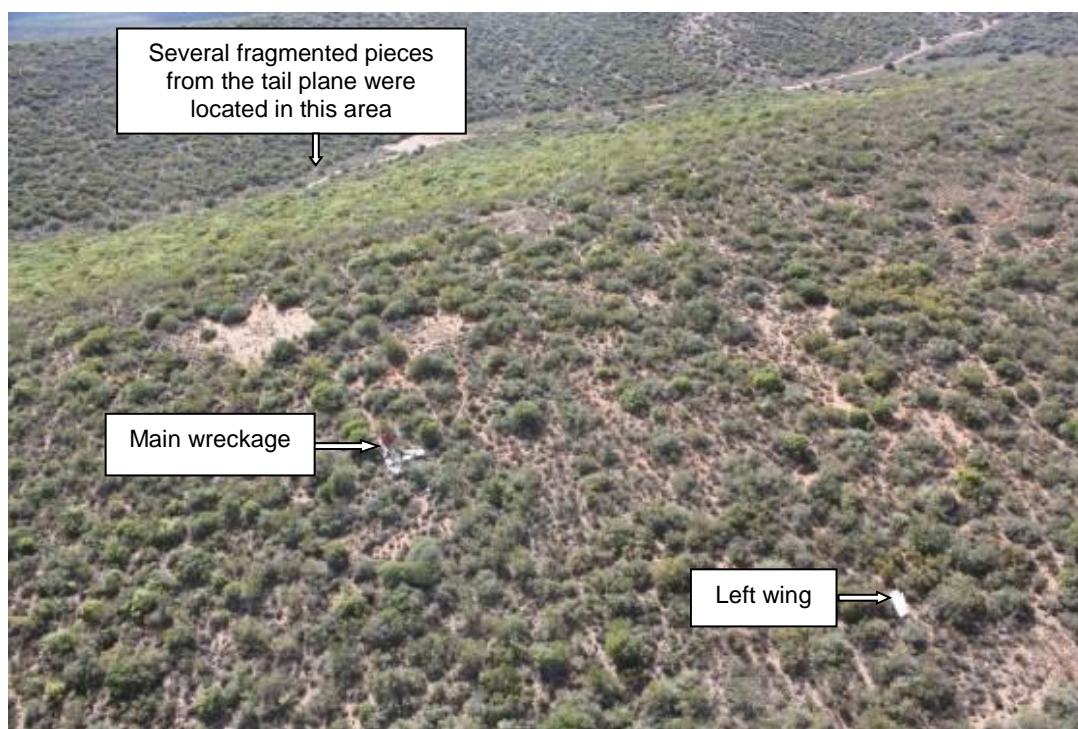
1.12.2 The left wing and the outer section of the right wing failed in flight. The left wing structure (illustration in Figure 8) was found 57m from the main wreckage. The weather radar dome, which was mounted underneath the right wing of the accident aircraft, was located several hundred metres from the main wreckage in a northerly direction. The entire horizontal tail plane failed in flight, and several pieces were found scattered over a large area to the north of the main wreckage, which included an

Figure 8: An aerial view of the wreckage field. The left wing was located 57 m to the south of the main wreckage (Picture: SA Police Services)

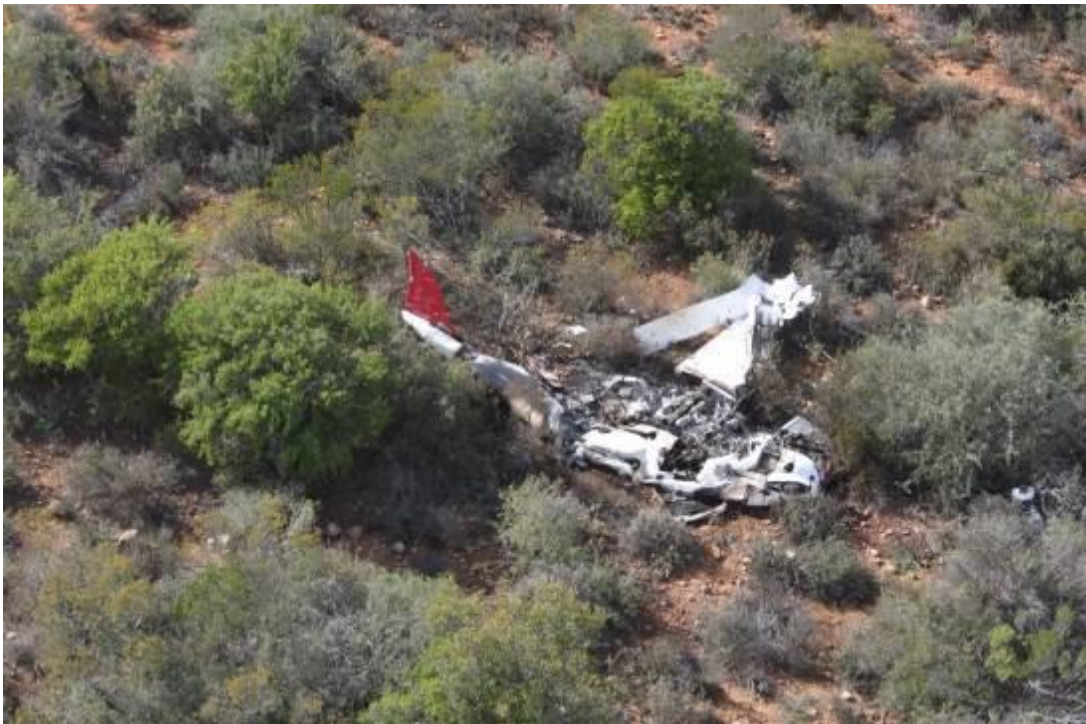
Figure 9: Aerial view of the main wreckage (Picture: SA Police Services)

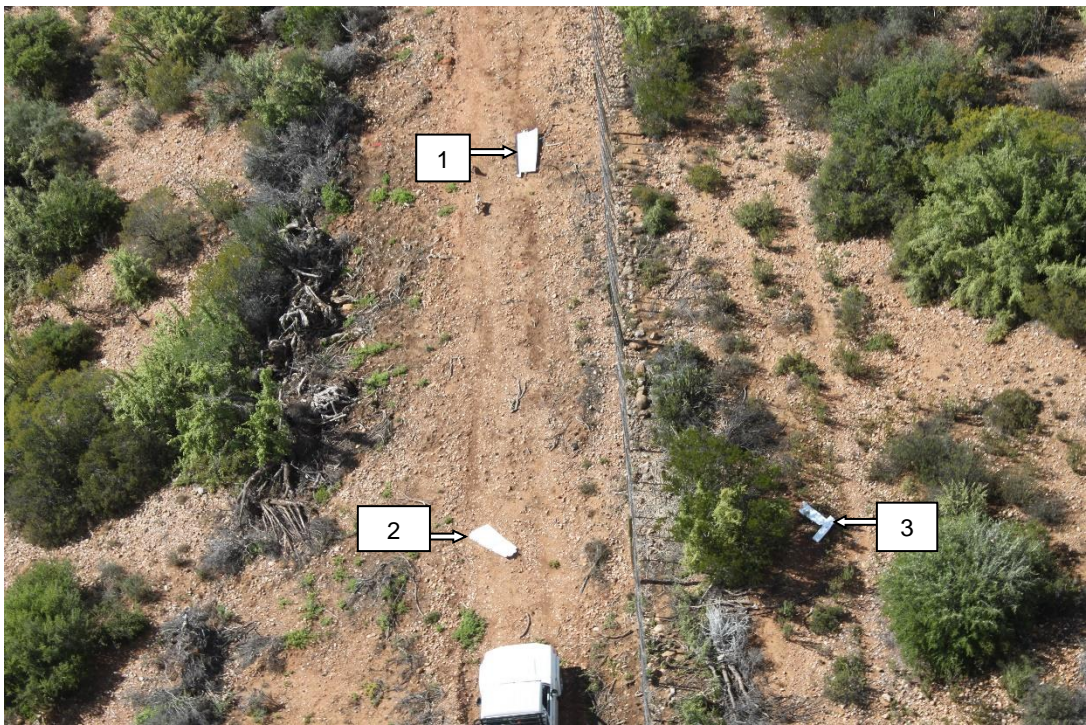
adjacent farm to the north of the military shooting range (FAR47). The three pieces of the horizontal tail plane (depicted in Figure 10) were found approximately 258m from the main wreckage. (It should be noted that this is a straight line measurement as the terrain is mountainous). The landing gear as well as the flaps were in the retracted (up) position. Although the left wing had separated from the aircraft in flight, the flap surface remained attached to the wing structure. The vertical fin and rudder assembly remained attached to the fuselage structure, but displayed evidence of deformation associated with impact as the aircraft came to rest in an inverted position.

Figure 10: Three pieces from the horizontal tail plane (Picture: SA Police Services)

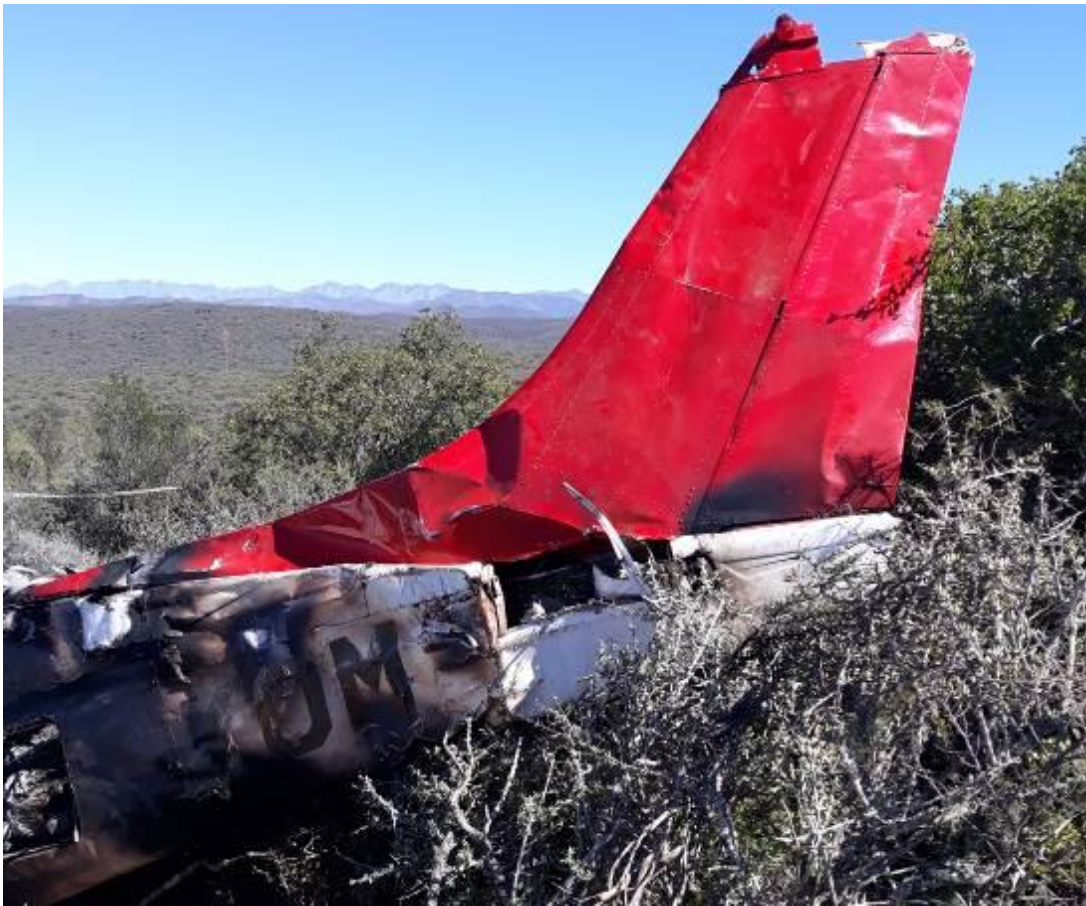
Figure 11: A view of the empennage (left-hand side) with the horizontal stabiliser and elevator missing

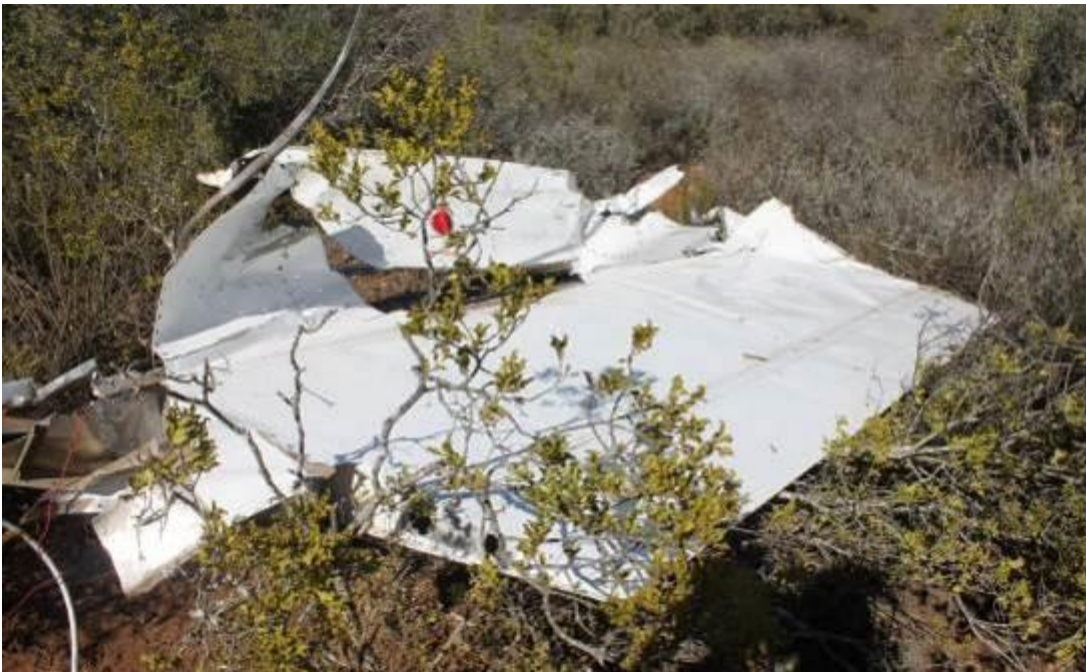
Figure 12: A major part of the left wing with the flap attached and in the up position

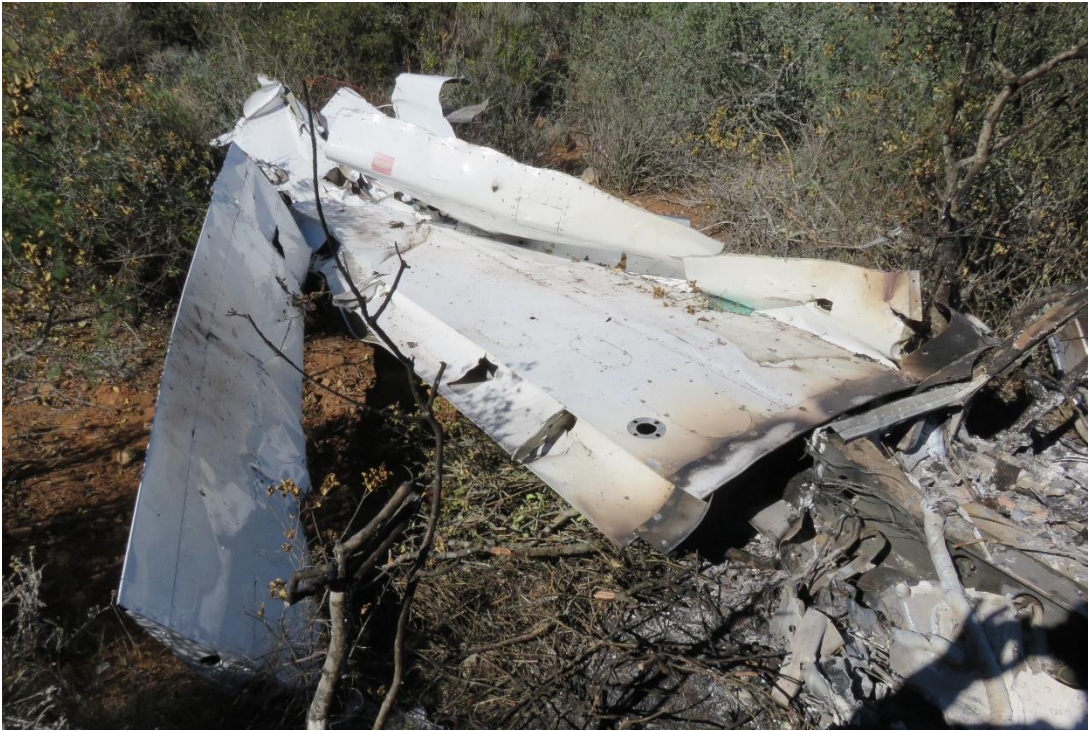
Figure 13: The right wing that was still attached to the fuselage

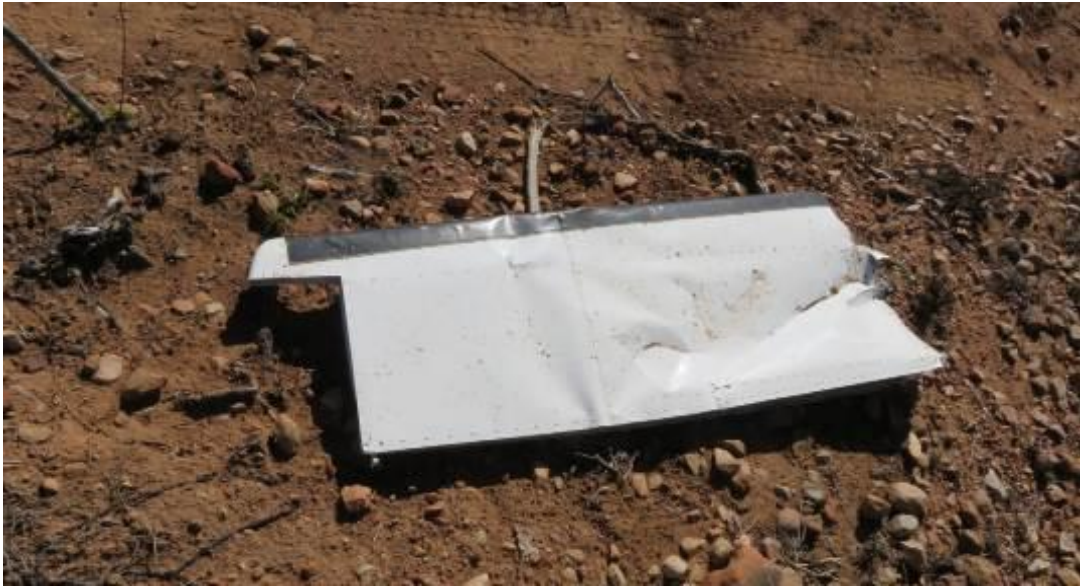
Figure 14: The outer section of the left horizontal stabiliser

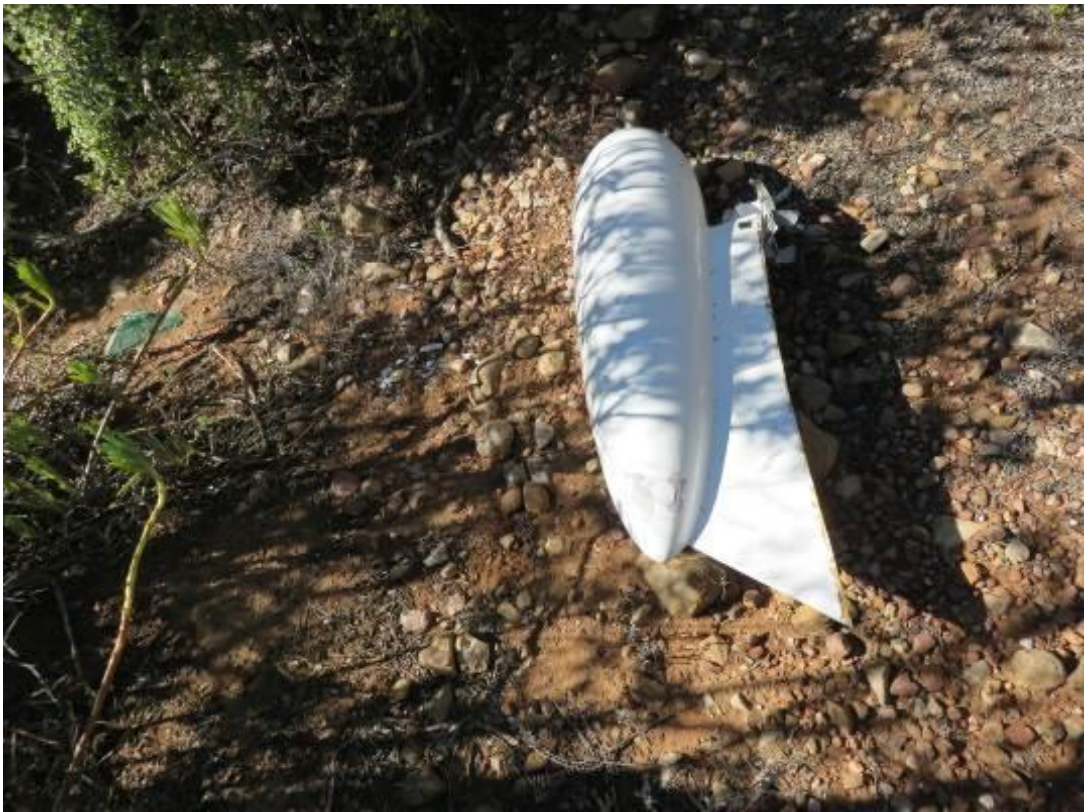
Figure 15: The Stormscope antenna that was mounted underneath the right wing

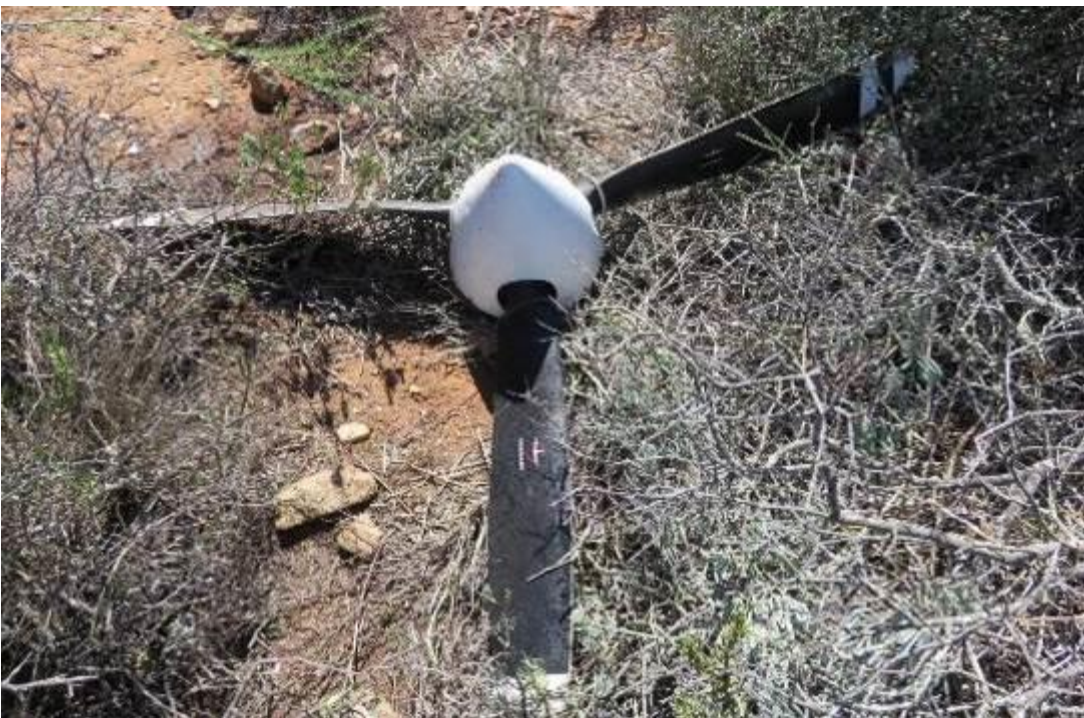
Figure 16: The propeller with the spinner still attached, displaying minor damage

front of the main wreckage, did not display any evidence of rotation, as the engine most probably stopped during the high ROD or when the aircraft became inverted as the fuel and lubrication systems of the engine were not accordingly designed. It was evident from the post-impact fire that an undetermined amount of fuel was still on board the aircraft at the time of the impact.

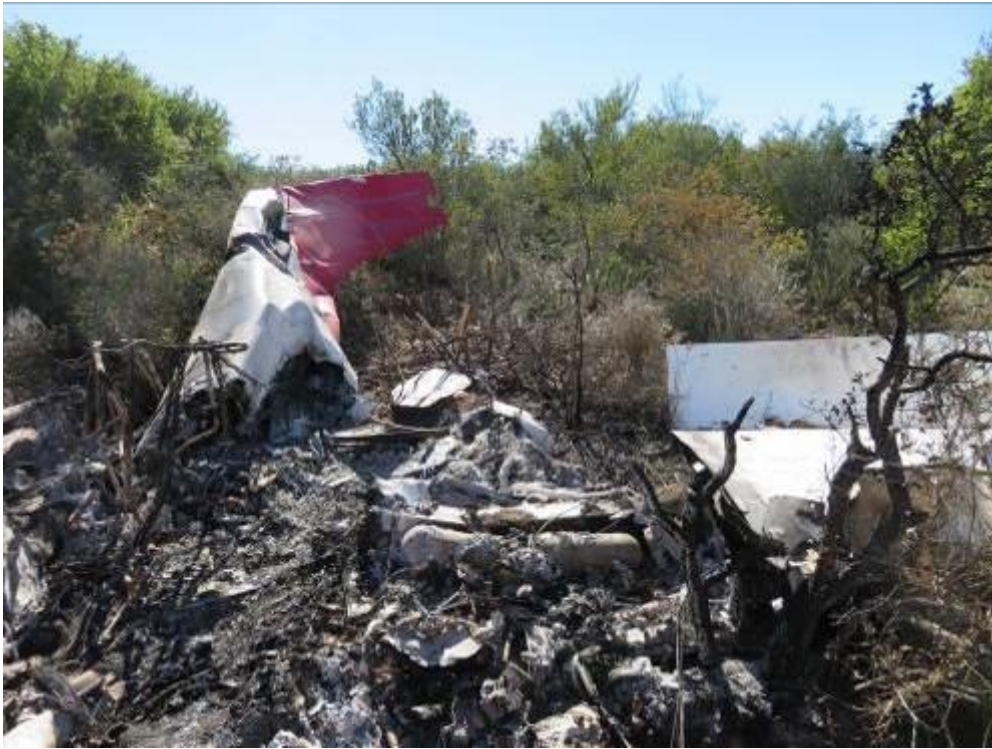
Figure 17: The cockpit/cabin area was consumed by post-impact fire

1.14.1 A post-impact fire erupted and consumed the cockpit/cabin area of the aircraft. The fire was contained to this area and the surrounding vegetation was not set alight by the post-impact fire.

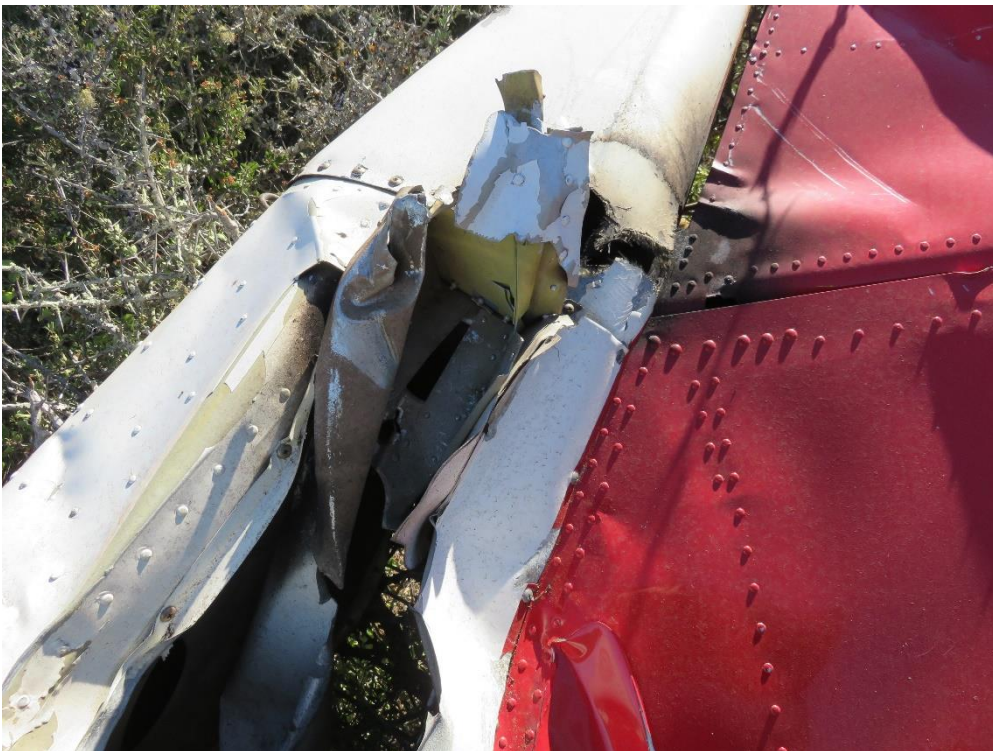
Figure 18: Deformation visible to the right aft fuselage where the horizontal tail plane was fitted

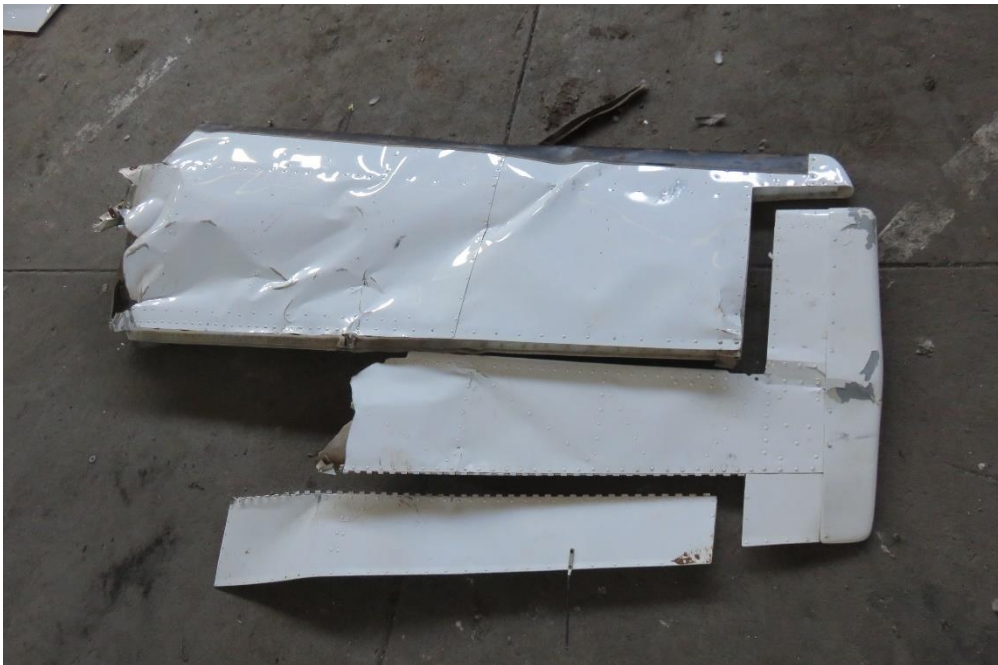
Figure 19: Some parts from the right horizontal tail plane that were recovered from the scene
