HELICOPTER ACCIDENT REPORT AND EXECUTIVE SUMMARY

Reference:	CA18/2/3/9688	
Helicopter registration	ZS-HKZ	Date of accident	28 February 2018		Time of accident	0945Z
Type of helicopter	Robinson R44 Raven II		Type of operation	Private (Part 91)		
Pilot-in-command licence type	Private Pilot		Age	57	Licence valid	Yes
Pilot-in-command flying experience	Total flying hours		157.9		Hours on type	157.9
Last point of departure	Farm Truter Boerdery near Ogies, Mpumalanga Province					
Next point of intended landing	Farm Truter Boerdery near Ogies, Mpumalanga Province					
Location of the accident site with reference to easily defined geographical points (GPS readings if possible)						
Farm Truter Boerdery (GPS position: 26°2'12.79" South 028°53'56.06" East) at an elevation of 4944 ft						
Meteorological information	Surface wind: 080°/6kt, Temperature: 25°C, Dew point: 12°C, QNH: 1023					
Number of people on board	1 + 1	No. of people injured	0	No. of people killed	2

Name of Owner : Truter Boerdery Trust
Type of Operation : Private (Part 91)
Manufacturer : Robinson Helicopter Company
Model : R44 Raven II
Nationality : South African
Registration Markings : ZS-HKZ
Place : Farm Truter Boerdery

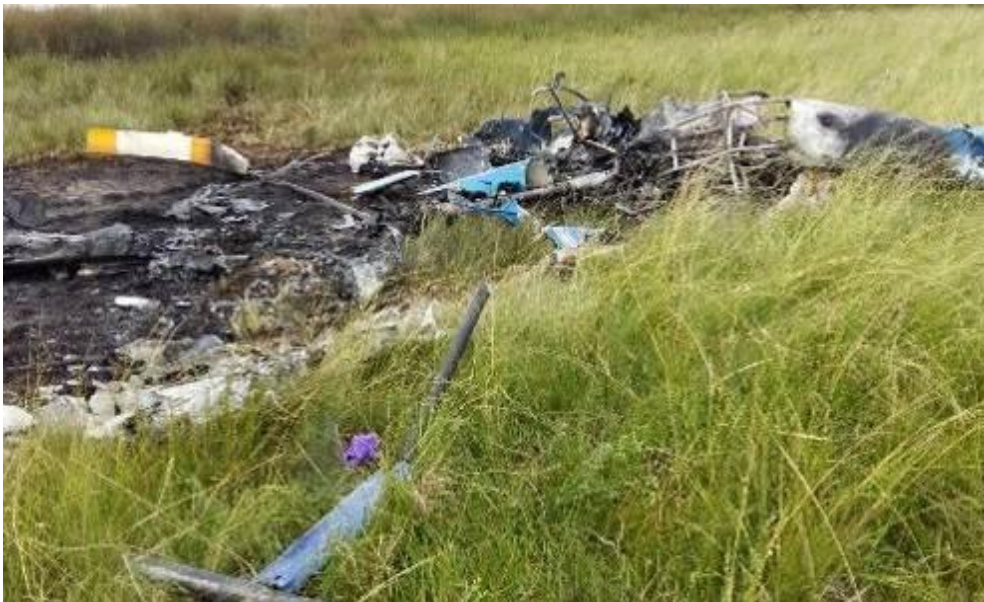
hub. The main wreckage was intact, with the major components still attached as seen in Figure 3 below. The auxiliary and the main fuel tank dislodged and were located at approximately 3 m and 1 m respectively from the wreckage. The tanks were deformed as a result of the impact. It could not be determined whether the tank had fuel inside although the area where the helicopter was resting had burnt out. The main wreckage was engulfed by fuel-fed fire, which subsequently burned some small vegetation around the wreckage. The grass vegetation at the accident site was green. The portion that burned was a result of fuel spillage caused by the ruptured fuel tank after impact, which led to the fuel-fed fire. The right-hand front cockpit door retainer with the vent door of the right cockpit door attached to it was lying on top of the main rotor blade. The impact on the retainer indicated that the leading edge of the main rotor blade had imprinted a dent on it as seen in Figure 4. The helicopter was consumed by fuel-fed fire which erupted after the crash. Only the last section of the tail boom, skid gear and half of the blade didn't catch fire.

Figure 3: The main wreckage destroyed by the post impact fire

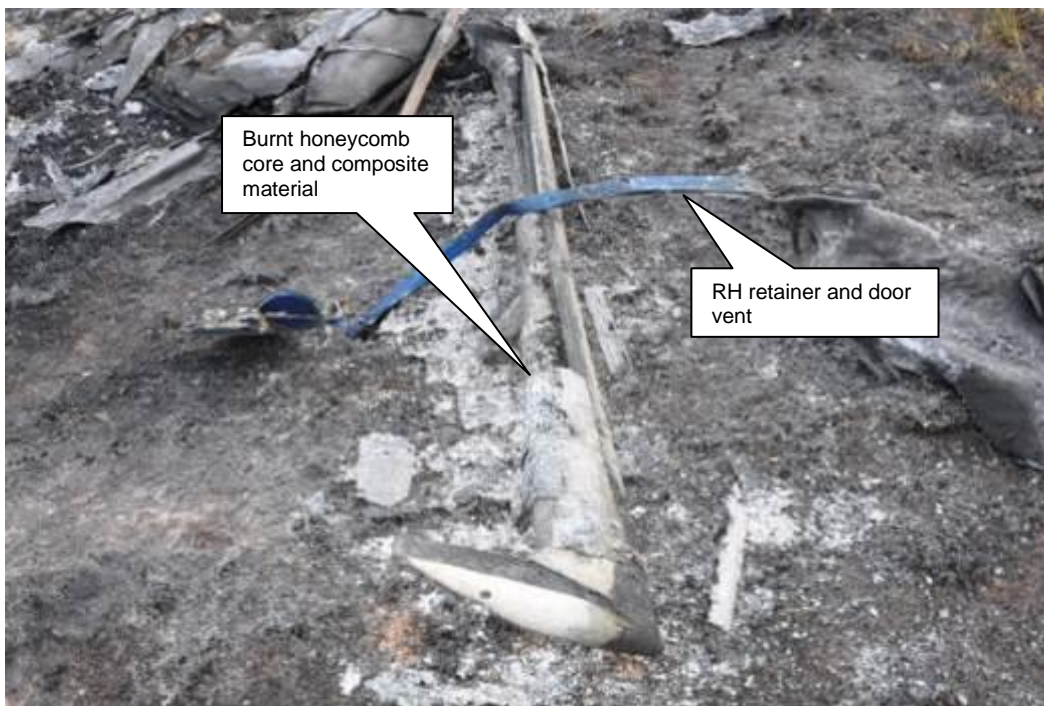
The main rotor blades were still attached to the main rotor hub. One of the blades was completely consumed by post-impact fire. The leading edge made of stainless steel had no impact marks while the other blade was consumed by fire from the root to the midsection only. The burnt blade didn't have signs of blade disintegration, as seen in Figure 6 below. The unburnt section of the main rotor blade didn't reveal any sign of disintegration or deformity, but it signifies a compression load on the top surface, and the trim tab was still attached to it; however, the blade was bent upwards in a curly position, indicative of damage caused by contact with the ground

Figure 4: Shows burnt honeycomb core and composite material

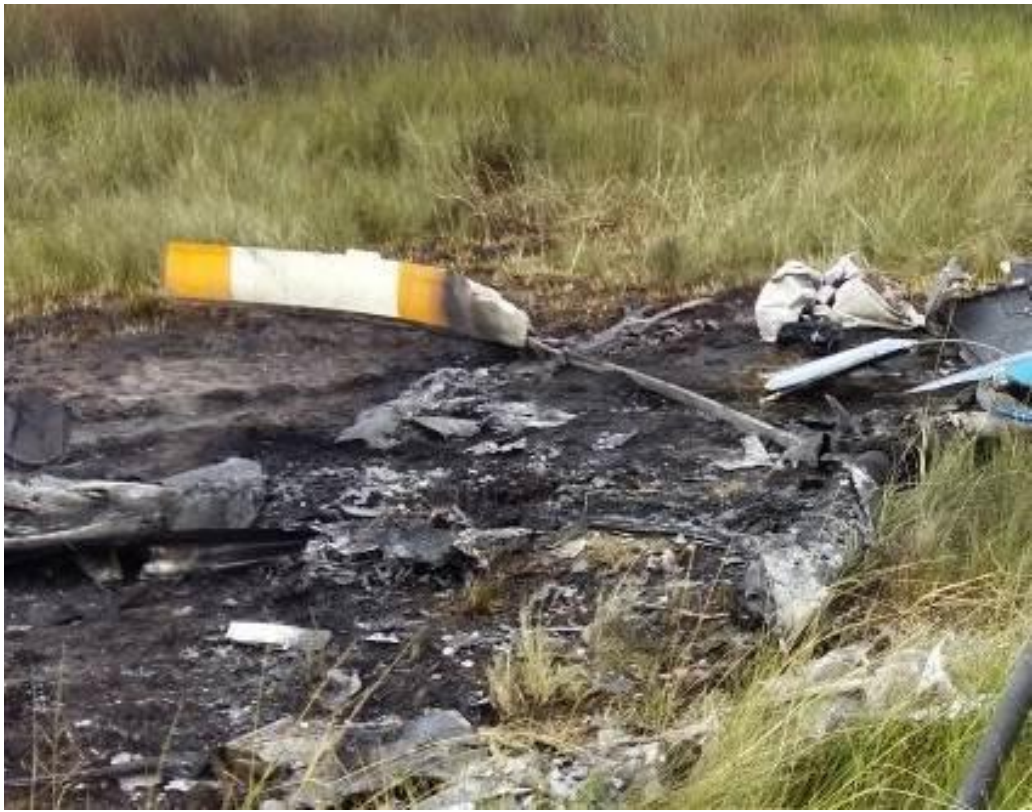
on the blade that was not rotating at full speed. The main rotor blade tip caps were still attached at the end of the blades. The balancing weights were still attached and secured to the blade ends. The inner part of the blade root was crushed, as seen in Figure 6, which is indicative of severe flapping. The main rotor hub was still intact, with the blade root attached to it. The pitch change links broke off in the middle, due to overload. The scissor link assembly broke off. All control tubes broke of ± 70 mm near the clevis holes (eye end). It appears that one of the main rotor blades had rotated 135° (see Figure 6 of the main rotor head). The swash plate was still intact and had no signs of failure prior to impact. The mast was still intact, although it was bent slightly. The teeter stops were crushed and the plate was bent, which is indicative of hub assembly contact.

Figure 5: The visible outer section of one of the main rotor blades

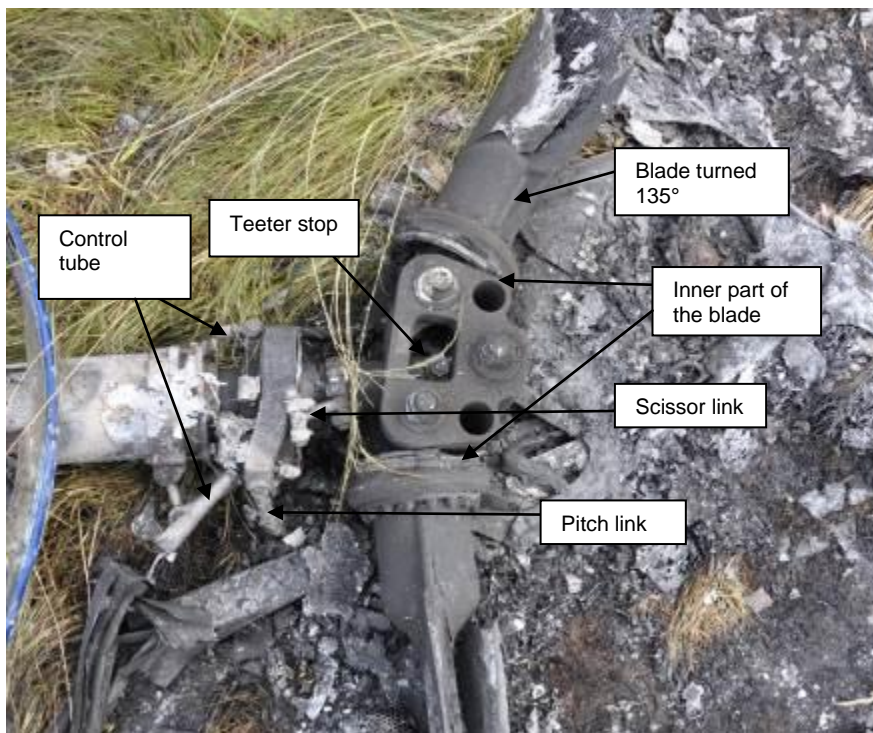
Figure 6: The main rotor hub assembly

2.2.3 Other rotor head damage found included broken pitch change links, a broken scissor link and a bent mast shaft from excessive movement of the spindle tusks. The inner surface of the blade root was crushed, which is consistent with extreme teetering of the blade. The cabin area was struck by the main rotor blade during

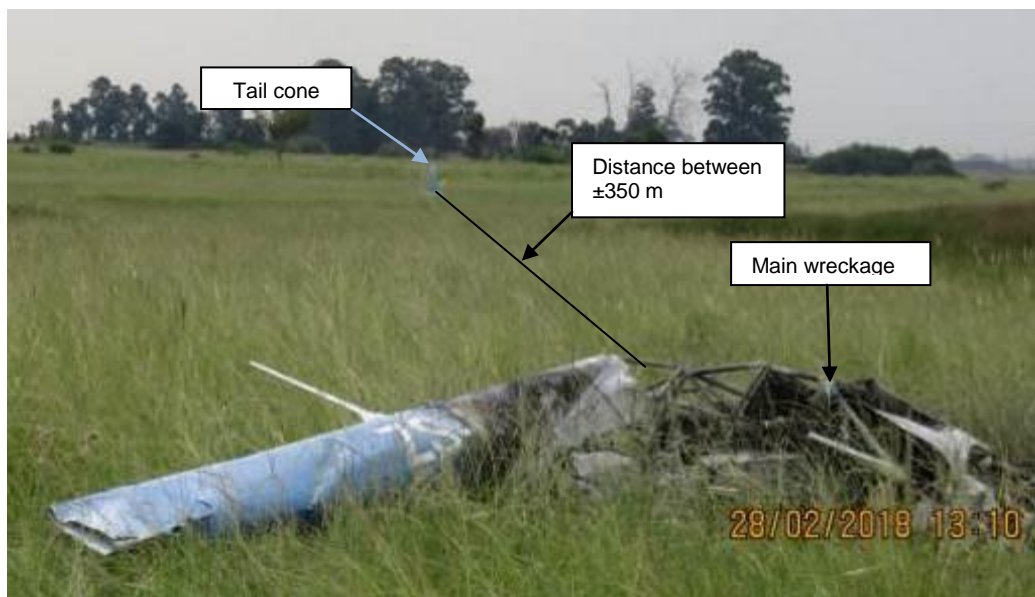
The tail section was located at a distance of approximately 350 m from the main wreckage, as seen in Figure 8 below. Observation of the impact point indicated that the main rotor blade severed the tail section in-flight. The yellow paint imprints on the impact point and the imprint were consistent with the yellow paint used on the main rotor blade tips. The tail drive shaft was severed at the same time as the tail section. The yellow paint imprints were visible on the tail drive shaft, as observed on the accident scene. The tail rotor control tube was located a distance of 5 m from the main wreckage. Observation revealed that it became dislodged when the helicopter impacted the ground. The tail rotor gearbox was turning freely, and no signs of oil leaks were observed around the housing. The temperature strip indicated 66°C, which was consistent with normal operation, as seen in Figure 11. The tail rotor blades were still intact with the output shaft. The damages observed on the tail rotor blades were as a result of the impact with the ground and they indicated damages caused by the impact on a stationary blade. The compression loads on the vertical stabiliser indicated that the tail cone impacted the ground with the vertical stabiliser first and then the tail rotor hub, as seen in Figure 9.

Figure 8: Shows the main wreckage and tail section

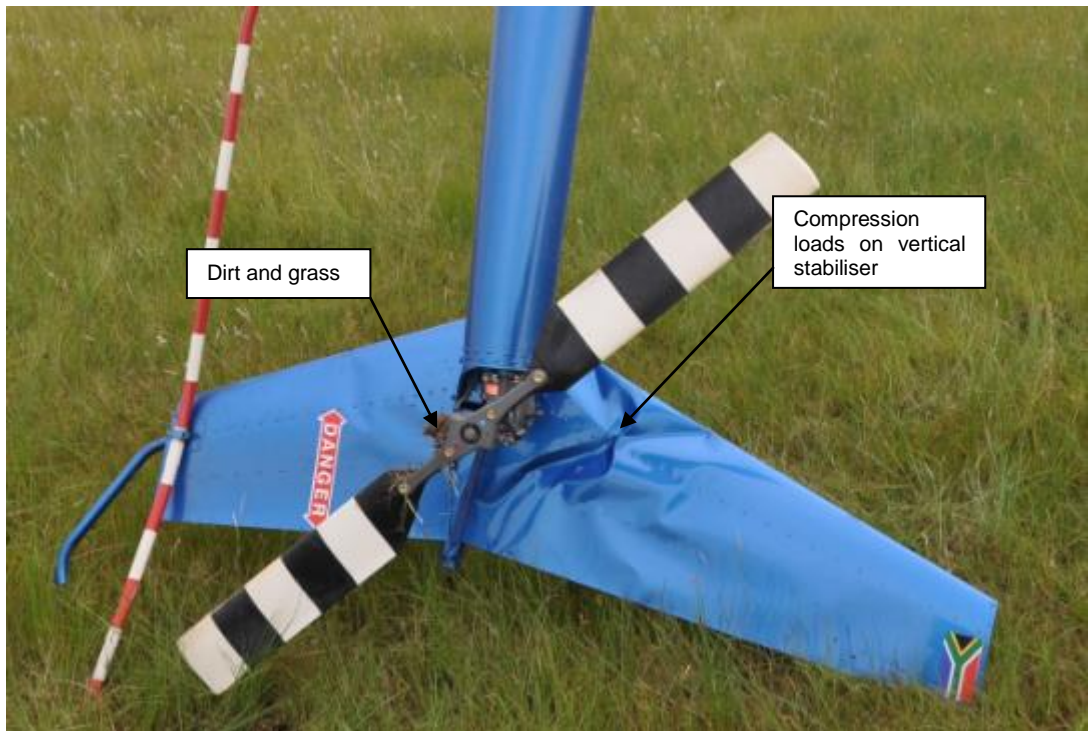
Figure 9: Shows a picture of the tail rotor blades assembly

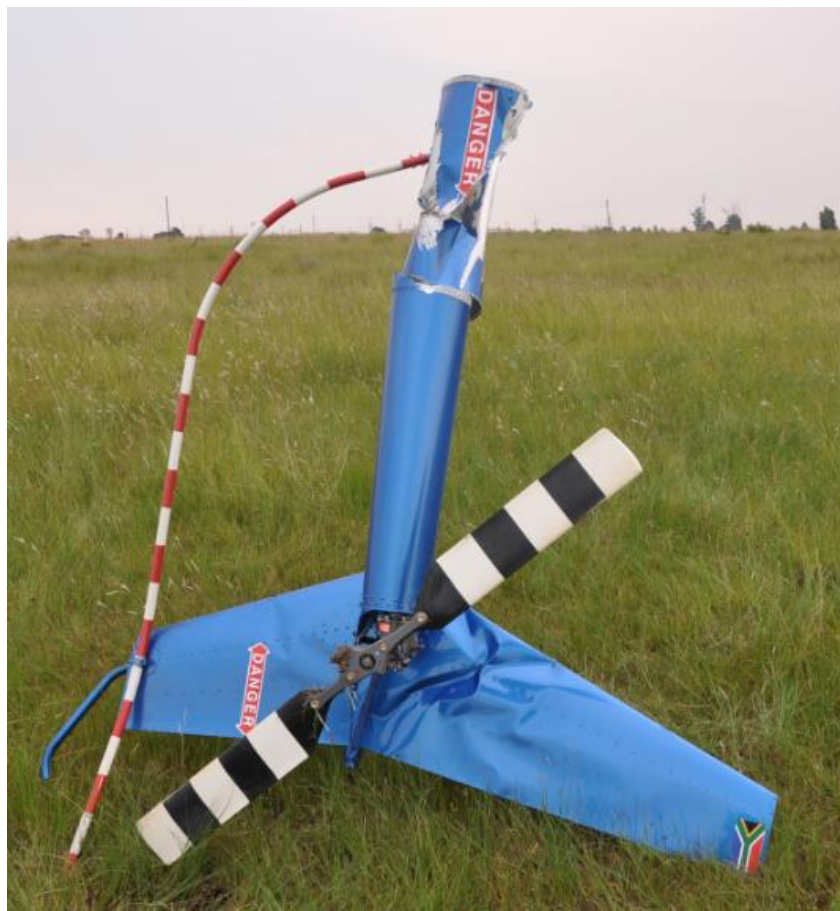
Figure 10: Shows the picture of the severed tail cone by the main rotor blades

2.2.2 The damage to the helicopter and distribution of the wreckage indicate that the main rotor blades struck the tail cone in-flight, causing the tail section to break and subsequently striking the cabin area as well during ground impact. The witness stated that the helicopter was flying at approximately 328 ft; however, based on the evidence on the main wreckage position and the severed tail cone as found on the wreckage distribution, the height was most likely to be higher because of the distance between the two. The damage was typical of that seen in other R44 accidents where there has been a low rotor RPM, following a loss of engine power. A loss of engine power in the R44 helicopter requires immediate and correct action from the pilot to enable a successful autorotation to be made. If there is too much delay, or incorrect action, or if the pilot waits too long to lower the collective, the rotor RPM will decay to the point from which recovery is impossible. This is emphasised in the POH, dated 03 October 2002, as supplied by the manufacturer. The helicopter was involved in a hard landing incident on 24 February 2016. All major class 2 components were replaced by an approved AMO which did the repairs, whereby the helicopter was returned back to service on 04 October 2016 by a qualified maintenance engineer. The damages on the rotor head components were as a result of the impact sequence. The damages sustained by the major components were as a result of the impact sequence. The damage sustained by the no 2 main rotor blade was indicative of damage caused by the impact on a blade that was turning at low RPM. The rotor RPM was critically low, causing the blade to diverge from the normal plain of rotation, which resulted in an action reaction in that the tail cone subsequently became severed.

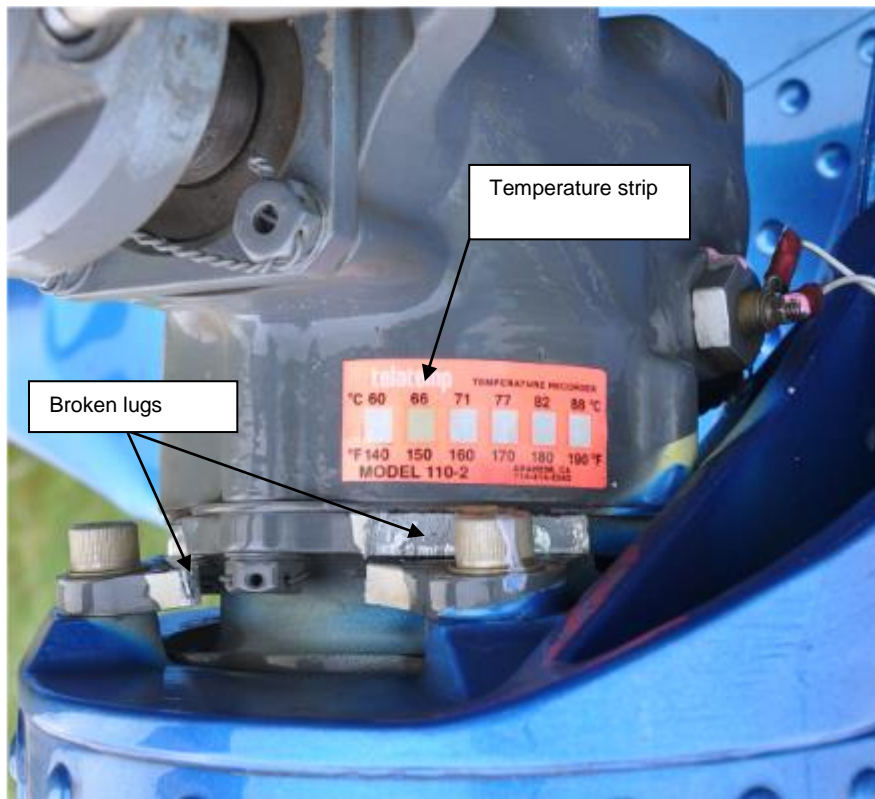
Figure 11: Shows the temperature strip on the tail rotor gearbox
