<b>AIRCRAFT ACCIDENT SHORT REPORT</b>
---------------------------------------

**CA18/2/3/9689 ZU-KAH, Accident**

**Aircraft manufacturer and model** : ICP Italy & Savannah Africa, Savannah S  
**Last Point of departure** : Hoedspruit Airfield (FAHT), Limpopo Province

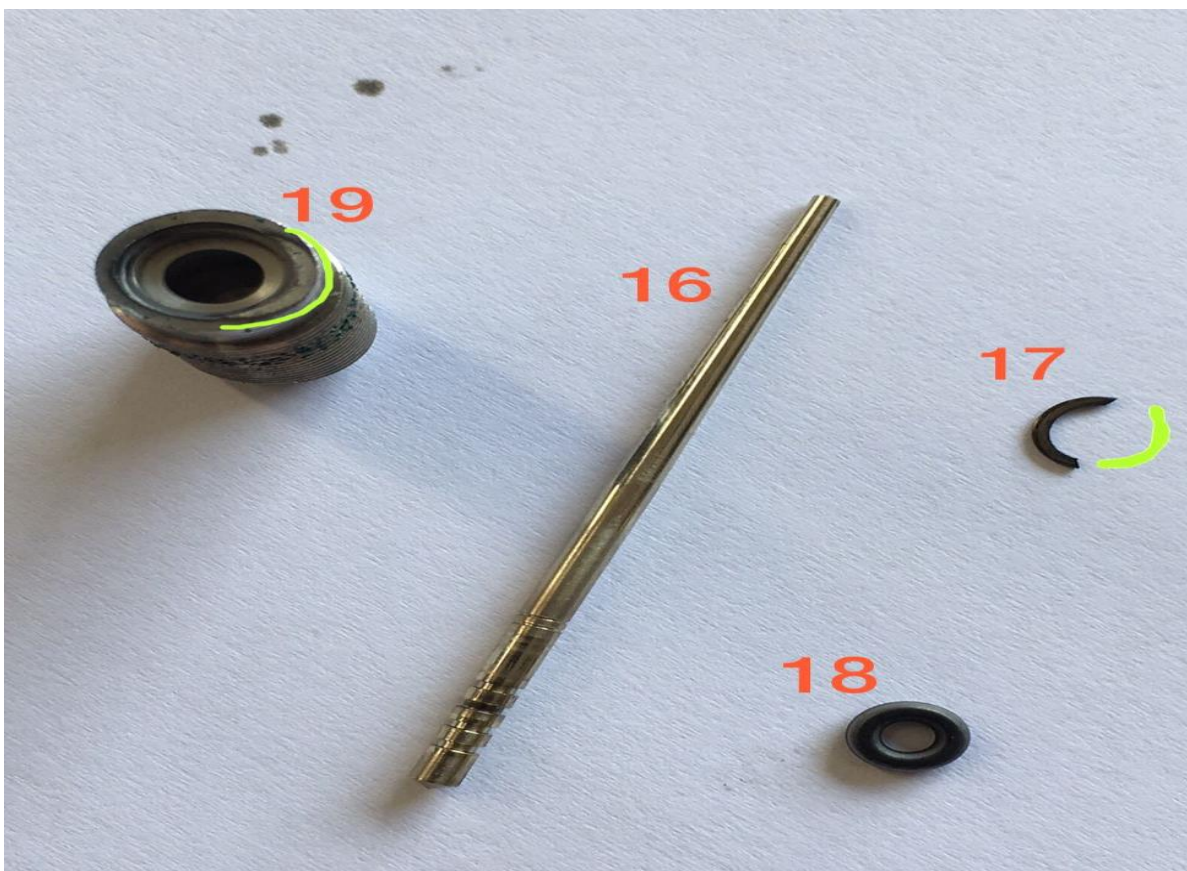
2.2 The engine teardown inspection revealed that the aircraft engine was fitted with a non standard Rotax mechanical fuel pump. The left hand side caburator had a disintegrated retaining clip and fixation screw. Part of the retaining clip was stuck in the needle jet, which restricted normal fuel flow. This resulted in the misbalance of fuel supply which would lead to rough running and subsequently engine stoppage (Figure 1).

Figure 1: The disintegrated carburetor components (17 retaining clip and 19 fixation screw)

3.1 Unsuccessful forced landing following engine failure due to fuel starvation following a failed retaining clip. The breaking off of the pin contributed to the rough running and subsequent stopping of the aircraft engine.

- 5.1 It is recommended that the aircraft owners and operators of this type of aircraft installed with Rotax engine to ensure compliance of caburator inspection at every 200 hours.

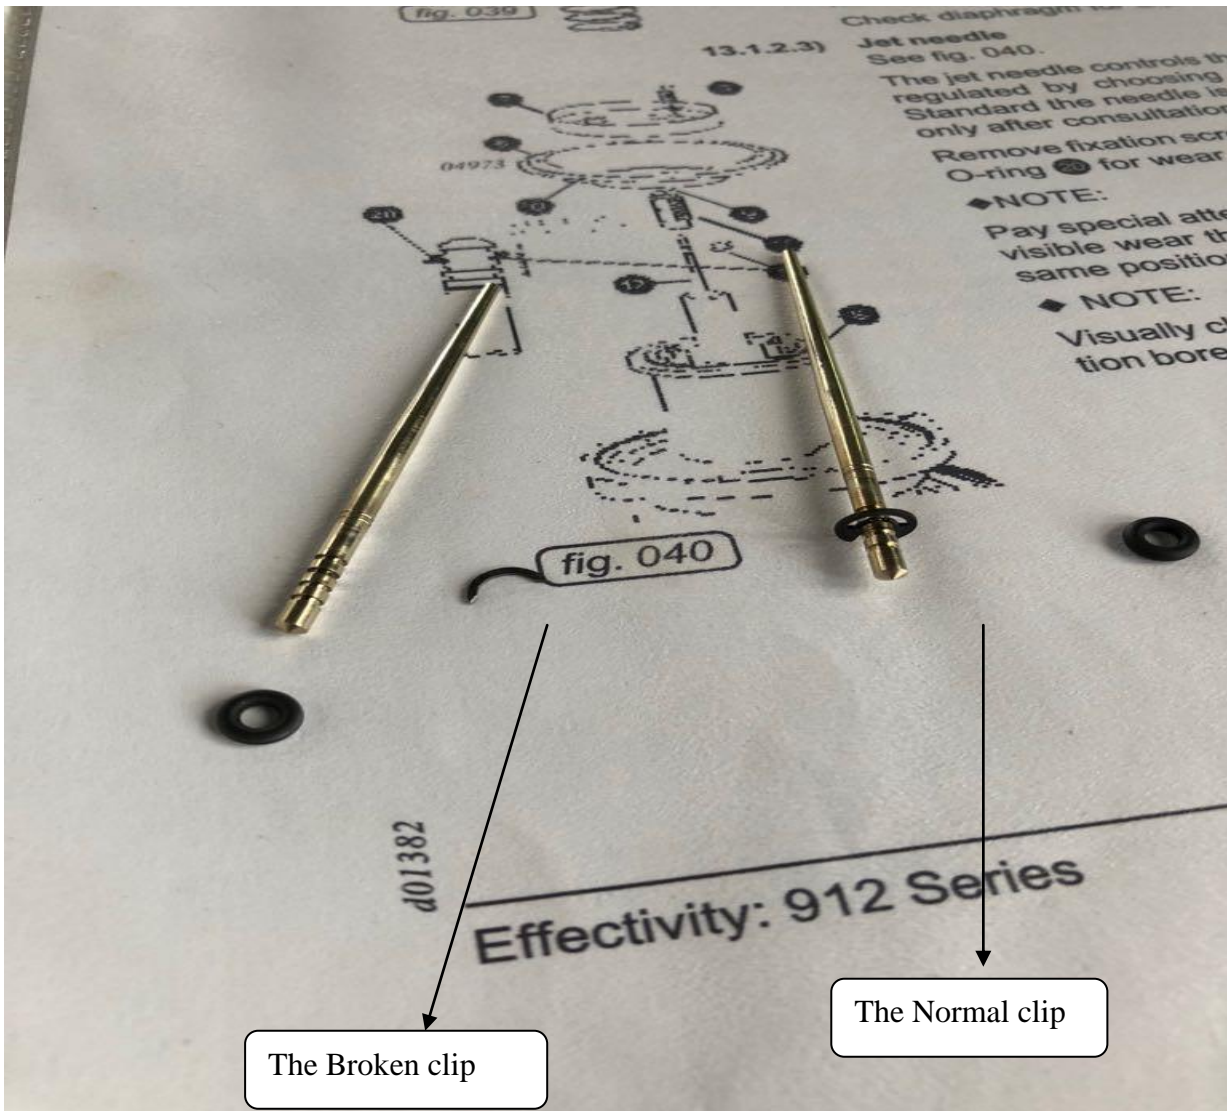
Figure 2: The two retaining clips side by side.

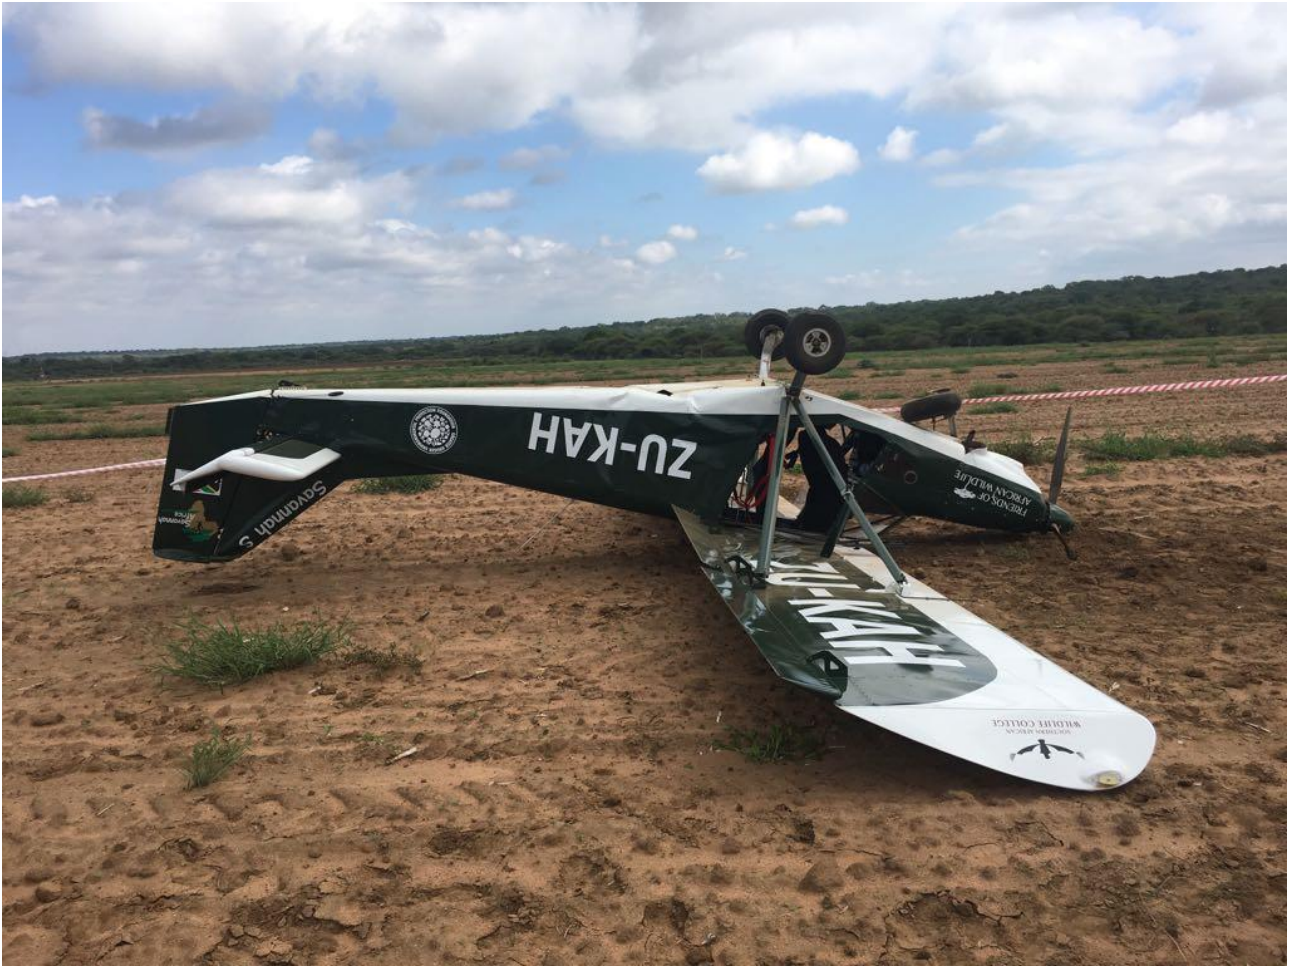
**Injuries** : None  
**Damage to aircraft** : Broken off nosewheel, damage to central fuselage, propeller, windscreen, right wing and tail fin.

Figure 3: The aircraft as it came to rest.
