AIRCRAFT ACCIDENT SHORT REPORT

CA18/2/3/9690: ZU-RLK, High rate of descent during landing sequence

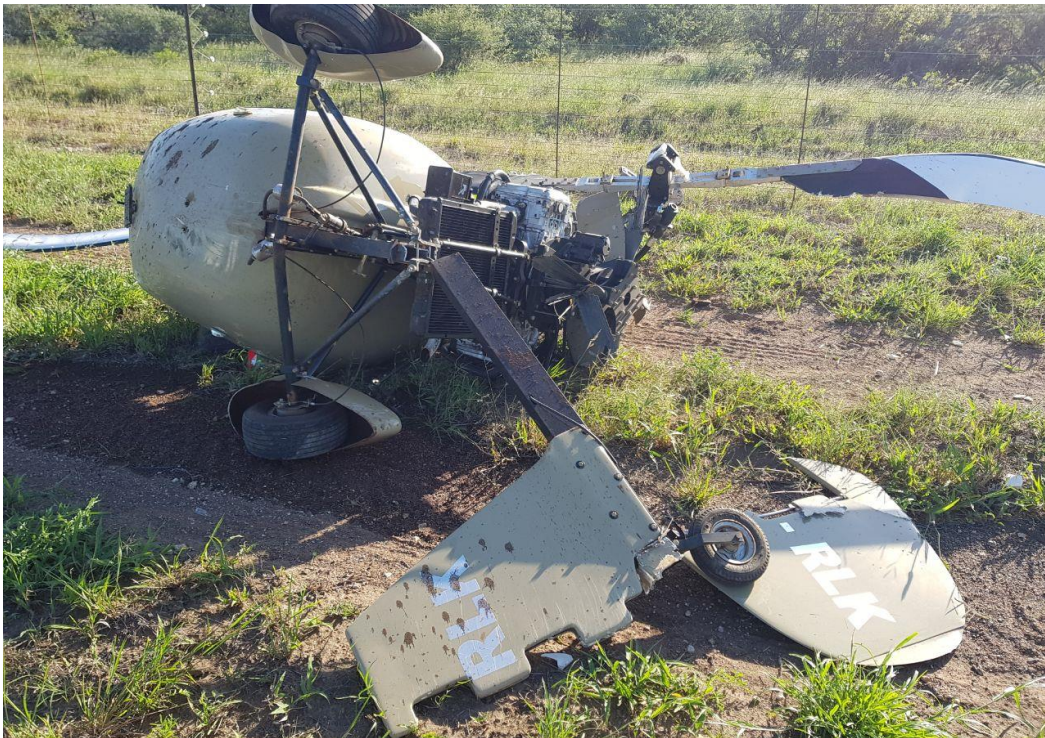
The gyrocopter skidded for 60 m then rolled over to the right during the landing sequence, and was substantially damaged. The pilot received minor injuries.

Figure 2: The gyrocopter as it came to rest

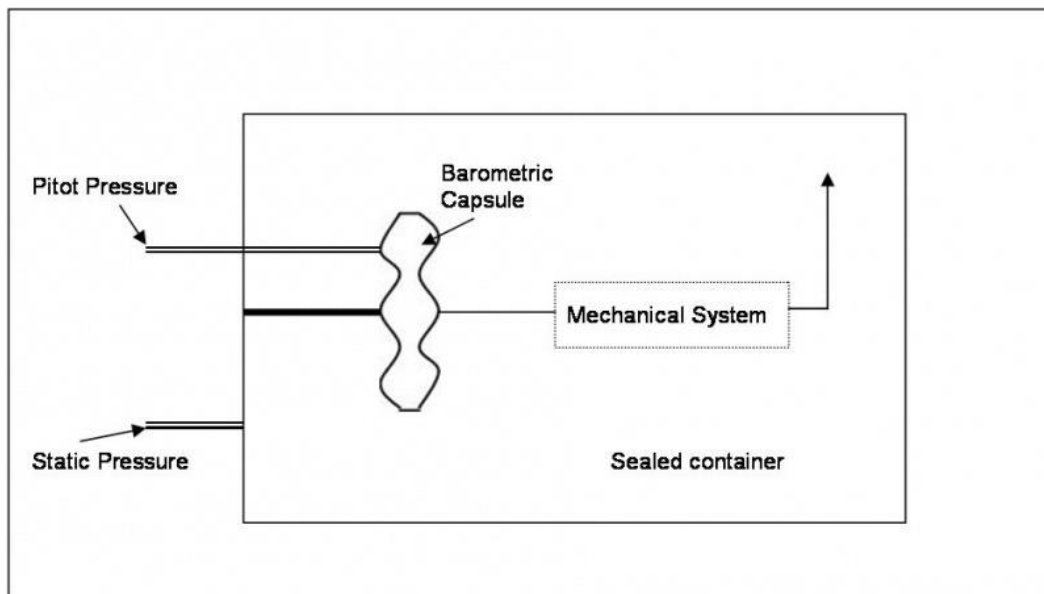
- The root cause of the electrical failure could not be determined with certainty.
- The airspeed indicator was mechanically driven through the pitot tube, which was located in the nose of the gyrocopter. It would have remained operational even in the case of a complete electrical failure.

Figure 3: An example of a simple airspeed indication system with no electrical input (www.skybrary.aero)
