AIRCRAFT ACCIDENT SHORT REPORT

CA18/2/3/9691

Date and time : 13 March 2018 1427UTC
Occurrence type : Accident
Aircraft registration : ZS-RNW
Aircraft manufacturer : Robinson Helicopter Company
Aircraft Type : R 22
Last point of departure : Rand Aerodrome (FAGM)
Next point of intended landing : Rand Aerodrome (FAGM)
Location of accident : 10 km south-west of Rand Aerodrome
GPS coordinates : 26° 18' 46.56" S; 028° 05' 17.09" E
Meteorological Information : Wind: 150°-240°/6 kts, T 23 °C, clouds: SCT045.
Type of operation : Training Part 141
Persons on board : 2
Injuries : 1 Serious and 1 minor
Damage to aircraft : Substantial

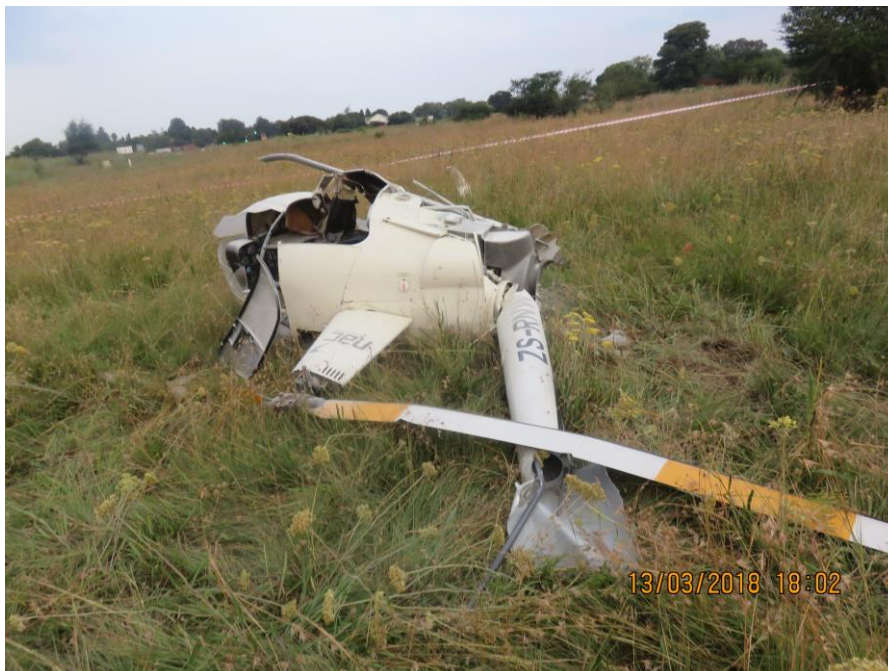
- 1.3 The instructor was unable to flare the helicopter; as a result the helicopter impacted the ground and sustained substantial damages, but the student and instructor managed to exit the helicopter. A small post-impact fire started and was extinguished by a bystander. The instructor sustained serious back injuries, while the student suffered minor injuries.

Figure 1: The helicopter as it came to rest in the open grassy field

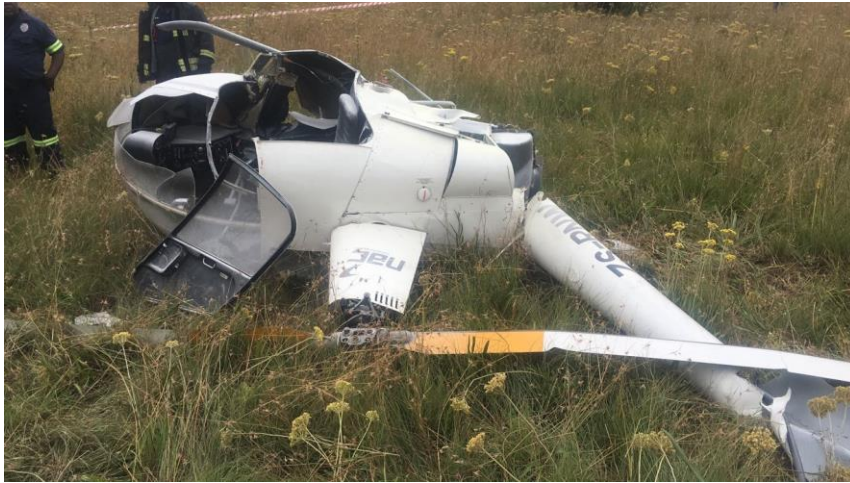
- 2.11 The wreckage also revealed that there was very little damage to the main rotor blades, indicating that the helicopter impacted the ground with low rotor RPM.

Figure 2: The rotor blades were mostly undamaged
