AIRCRAFT ACCIDENT SHORT REPORT

CA18/2/3/9693 : ZU-ZAN Investigation of a loss of control after landing

Aircraft manufacturer and model : Jabiru J400

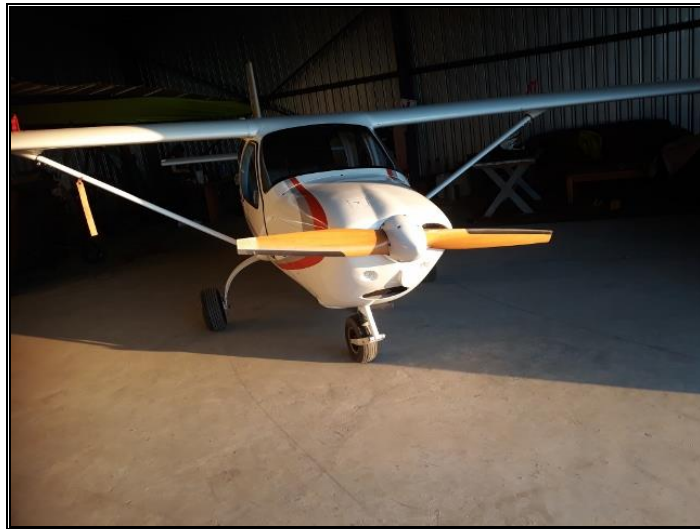
The pilot stated that the second approach was stable and flare was more controlled. When the main landing gear touched the runway, the left gear collapsed. The pilot tried to maintain directional control with little success. The aircraft veered off to the left of the runway. The aircraft exited the runway, subsequently collapsing the right main landing. The aircraft skidded and came to rest approximately 350ft from the edge of the runway. The propeller came into contact with the ground.

Figure 3: Shows the aircraft after recovery picture courtesy of the Rick Mey.

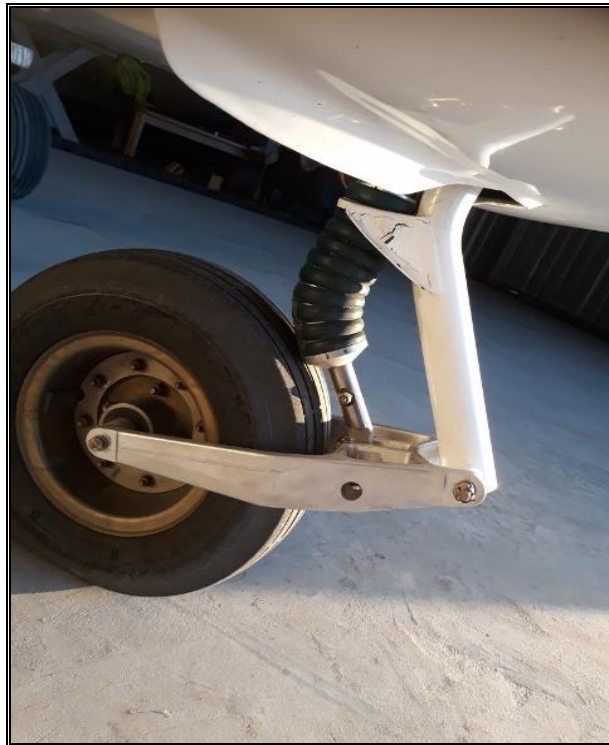
The aircraft was substantially damaged on the undercarriage, the right wing and right elevator scratched, tail undercover cracked and the propeller tips damaged. The occupants were not injured.

Figure 4: Shows damage on the nose gear.
