**AIRCRAFT ACCIDENT SHORT REPORT**

CA18/2/3/9694: ZS-MXN, Accident : Loss of control after take off  
Date and time : 09 April 2018, 1400Z  
Location : Fisantekraal Airfield (FAFK), Western Cape Province  
Occurrence type : Accident  
Aircraft registration : ZS-MXN  
Aircraft manufacturer and model : S.A. Avions Pierre Robin DR500  
Last Point of departure : Fisantekraal Airfield (FAFK), Western Cape Province  
Next point of intended landing : Stellenbosch Airfield (FASH), Western Cape Province  
Location of accident site with reference to easily defined geographical points (GPS readings if possible) : Left of Runway 23 (RWY23),FAFK,33°46'17.0" S 018°44'24.0" E  
Meteorological Information : FACT 091400Z 17017KT 9999 FEW025 21/15 Q1015 NOSIG=  
Type of operation : Private  
Persons on board : 1 + 0  
Injuries : None  
Damage to aircraft : Wings, fuselage and landing gear.

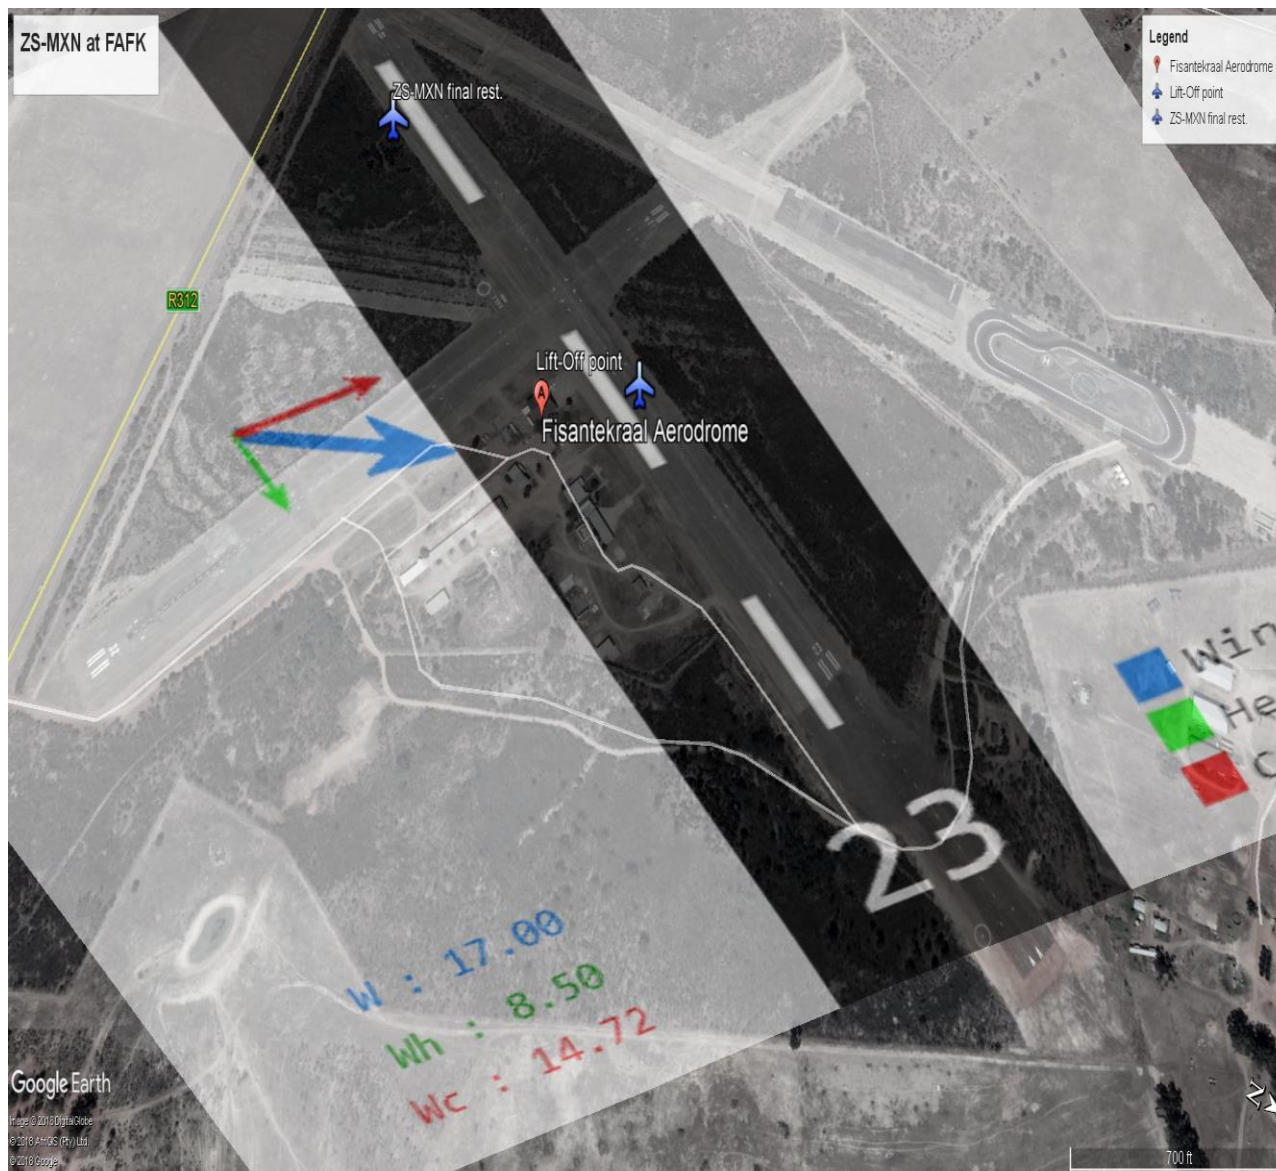
- 2.2 According to the available meteorological records at the time of accident, there was a crosswind component of 14.72 knots(KT) from the left of RWY23 during the take off. The closest aviation weather reporting station is Cape Town International Airport (FACT). The pilot report had a wind velocity of 5KT from 230° magnetic. RWY23 is straddled by bushes to the right, buildings and bushes to the left of the runway. This shields the runway from strong winds originating from the sides. Shortly after take off, the aircraft experienced a rightward drift from the crosswind.

**Figure 1: FAFK with wind components.**

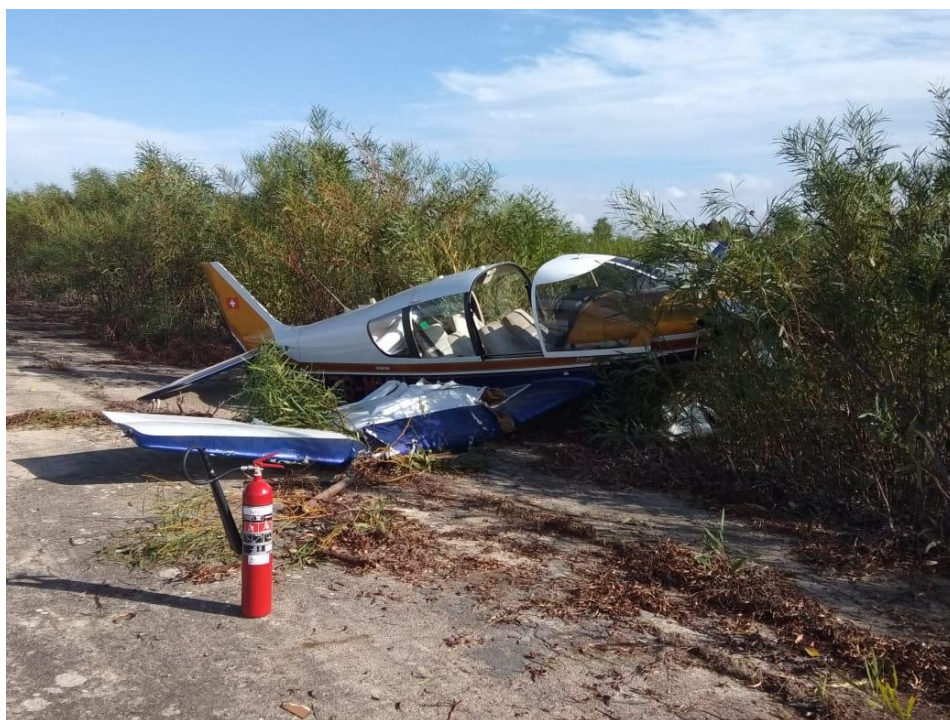
aircraft veered off to the left of RWY23 and collided with bushes on the left-hand side of the runway. The aircraft sustained substantial damage to the fuselage, wings and landing gear.

- 3.5 The aircraft veered off and collided with bushes to the left of RWY23. The aircraft sustained damages to the wings, fuselage and landing gear.
- 3.6 The pilot was not injured during the accident sequence and disembarked without any assistance.
- 3.7 The investigation revealed that the aircraft veered off the runway centreline after take-off, however it could not determine what caused the flight control to jam as reported by the pilot. The post flight inspection revealed that the flight controls had a full and free movement and there was no obstructions found even after the removal of the wing few days after the accident. All damages were as a result of the accident.
- 3.8 There was a crosswind component of 14.72 KT during take-off which may have caused wind shear.
- 3.9 All the damage sustained to the aircraft could be attributed to the accident sequence.

Figure 2: The aircraft as it came to rest.
