AIRCRAFT ACCIDENT REPORT AND EXECUTIVE SUMMARY

Reference:	CA18/2/3/9695	
Aircraft Registration	ZU-BUA	Date of Accident	1 June 2018		Time of Accident	1035Z
Type of Aircraft	Chayair, Sycamore MK1 (Gyroplane)		Type of Operation		Operation of Non-type Certificated Aircraft (Part 94)	
Pilot-in-command Licence Type	National Pilot Licence	Age	36		Licence Valid	Yes
Pilot-in-command Flying Experience	Total Flying Hours	7017		Hours on Type	6107.1	
Last point of departure	Klipriver Airfield Gauteng Province					
Next point of intended landing	Klipriver Airfield Gauteng Province					
Location of the accident site with reference to easily defined geographical points (GPS readings if possible)						
Klipriver Airfield – Walkerville – Gauteng Province – 26°28'31.87"S 028°6'42.45"E, at elevation 4997 ft.						
Meteorological Information	Wind direction 050°, Wind speed 4 knots, Visibility >10 km, Temperature +11°C, Cloud cover - none.					
Number of people on board	1+1	No. of people injured	1	No. of people killed	0

Reference Number : CA18/2/3/9695
Name of Owner/Operator : L.E. Tollemache
Manufacturer : Chayair Sycamore (Musina, South Africa)
Model : Sycamore MK1
Nationality : South Africa
Registr

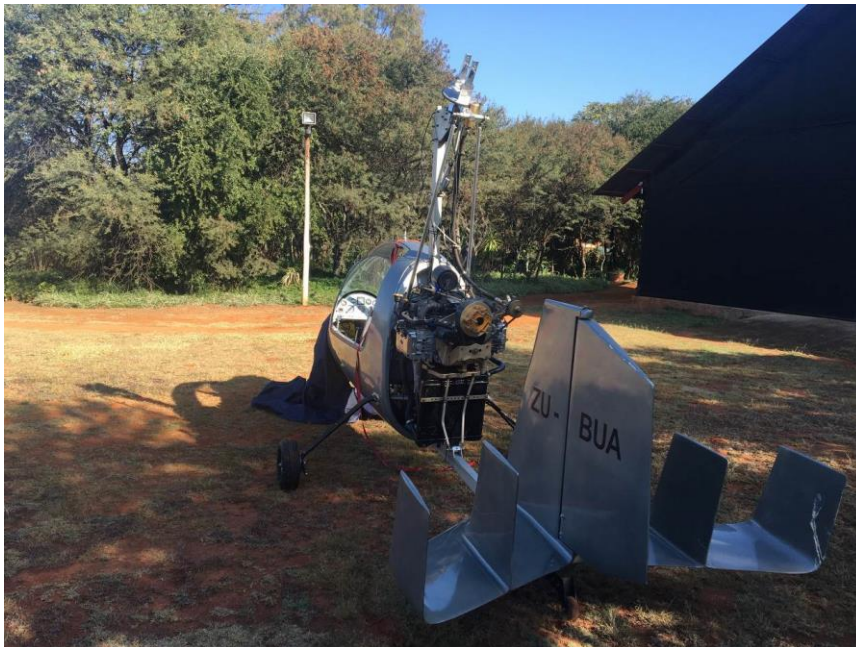
Figure 3: Shows damage to right-hand vertical stabiliser (picture taken after recovery)

The aircraft suffered substantial damage to the main rotors, landing gear and tail section during the impact sequence. The rotor blades were substantially damaged. The damage to the blades is consistent with damage expected from blades impacting the vertical fin and the ground at flight revolutions per minute (rpm). The damage to the landing gear is consistent with the damage expected after impact with the ground. The damage found on the right-hand vertical stabiliser gives the impression that the rotor blade impacted with the right-hand vertical fin after loss of control.

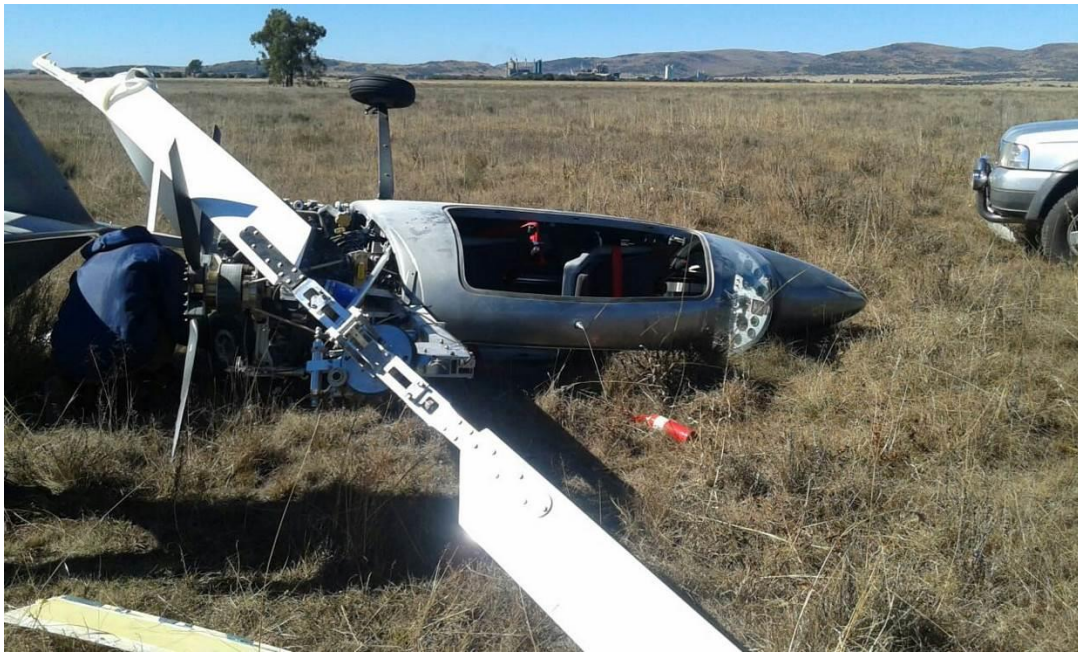
- 1.12.1. According to the PF's statement, the aircraft did a 90° banked turn to the right shortly after take-off when an inflight upset was experienced. The aircraft lost height rapidly and it went into a right-hand spiral dive before impacting with the ground. During impact, the landing gear impacted hard with the ground and the aircraft rolled over onto its right-hand side. See Figure 4. From evidence obtained from the aircraft after the accident it was noted that the propeller blades were still intact. No signs of rotational damage were found on the propeller. The main rotor blades were substantially damaged during the accident. The damages seen on the rotor blades are consistent with damage caused by impact with the ground. The right-hand main landing gear and nose landing gear sustained substantial damage due to impact with the ground. The tail section sustained damage to the right-hand vertical fin caused by rotor blade impact to the tail.

Figure 4: Aircraft in the final resting position (courtesy of the owner of the aircraft)

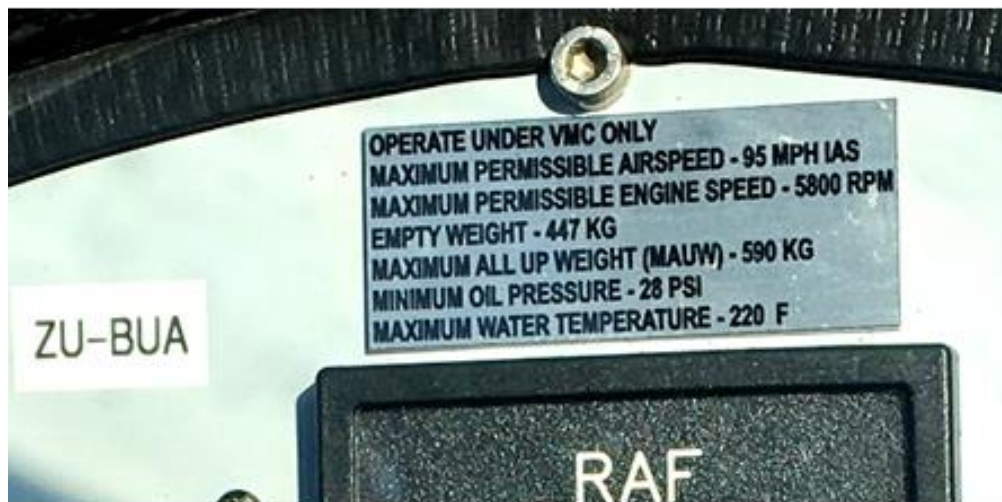
The pilots combined weighed 159 kg. The PF and the owner stated that 35 litres (around 27 kg) of fuel was added to the aircraft prior to flight. This is a minimum total take-off weight of 632 kg. According to the POH, the MAUW was exceeded by 7%.

1.18.3. The Maximum All Up Weight (MAUW) was exceeded during the accident flight. A data plate on the instrument panel clearly shows the MAUW at 590 kg.

Figure 6: Shows a picture of the data plate on the instrument panel giving the MAUW as 590 kg
