AIRCRAFT ACCIDENT SHORT REPORT

CA18/2/3/9697 : ZS-WLI, Aborted take-off due to engine power loss

Date and time : 4 April 2018; 1033Z
Location : Rhino Park Airfield, approximately 85 m from the threshold of runway 09
Occurrence type : Accident
Aircraft registration : ZS-WLI
Aircraft manufacturer and model : Bellanca, Citabria 7ECA
Last Point of departure : Fly Inn Estate
Next point of intended landing : Fly Inn Estate
Location of accident site with reference to easily defined geographical points (GPS readings if possible) : S25°50'03.82", E028°32'06.02"
Meteorological Information : Wind: 280°/10 kts, visibility: >10 km, temperature: 21°C, dew point: 15°C
Type of operation : Private, Part 91
Persons on board : 1 + 1
Injuries : 1 + 1
Damage to aircraft : Substantial

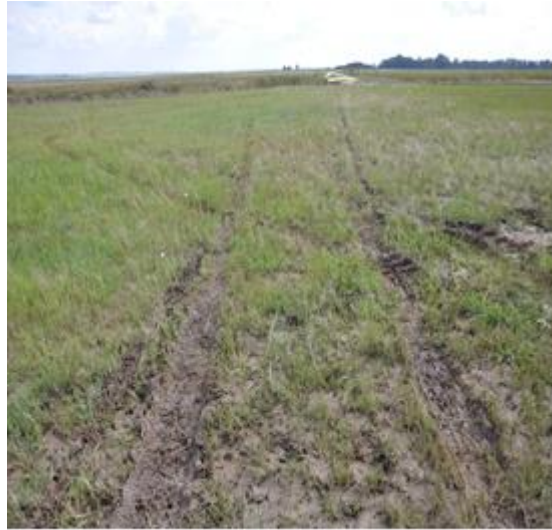
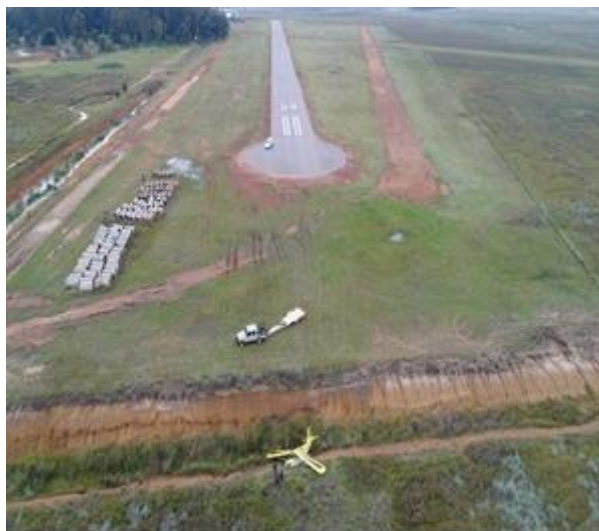
- 2.3 The pilot stated that he applied brakes after the tail had touched the ground but the brakes locked, resulting in the aircraft skidding on the runway and exiting the runway onto the muddy surface, eventually coming to rest in a ditch approximately 85 m from the threshold of runway 09.

Figures 1 & 2: The muddy skid marks (left) and the aircraft's final position after the accident (right)

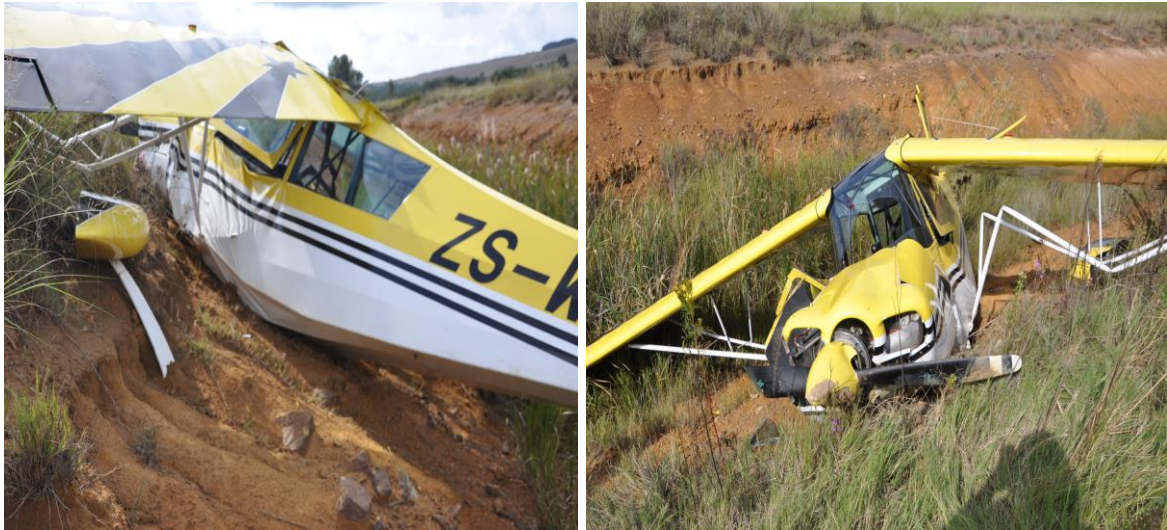
2.4 Witnesses at Rhino Park Airfield rushed to the accident site to assist the injured. Both occupants were seriously injured and were rushed to the hospital. The aircraft sustained substantial damage to the propeller blades, engine cowlings, windshield, main landing gears and the left-hand wing.

Figures 3 & 4: Damage sustained by the aircraft

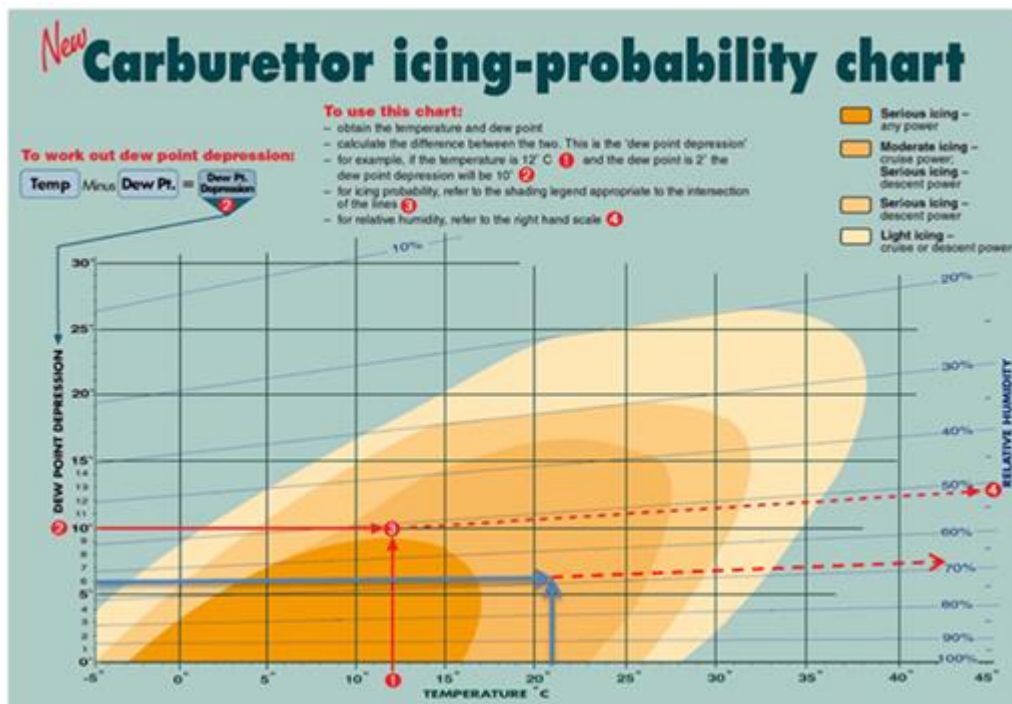
In order to determine whether or not there was a probability of carburettor icing during the flight, a carburettor ice potential chart was used to determine if the weather conditions were indeed favourable to carburettor icing (Figure 5).

The weather information included on the pilot questionnaire was as follows: wind: 280°/10 kts, temperature: 21°C (70°F), dew point: 15°C (59°F), cloud: CAVOK, visibility: >10 km). With both temperature and dew point information available, dew point depression was determined to be 6°C. According to the carburettor icing-probability chart below, icing probability was moderate in cruise power and serious in descent power.

Figure 5: A carburettor icing-probability chart

- 3.8 The aircraft's weight and balance was within limits, therefore did not contribute to the accident.
- 3.9 The pilot stated that he suspected carburettor icing to be the cause of the accident. According to the carburettor icing-probability chart, the engine had moderate icing probability in cruise power and serious icing probability in descent power.
- 3.10 The aircraft flew from Fly Inn Estate and landed at Rhino Park Airfield on runway 09, and back-tracked to take off again on runway 27.
- 3.11 According to the aircraft's pilot operating manual, the carburettor icing lever should be in the "cold" position during take-off.
- 3.12 It is possible that during the taxi at Rhino Park Airfield, the carburettor might have accumulated ice and that affected the engine performance during take-off.
