AIRCRAFT ACCIDENT REPORT AND EXECUTIVE SUMMARY

Reference:	CA18/2/3/9699	
Aircraft registration	ZS-HHI	Date of accident	9 April 2018		Time of accident	1115Z
Type of aircraft	AS350B3 (Helicopter)		Type of operation		Private (Part 91)	
Pilot-in-command licence type		Private	Age	47	Licence valid	Yes
Pilot-in-command flying experience		Total flying hours	546.3		Hours on type	18.2
Last point of departure		Private helipad near Nigel, Mpumalanga Province				
Next point of intended landing		Private helipad near Nigel, Mpumalanga Province				
Location of the accident site with reference to easily defined geographical points (GPS readings if possible)						
Transnet railway service road near Frutuna (GPS position; 26°36'42.10" South 028°32'39.70" East)						
Meteorological information		Surface wind: variable 20–25 kt, Temperature: 20°C, Visibility: CAVOK				
Number of people on board	1 + 4	No. of people injured	1 + 1	No. of people killed	0	
Synopsis

Probable cause						
<p>The pilot executed a non-standard manoeuvre (referred to as a pedal turn) in strong wind conditions, which resulted in a loss of tail rotor effectiveness and subsequent loss of control.</p>						
SRP date	12 February 2019

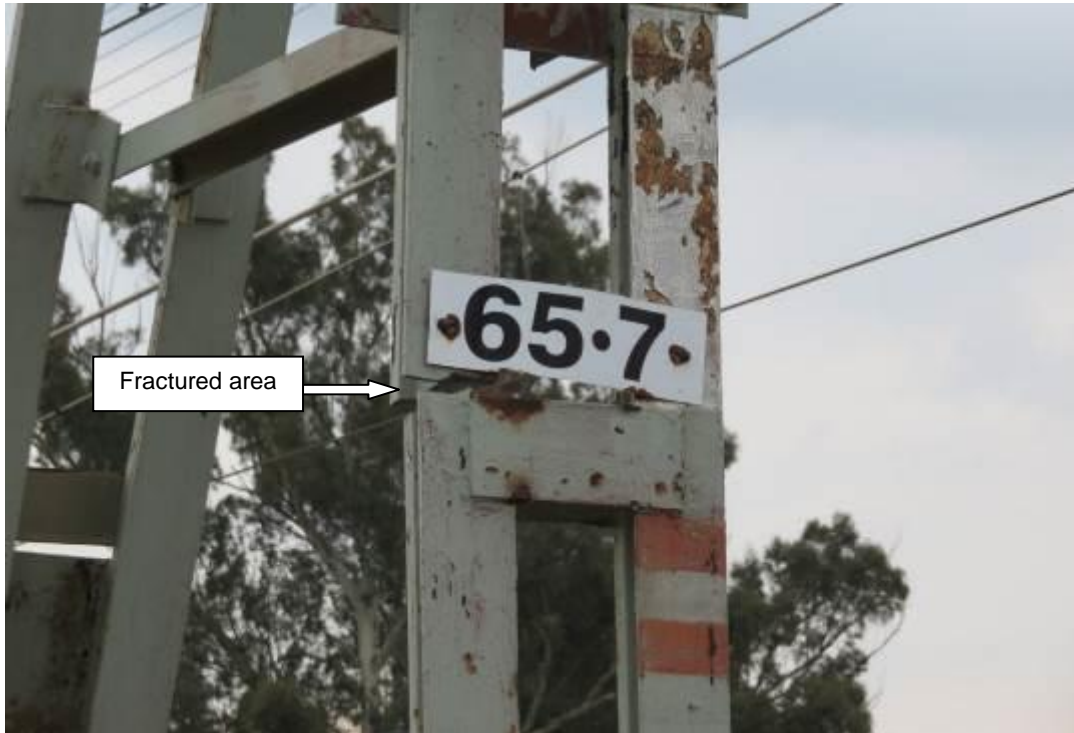
- 1.4.1 An electrical conductor support pole from the railroad service was damaged during the accident sequence and needed to be replaced (Figures 1 and 2). One of the electrical conductors was also severed. The railroad line was taken out of commission as repairs had to be effected before the line was declared safe and normal services could resume. During the on-site investigation, a train had to be stopped some distance from the accident scene as it was unable to proceed due to damage to the infrastructure.

Figure 1: The railroad electrical support pylon that fractured and needed to be replaced

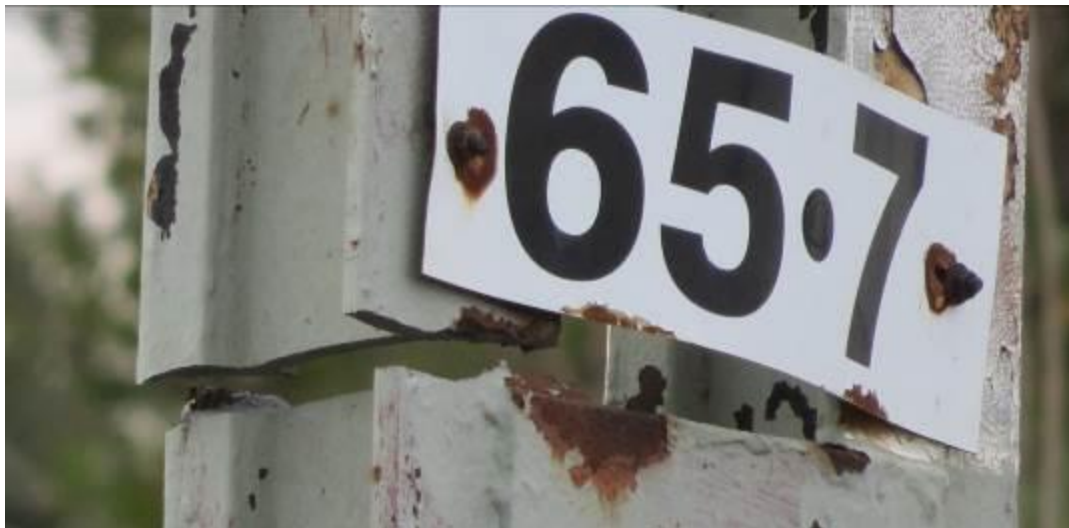
Figure 2: A close-up view of the pylon that fractured

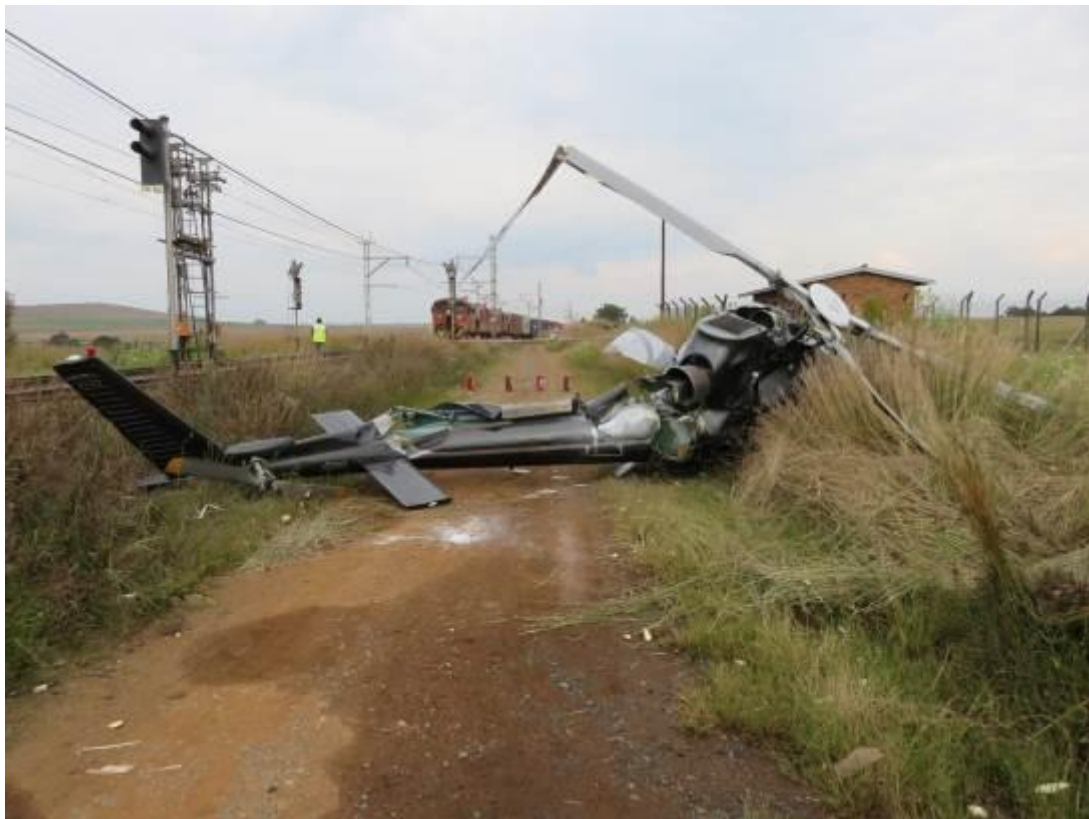
1.12.1 The helicopter impacted with a gravel road in a vertical attitude on a heading of 162°M. Very little to no lateral movement was observed on the ground. The forward fuselage was lying in a right nose-down attitude, with the cockpit/cabin area remaining intact although some distortion to the roof structure had occurred. No damage was caused to the instrument panel, and the helicopter had dual controls fitted. The skid gear collapsed, and the right forward skid was found bent upwards at an angle of almost 90°, penetrating the cabin area on the pilot's side. All three main rotor blades displayed evidence of rotation, with one of the blades failing at mid-span. The main rotor gearbox assembly was found tilted towards the right (when viewed from behind). The control rods were still secured to the non-rotating swash plate. The tail boom was found to be severely distorted and only partially connected to the main fuselage. The lower vertical fin was bent towards the left with some damage evident on the tail rotor blades as well as the horizontal stabilisers. The tail boom as well as the tail rotor drive shaft were twisted forward of the horizontal stabilisers, which is associated with a main rotor blade strike. As the main rotor blades turn in a clockwise direction, the deformation of the tail rotor drive shaft and the tail boom structure is in line with this observation. The deformation of the entire fuselage and associated damage was that of a helicopter that was turning in an anti-clockwise direction before it impacted with the ground.

Figure 5: The helicopter as it came to rest next to the railway line

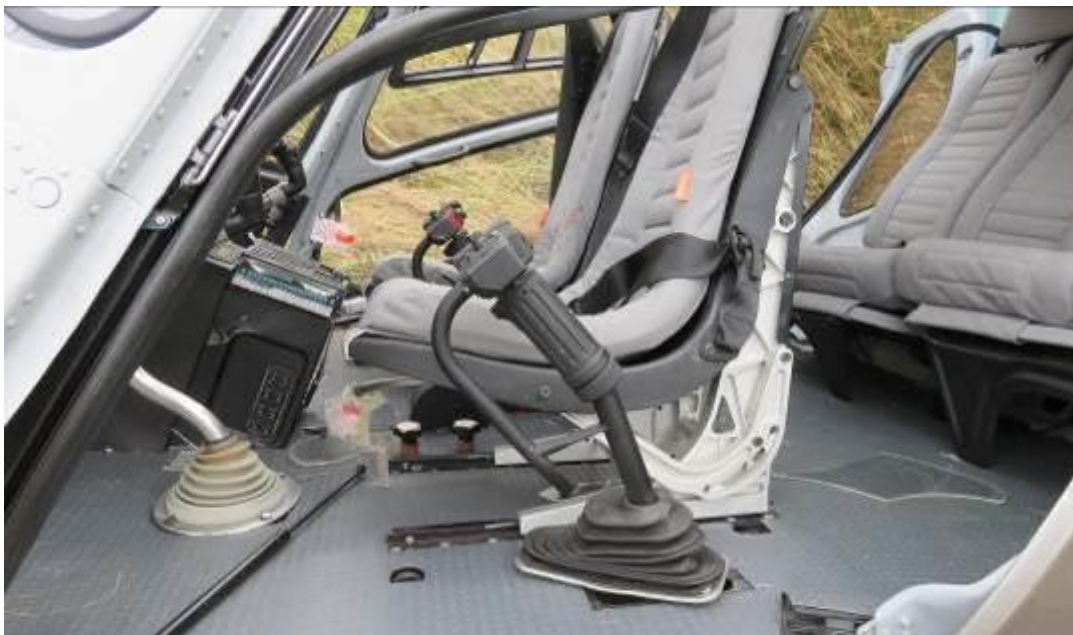
Figure 7: A side view from the left of the cockpit with the collective pitch levers in the full up position

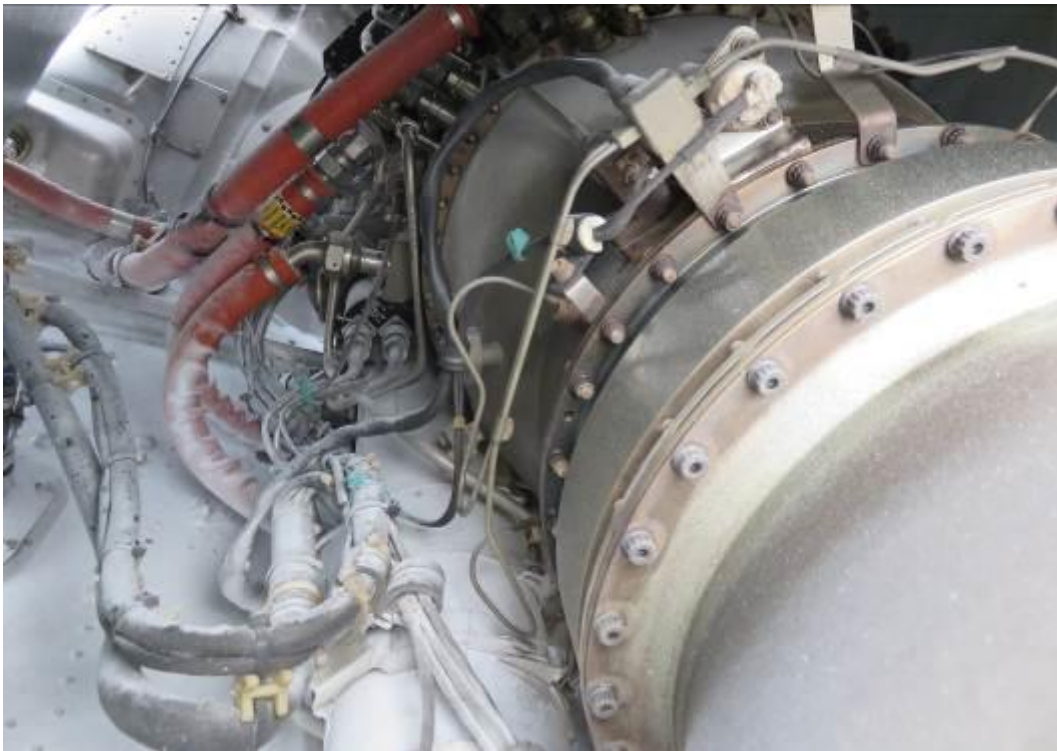
Figure 8: The engine nacelle with evidence of fire extinguisher contents having been discharged

1.14.1 Following impact, people at the farmstead rushed to the scene of the accident with portable fire extinguishers. One of the people observed smoke emanating from the engine nacelle and activated one of the portable fire extinguishers into the engine nacelle area to contain any possible fire that might have erupted (Figure 8).

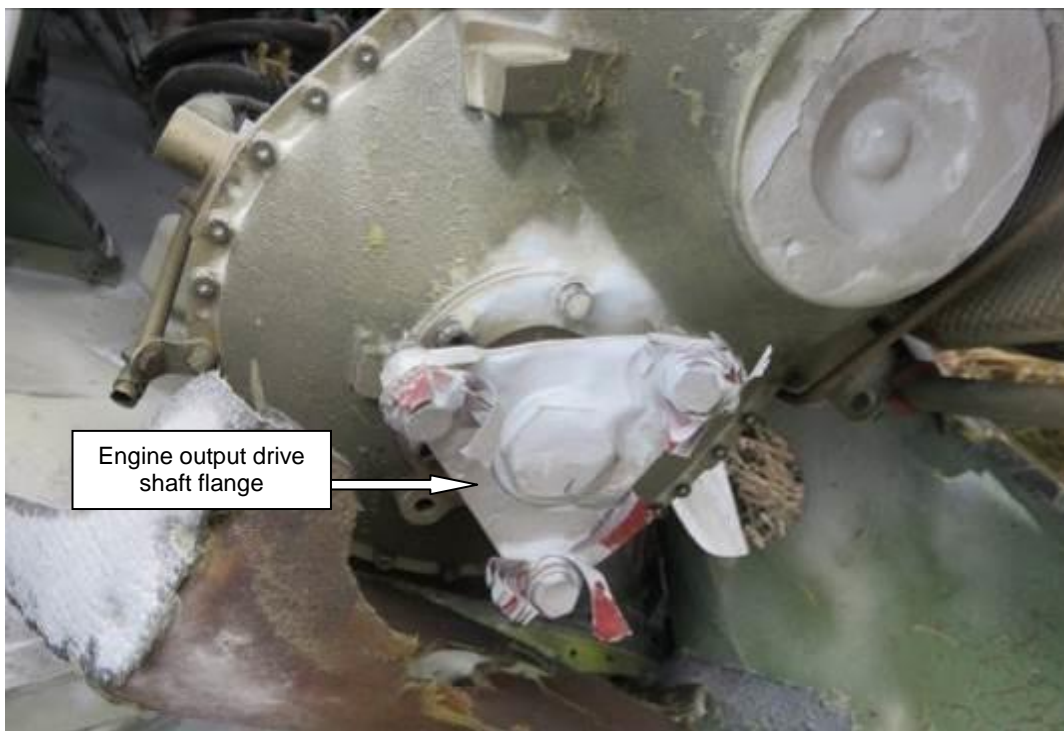
Engine output drive shaft flange

Figure 9: Output drive shaft flange from the engine to the tail rotor drive, displaying evidence of power

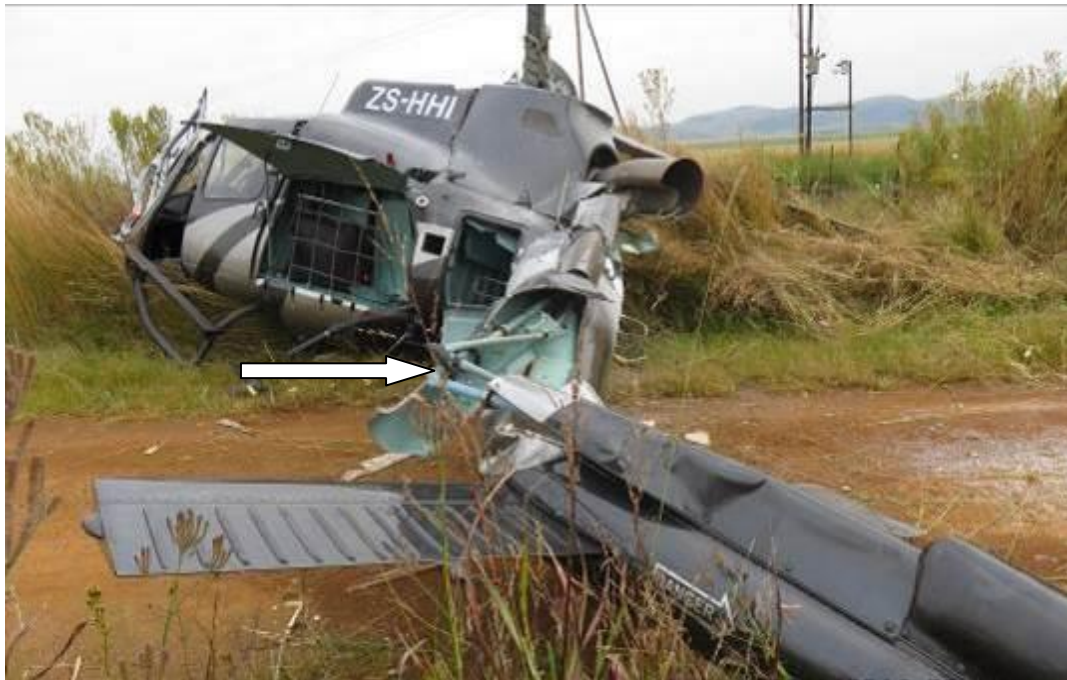
Figure 10: The tail rotor drive shaft and tail boom, having been struck by the main rotor blades

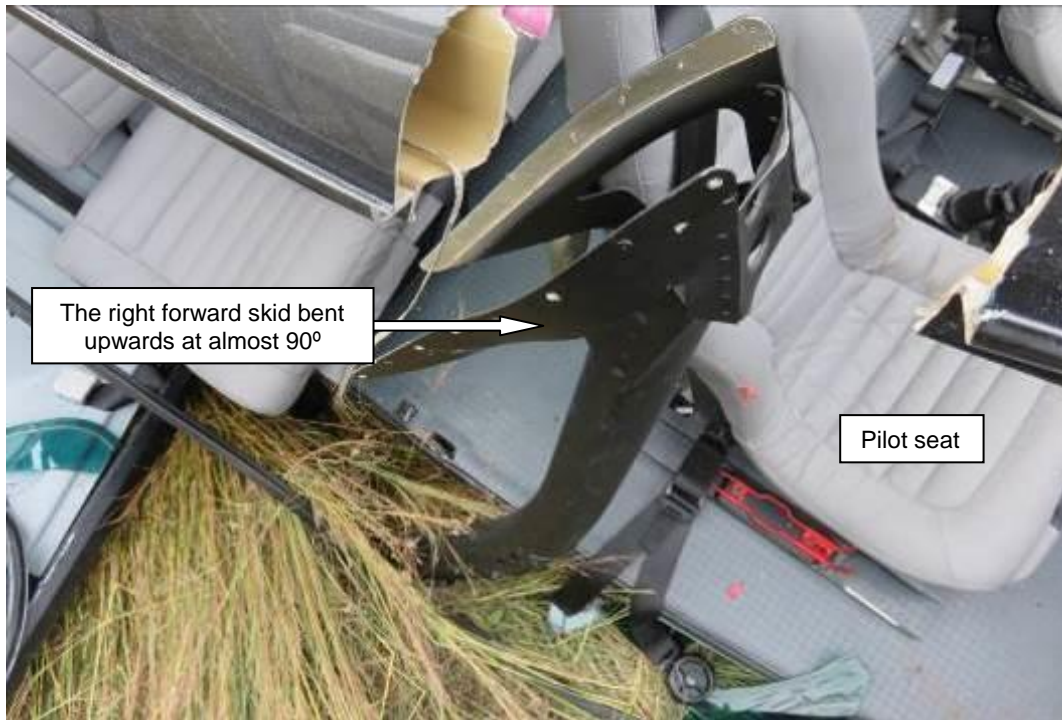
1.15.1 The accident was survivable. The cockpit cabin area remained intact. Three of the passengers were seated in the aft row of seats, and were making use of the helicopter-equipped safety harnesses, which included a shoulder harness. Apart from shock, none of them were injured in the accident. The pilot was seated in the right front seat, and was secured by the helicopter-equipped four-point safety harness. He suffered from a laceration to his head as well as his right upper arm, the latter caused by the forward right skid gear bending upwards at an angle of almost 90° and penetrating the cabin during the impact sequence. The passenger seated next to the pilot was also secured by means of the four-point safety harness. She suffered from a serious laceration to her head. Available evidence indicates that she and the pilot impacted the overhead throttle quadrant when the roof structure partially collapsed due to impact damage. The front-seated passenger was attended to on-scene by paramedics and was taken to a private hospital where she underwent further medical tests. She was discharged from hospital the following day. According to a letter from a medical practitioner, she suffered from concussion and multiple soft tissue injuries.

Figure 11: The right forward skid gear that penetrated the cabin

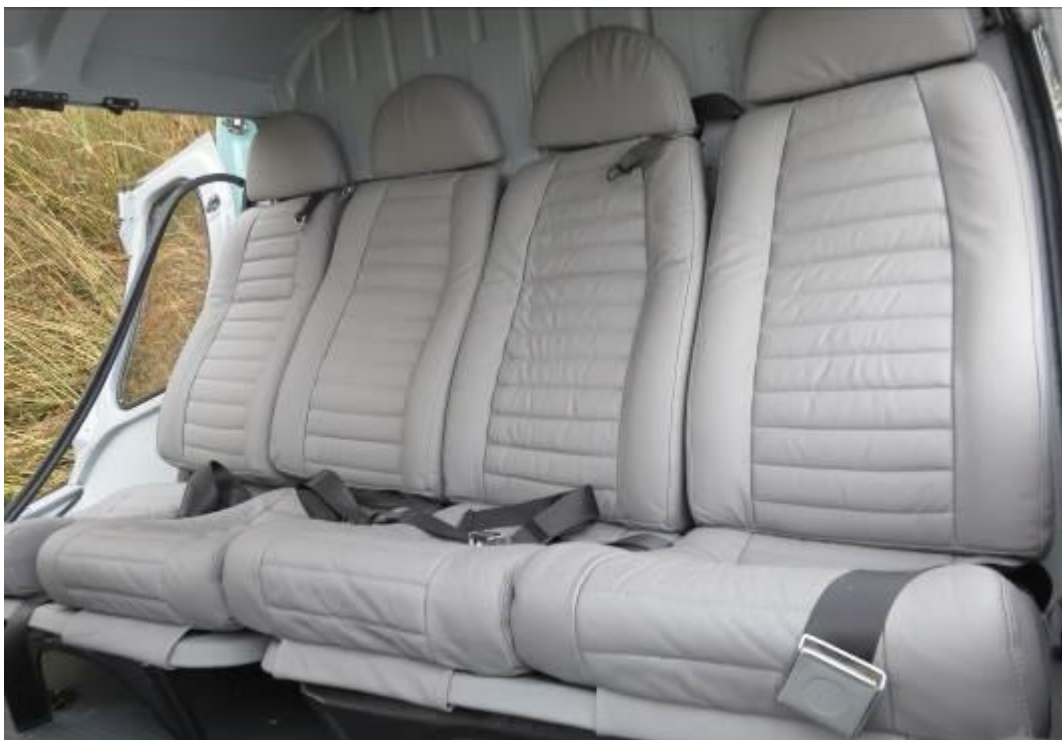
Figure 12: The four aft cabin seats, with the cabin structure that remained intact

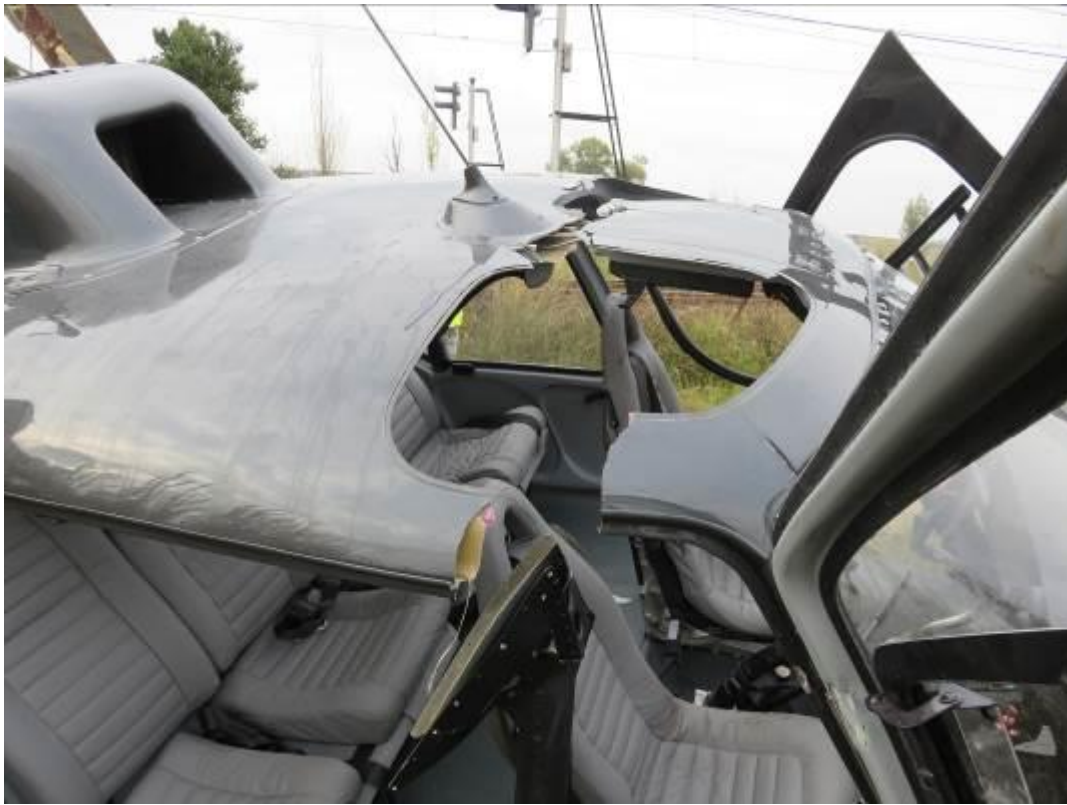
Figure 13: Failure of the roof structure

- 3.1.12 Apart from the roof structure, the cockpit/cabin area remained intact. The pilot and front-seated passenger were each secured by a four-point safety harness and the passengers in the aft seats were secured by the helicopter-equipped safety harnesses.
- 3.1.13 The main rotor blades displayed evidence of severe deformation due to the accident, with one of the blades partially fractured at approximately mid-way along the blade.
- 3.1.14 The helicopter was operated within its MTOW and CG limitations as specified in the flight manual.

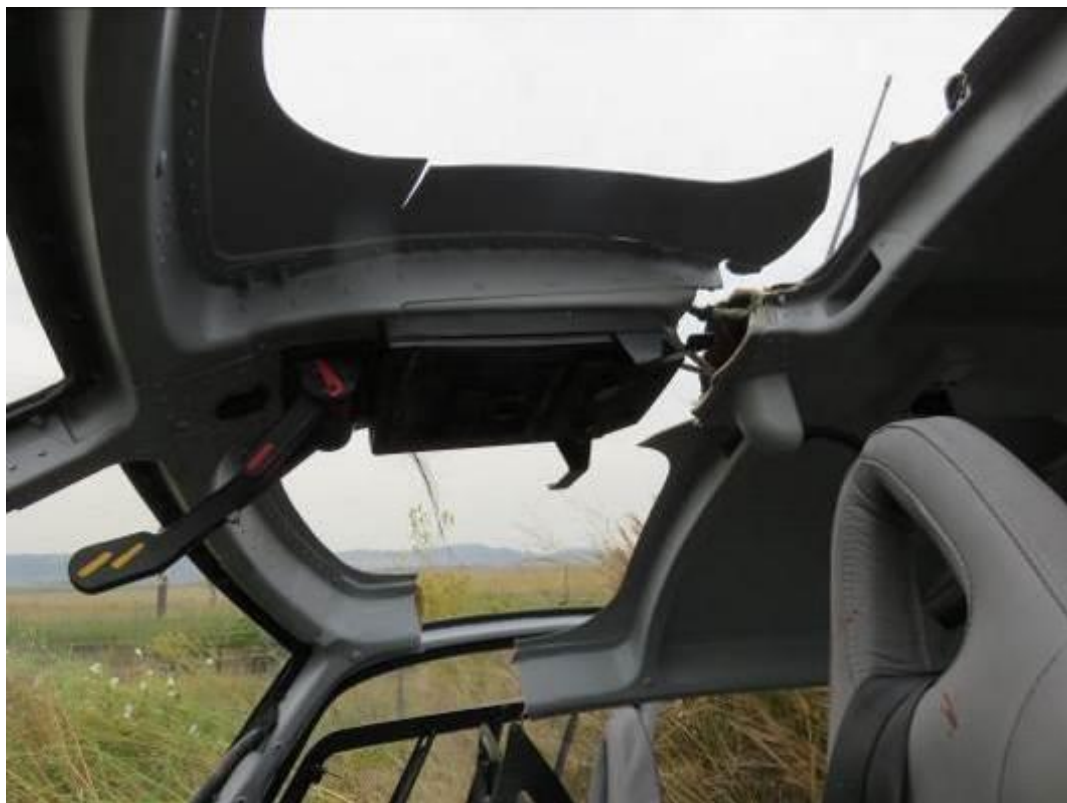
Figure 14: Inside view of the damaged roof structure, with the rotor brake/fuel shut-off quadrant visible
