AIRCRAFT ACCIDENT SHORT REPORT

CA18/2/3/9700: ZS-RGJ, Hard landing after an unsuccessful rapid deceleration (quick stop) training flight

Aircraft registration : ZS-RGJ

Aircraft manufacturer and model : Robinson Helicopter Company, R22 Beta

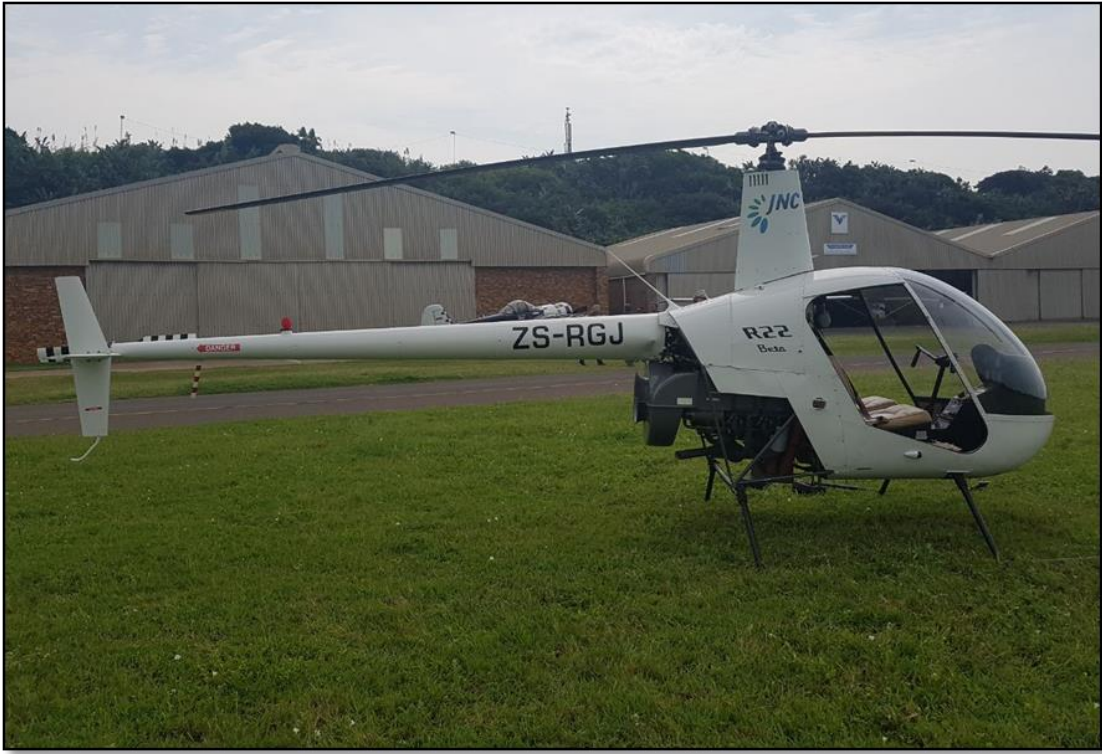
- 2.2 During levelling off at the end of the quick stop, the low RPM horn went off and the aircraft suddenly lost height. The pilot increased the collective to stop the aircraft from losing more height, but the aircraft hit the ground hard and then lifted off the ground with the right skid only. The aircraft then pivoted about the left skid and the pilot stopped the turn by applying the cyclic and right pedal. Once the aircraft stopped turning, the pilot decreased the collective to settle the aircraft back on the ground.

Figure 1: Helicopter after landing

- 5.1 The helicopter landed hard following a loss of rotor RPM due to insufficient collective input at the end of a quick stop.

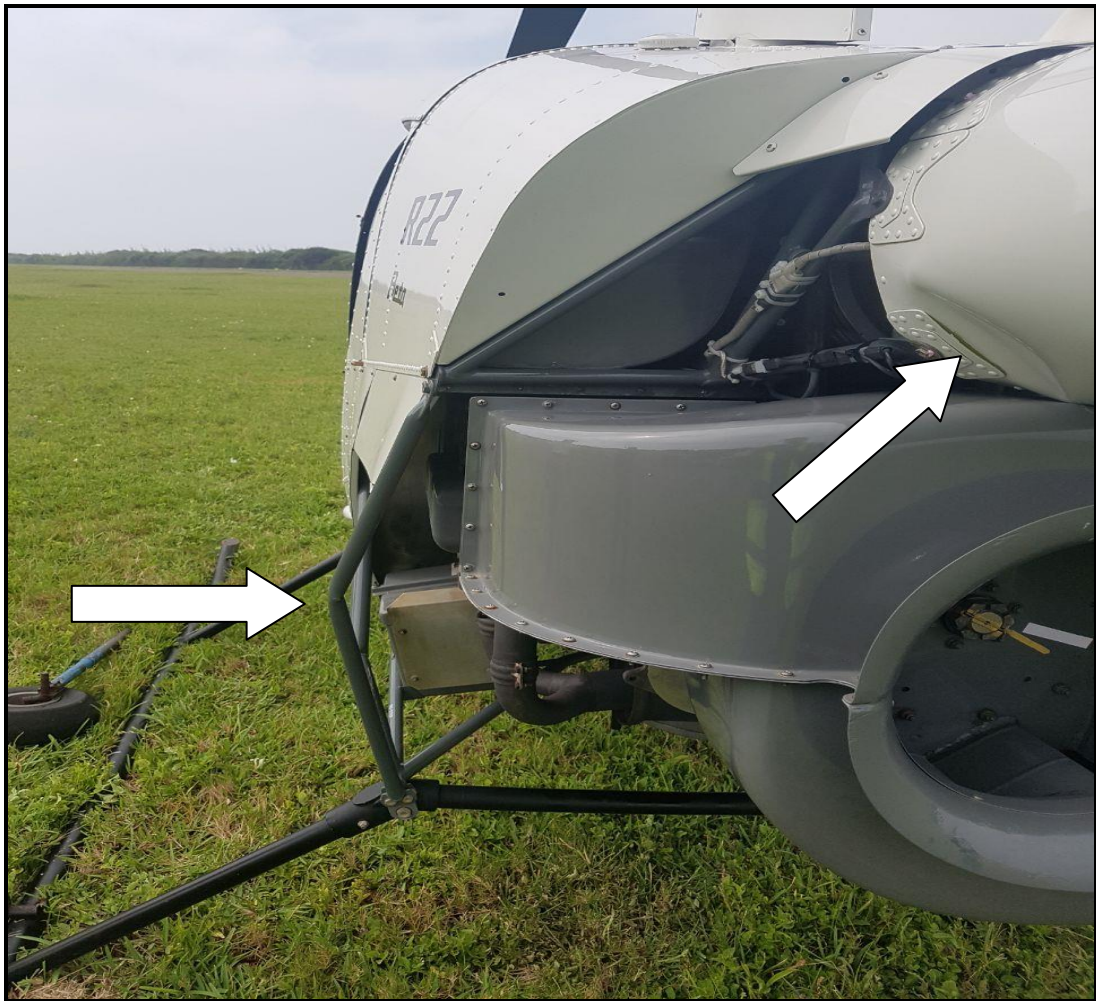
Damage to aircraft : Damage to the skid gear and lower fuselage

- 2.3 The helicopter sustained damage to the tail cone root and the lower left hand frame. The student pilot sustained no injuries.
- 2.4 The accident occurred during daylight conditions at a geographical position that was determined to be 29°46'9.76" South 031°3'32.25" East at an elevation of 40ft above mean sea level (AMSL).

Figure 2: Damage to the structure
