AIRCRAFT ACCIDENT REPORT AND EXECUTIVE SUMMARY

Reference:	CA18/2/3/9702	
Aircraft Registration	ZS-REG	Date of Accident	28 April 2018		Time of Accident	0547Z
Type of Aircraft	Bell Helicopter Textron 206L-4		Type of Operation		Private (Part 91)	
Pilot-in-command Licence Type		PPL (Helicopter)	Age	43	Licence Valid	Yes
Pilot-in-command Flying Experience		Total Flying Hours	176,6		Hours on Type	41,0
Last point of departure		Farm Snymansdrift, East of Kuschke Nature Reserve (S24°0'35,90" E029°18'22,04"), Limpopo				
Next point of intended landing		Farm Snymansdrift, East of Kuschke Nature Reserve (S24°0'35,90" E029°18'22,04"), Limpopo				
Location of the accident site with reference to easily defined geographical points (GPS readings if possible)						
Farm Snymansdrift, East of Kuschke Nature Reserve (S24°01'26,5" E029°19'06,1") Elevation: 4800 ft						
Meteorological Information		Surface wind: Nil, Temperature: 13 °C, Pressure altitude: 1015 hPa, Dew point: 11 °C, visibility: 5000 m, Cloud: Overcast, and broken at 1000 ft AGL mist present

Name of Owner : Breaker Flight (Pty) Ltd
Name of Operator : Private (Part 91)
Manufacturer : Bell Helicopters
Model : 206L-4
Nationality : South Af

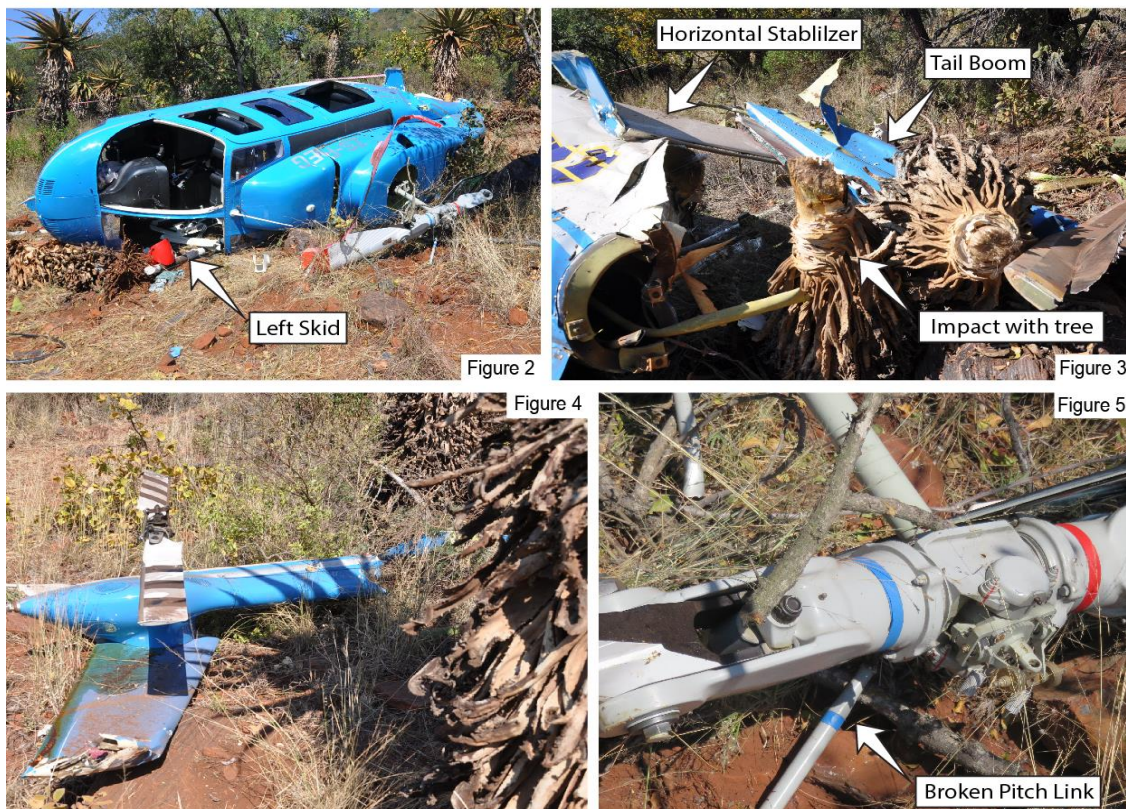
The helicopter was substantially damaged during the impact sequence.

Figure 2: The wreckage as it lay on its port side on the broken left skid, **Figure 3:** Separation of the tail boom and fuselage resulting from impact with the tree., **Figure 4:** The separated tail rotor assembly. The tail rotor blades are still intact, but the strobe section impacted terrain and separated, **Figure 5:** The main rotor hub showing one broken pitch link. The other pitch link was broken off. (Figures 2, 3, 4 & 5 sourced from IIC)

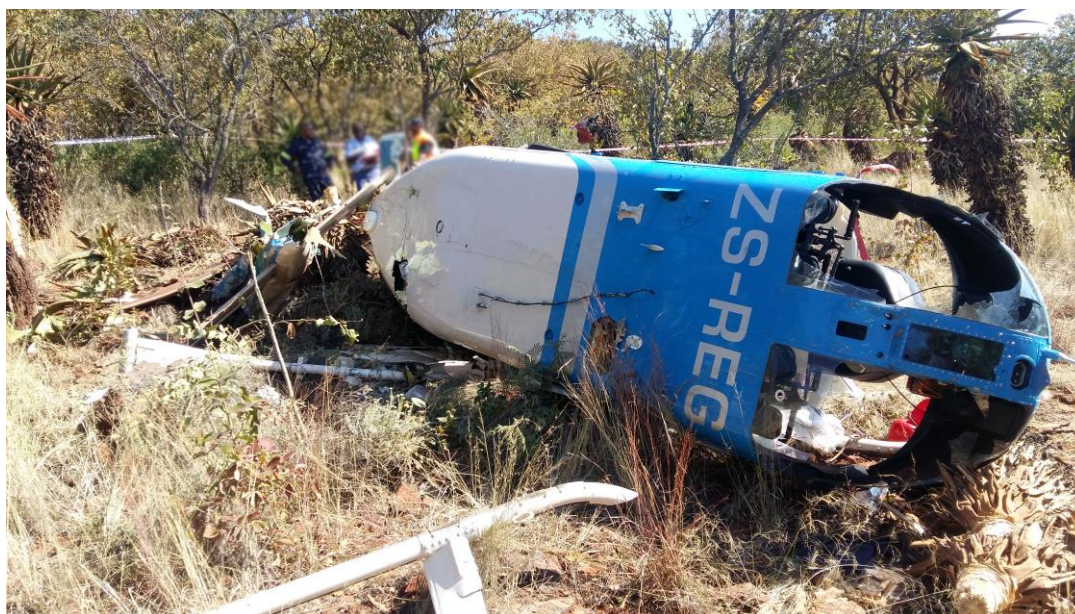
1.12.1 The helicopter impacted dense bushy terrain on its skids and the fuselage flipped over on its port side with a heading of 300 °M (magnetic). The helicopter was substantially damaged: the tail boom was broken off the main fuselage, the tail rotor section was severed from the tail boom, and the skids were torn off the belly of the fuselage and broke into 3 pieces.

Figure 6: The main wreckage as it came to rest.

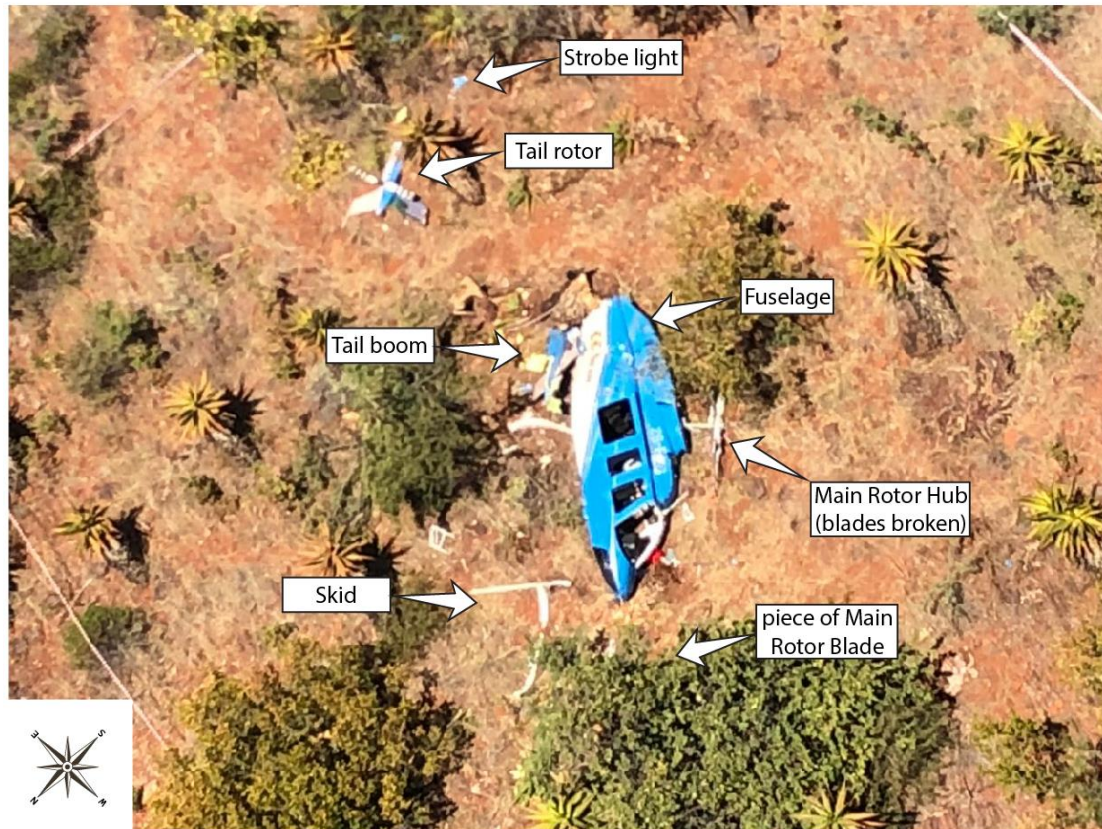
Figure 7: Aerial view of the wreckage showing the distribution of parts after impact.
(Image courtesy of first responder to crash site)

The safety harnesses of the pilot and passengers were found intact. The main rotor blades were found broken into different sections. The main rotor pitch links were both broken, with the collective pitch lever being in the 'down' position and the throttle in idle position. The collective pitch lever control panel was broken off the lever. The cyclic control stick was in the neutral position.
