AIRCRAFT ACCIDENT REPORT AND EXECUTIVE SUMMARY

Reference:	CA18/2/3/9704	
Aircraft Registration	ZS-DEX	Date of Accident	3 May 2018		Time of Accident	0608Z
Type of Aircraft	Falcon 900EX (Aeroplane)		Type of Operation	Private (Part 91)		
Pilot-in-command Licence Type	Airline Transport	Age	46		Licence Valid	Yes
Pilot-in-command Flying Experience	Total Flying Hours	6 362.2		Hours on Type	186.8	
Last Point of Departure	Cape Town International Aerodrome (FACT), Western Cape Province					
Next Point of Intended Landing	Rand Aerodrome (FAGM), Gauteng Province					
Location of the accident site with reference to easily defined geographical points (GPS position)						
Upon landing on Runway 17 at FAGM (GPS position: S26°14'14.00" E028°08'55.44"), elevation 5 448ft						
Meteorological Information	Wind: 190°C at 12 kts; Temperature: 12°C; Visibility: CAVOK and Dew Point 7°C					
Number of people On-board	2 + 10	No. of People Injured	0	No. of People Killed	0

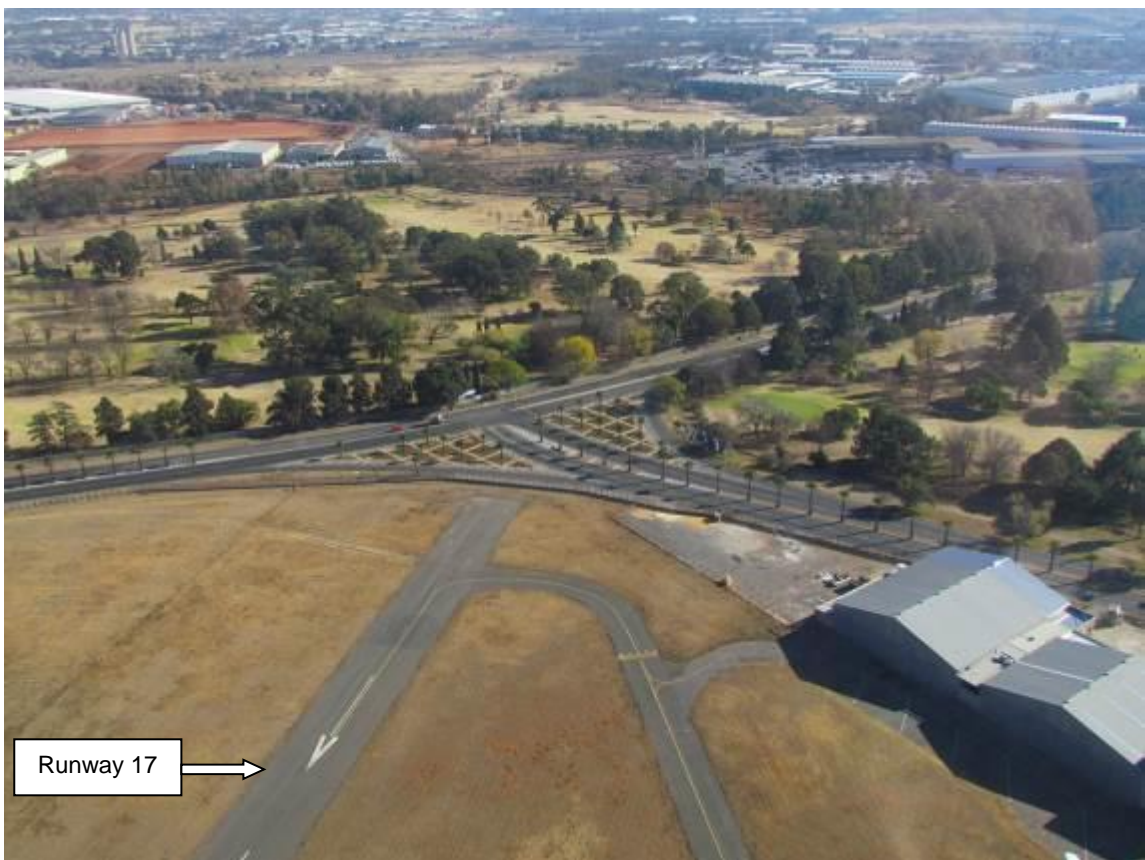
Figure 5: An aerial view of the approach path for Runway 17

From the photographic evidence in Figures 5 and 6 and the evidence under subparagraph 1.10 (Aerodrome Information) in this report, it was evident that the aircraft must have been very low on the final approach segment for Runway 17 in order for the right wing to have collided with trees. An important thought to remember during this low approach and subsequent right bank where the right wing was damaged by trees is that should this right turn have been executed a few seconds earlier, the aircraft could have possibly impacted with the high-tension wires instead of the trees, which could have resulted in a totally different outcome to this accident.

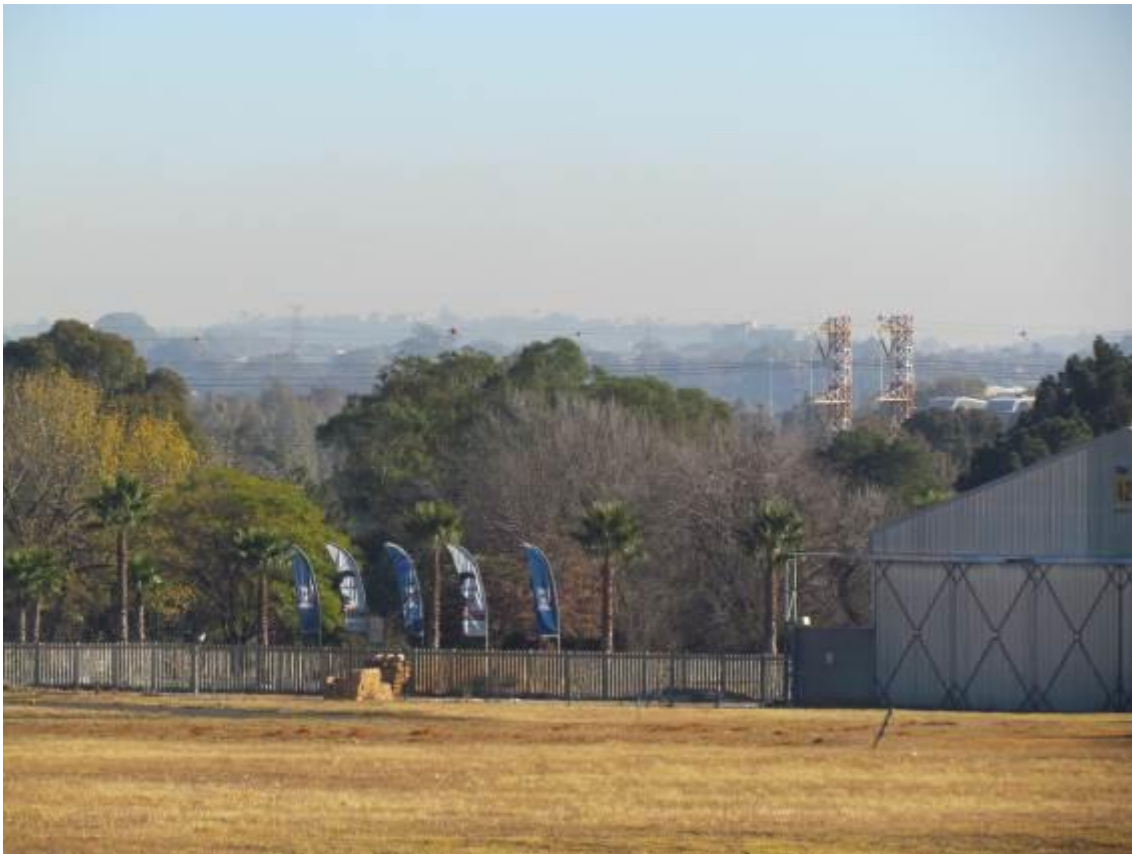
Figure 6: The high-tension wires and high trees on the final approach path for Runway 17

- 3.4.6 The PM was the first of the two crew members to indicate that he had the runway visual, which was 38 seconds before the aircraft touched down.
- 3.4.7 There were high-tension power lines and high trees on the final approach path for Runway 17, which was noted on the approved aerodrome chart.

4.2.2 It is recommended to the DCA to issue a Notice to Airman (NOTAM) alerting the airman of limitations requirements at aerodromes such as FAGM with regard to high performance aircraft (e.g business jets) being allowed to approach and land on Runway 17 at FAGM.

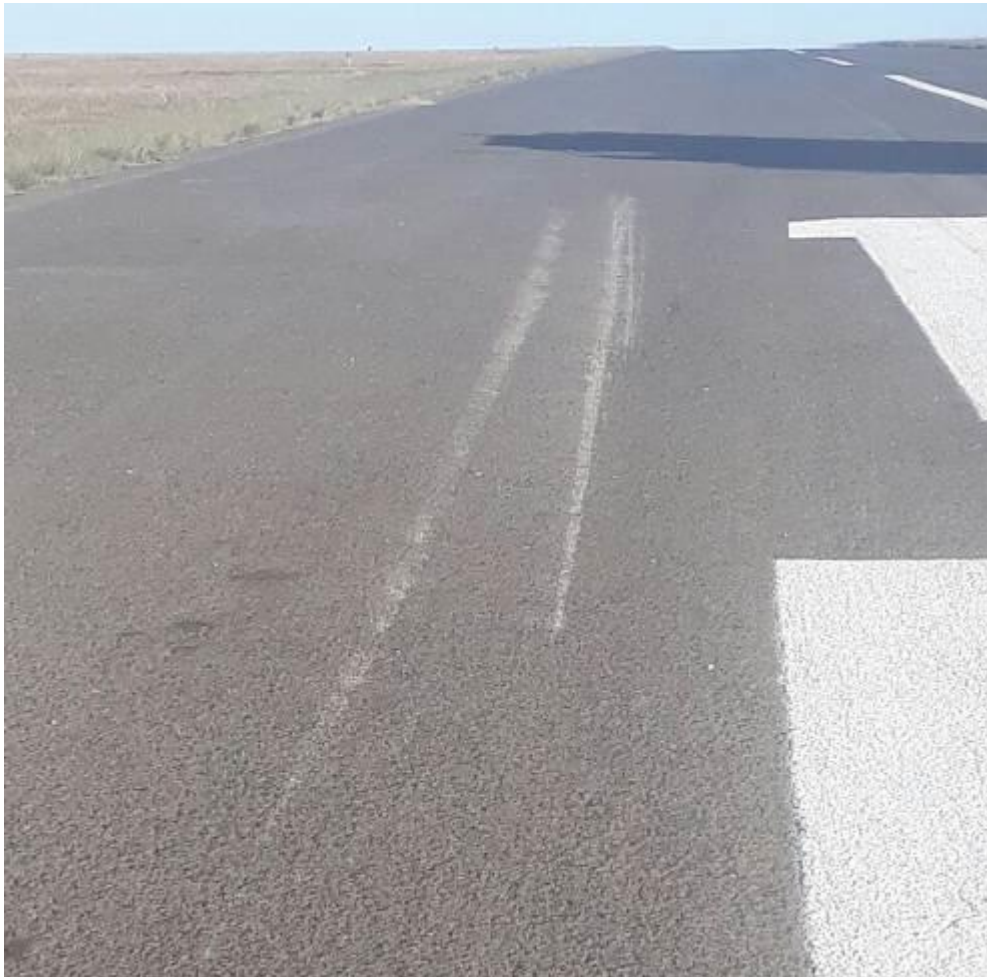
1.12.1 The aircraft was taxied to the main apron after landing where it was parked. It was only during the post-flight walk-around that the damage to both the wings and flight control surfaces were noted. The PM asked the PF during the landing roll if he was sure they had collided with a tree, which was confirmed to be the case during the walk-around. The scrape markings (see Figure 9) were caused by the left wing that had made contact with the runway surface during landing. These markings were at the threshold of runway 17.

Figure 9: Scrape markings from the left wing at the threshold of Runway 17

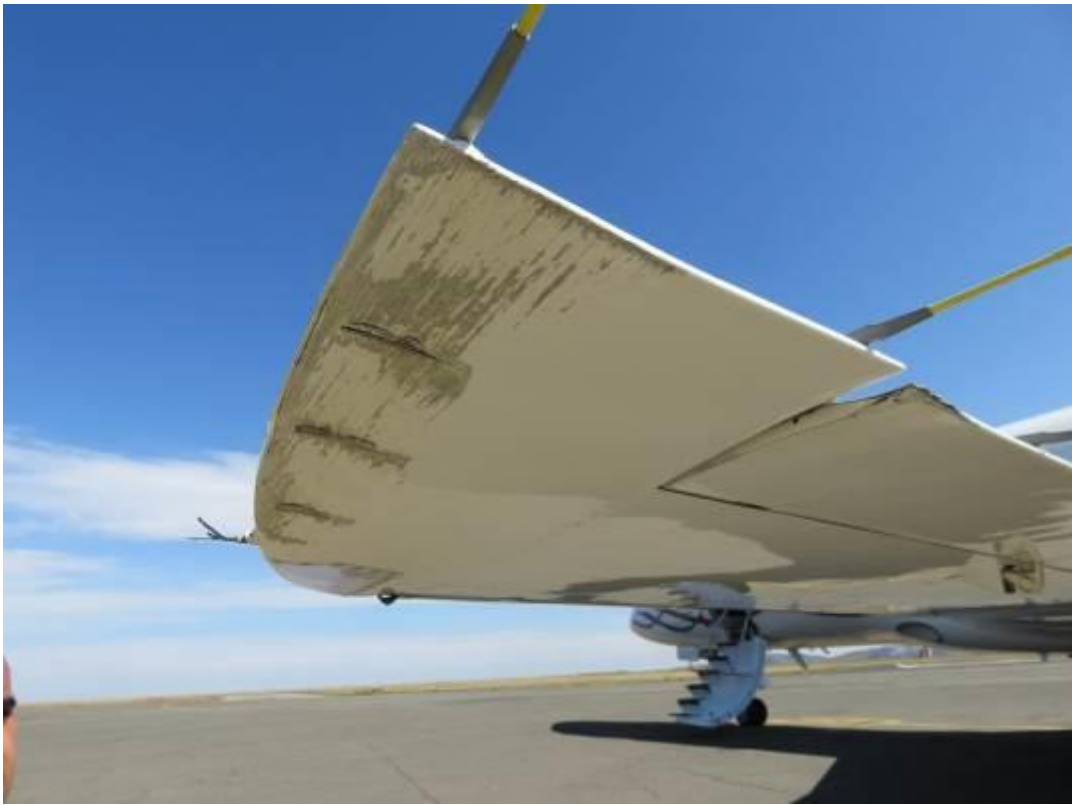
Figure 10: Scrape markings visible on the lower left wing-tip surface, as well as the aileron

- 3.2.14 The aircraft sustained damage to both slats, ailerons and wing tips, which required replacement. The wing structure also needed to undergo a detailed structural inspection, which will include non-destructive testing on certain areas as prescribed by the manufacturer.

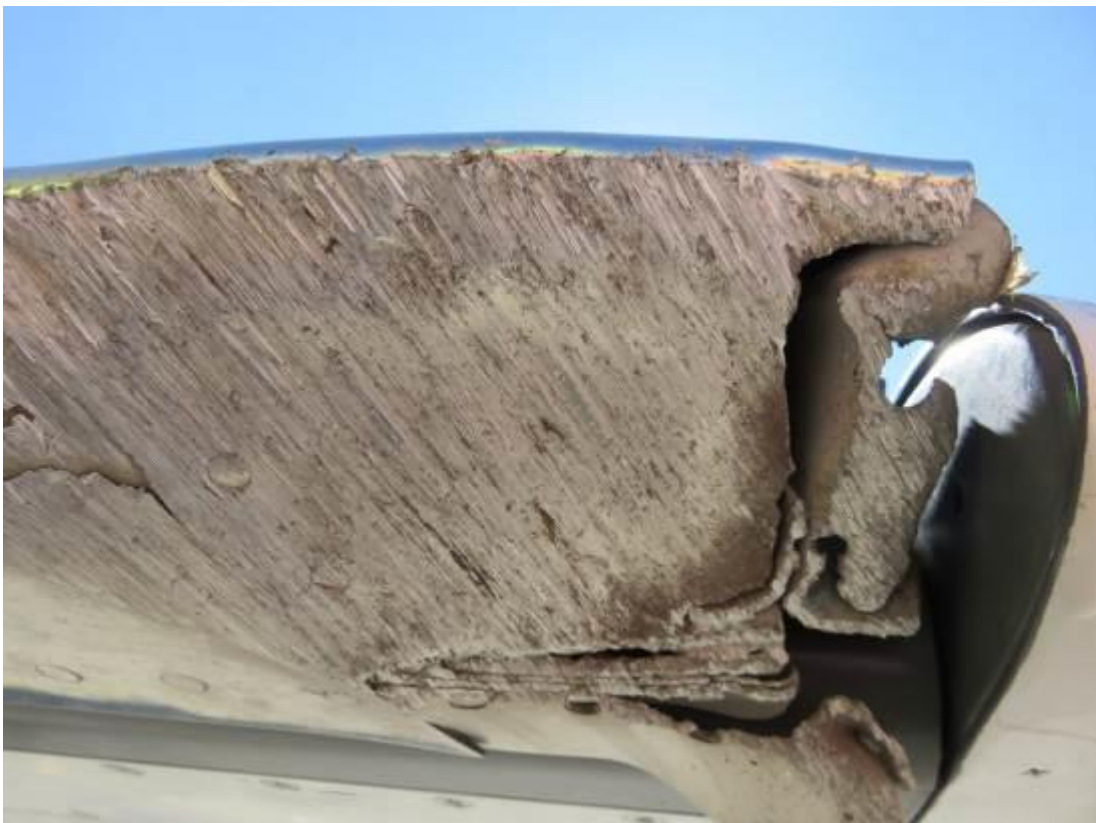
Figure 11: Damage to the left-wing leading edge slat, lower surface

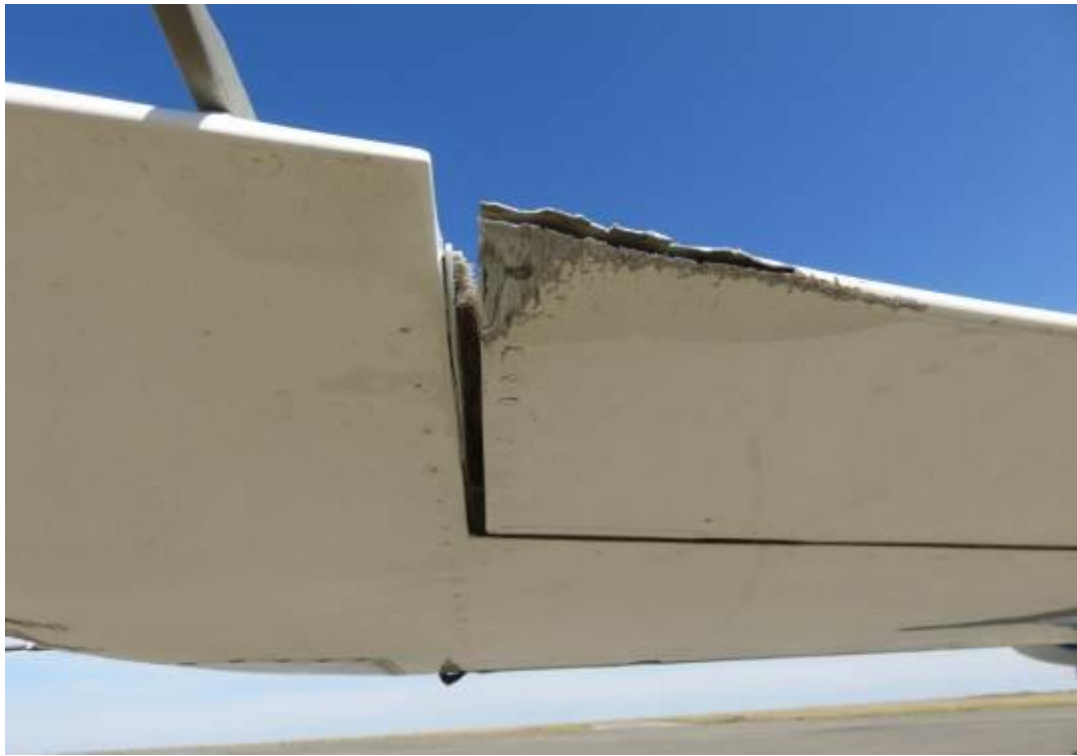
Figure 12: Damage to the aileron (left wing)

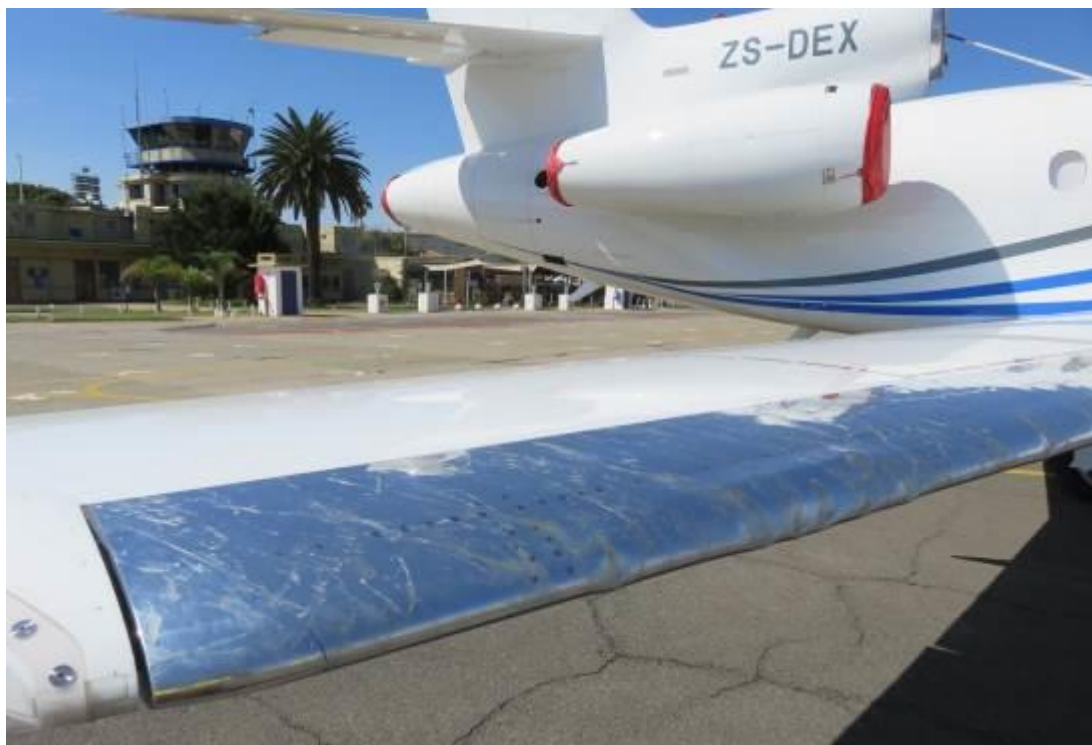
Figure 13: Damage to the right-wing slat, which was caused by vegetation (impact with trees)

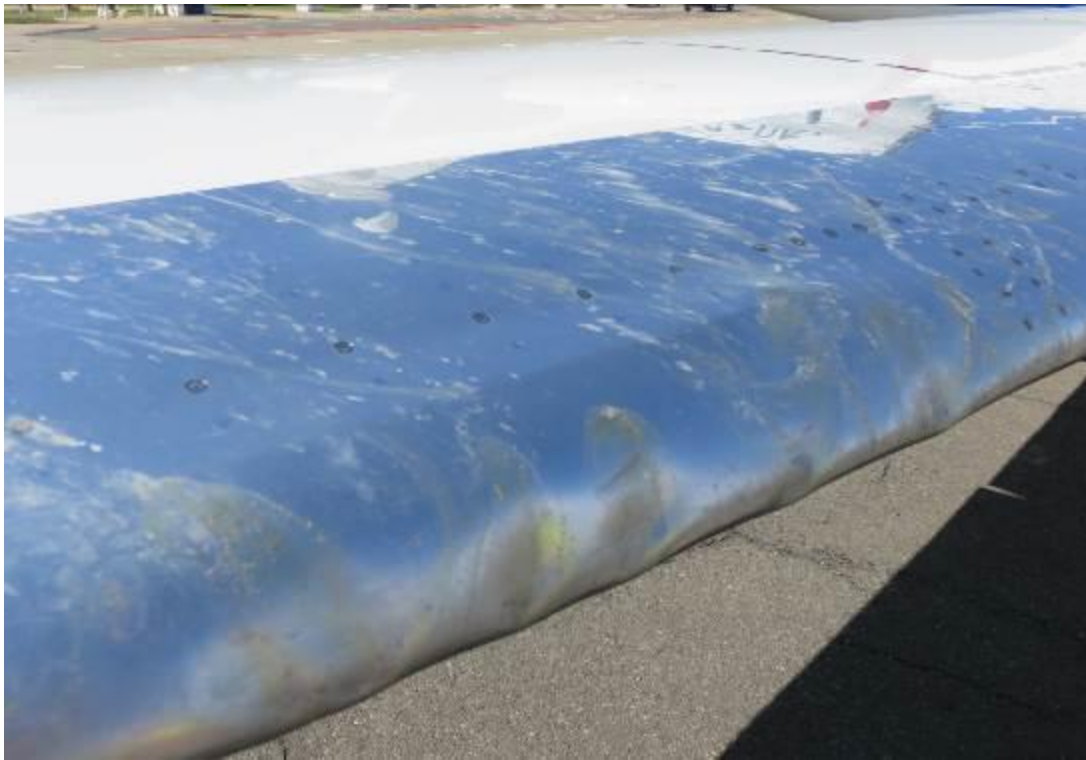
Figure 14: Closer view of the damage to the right-wing slat

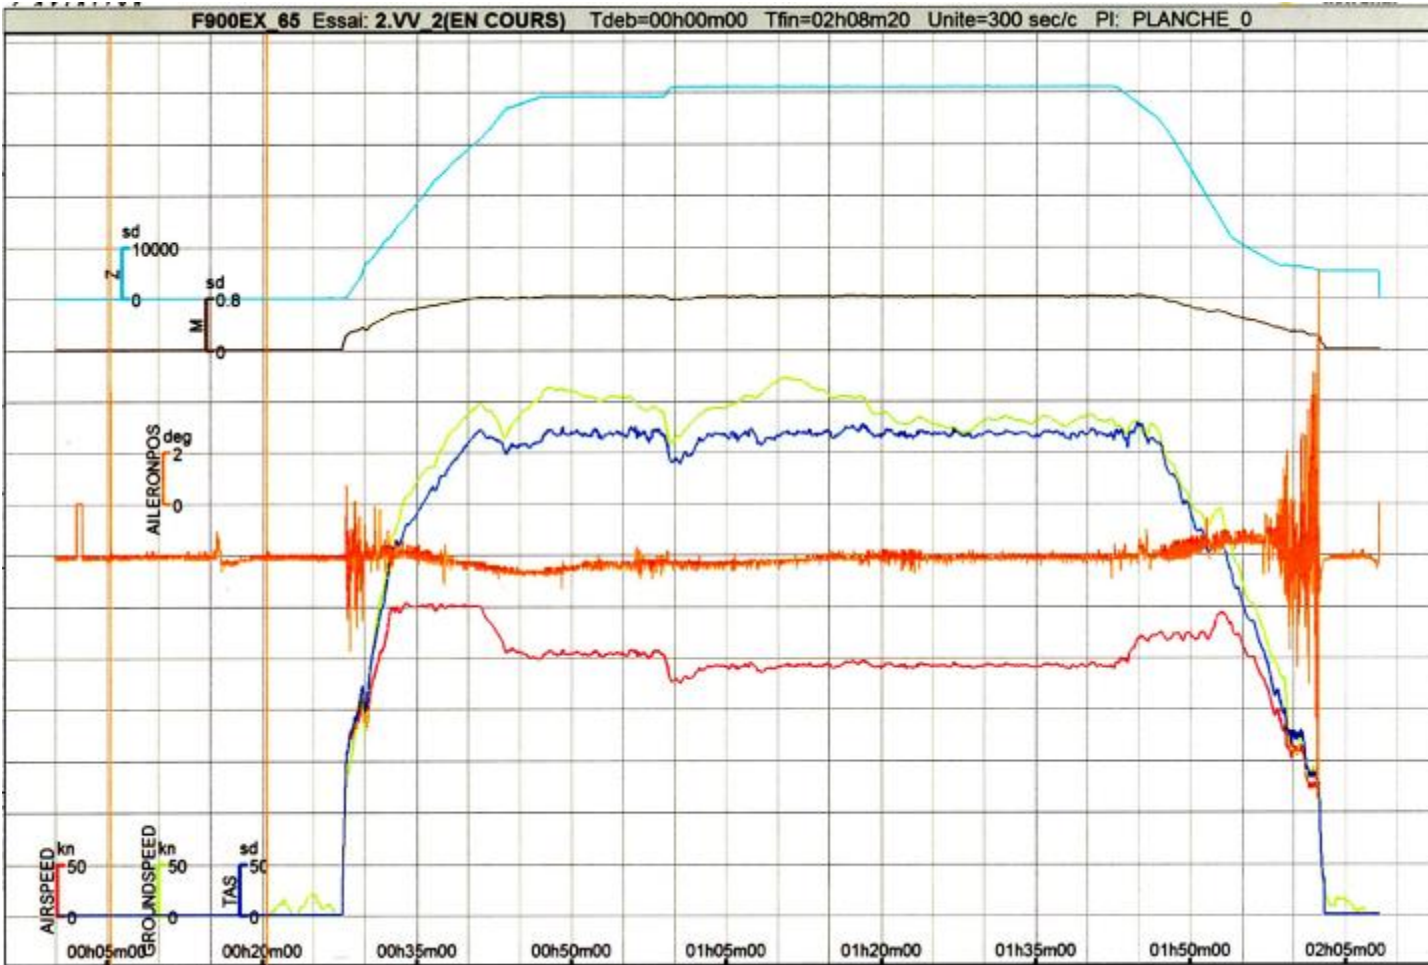
- 1.16.3 The orange line (Figure 15b below) displays the aileron input during the flight. During the final approach phase of the flight, these control surfaces displayed substantial inputs, which included several noticeable deflections of 11° and more.

Figure 15b: The orange line displays the aileron position during the flight with substantial input noted during the approach
