<b>AIRCRAFT ACCIDENT SHORT REPORT</b>
---------------------------------------

**CA18/2/3/9705: ZS-ROX, Decay in rotor revolutions per minute (RPM) during an out of ground effect hover turn after getting airborne from a confined area**

**Aircraft manufacturer and model** : Robinson Helicopter Company, R44 Raven II

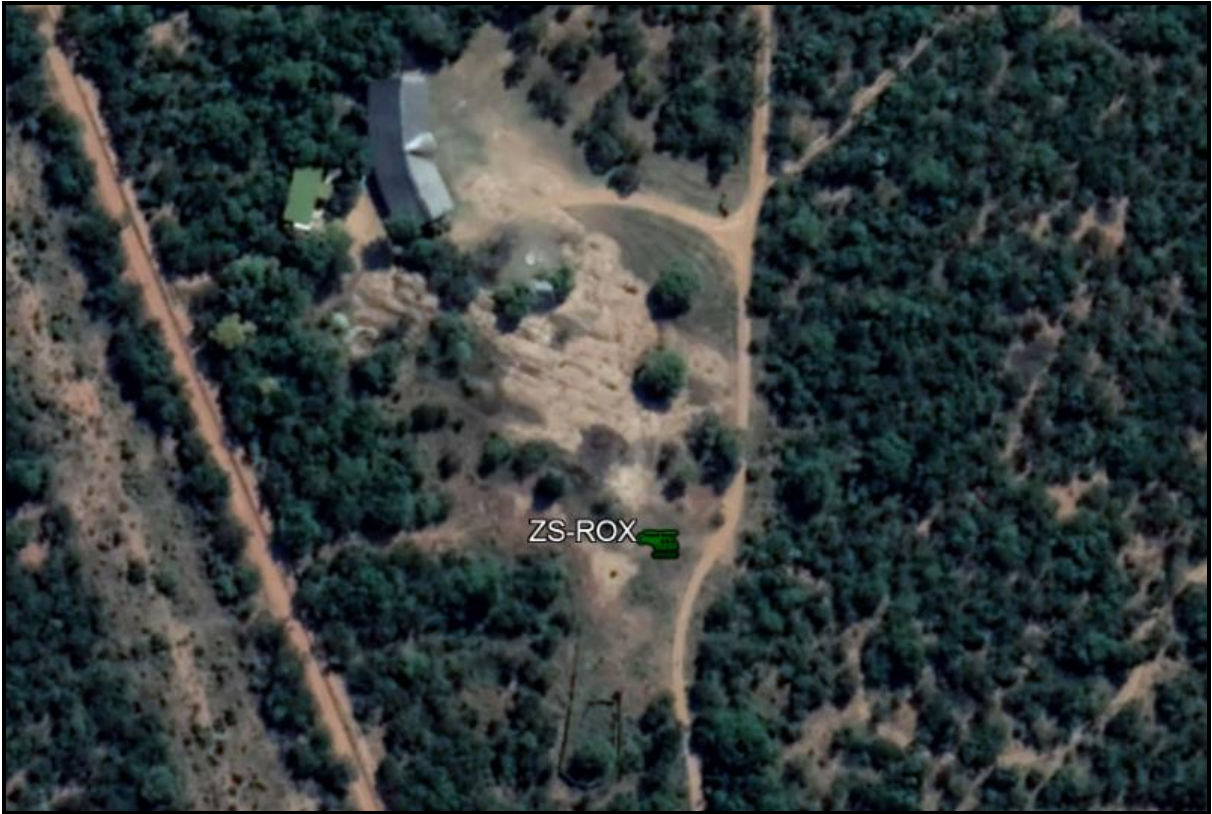
- 2.2 At 1400Z, the helicopter was facing north and the wind was coming from the south so the pilot took off into a hover and made a right pedal turn towards the south to face the wind. As the helicopter left ground effect, approximately 3 meters above the trees, it experienced low rotor RPM. The pilot immediately landed and the helicopter impacted hard with the ground.

Figure 1: Helicopter landing site

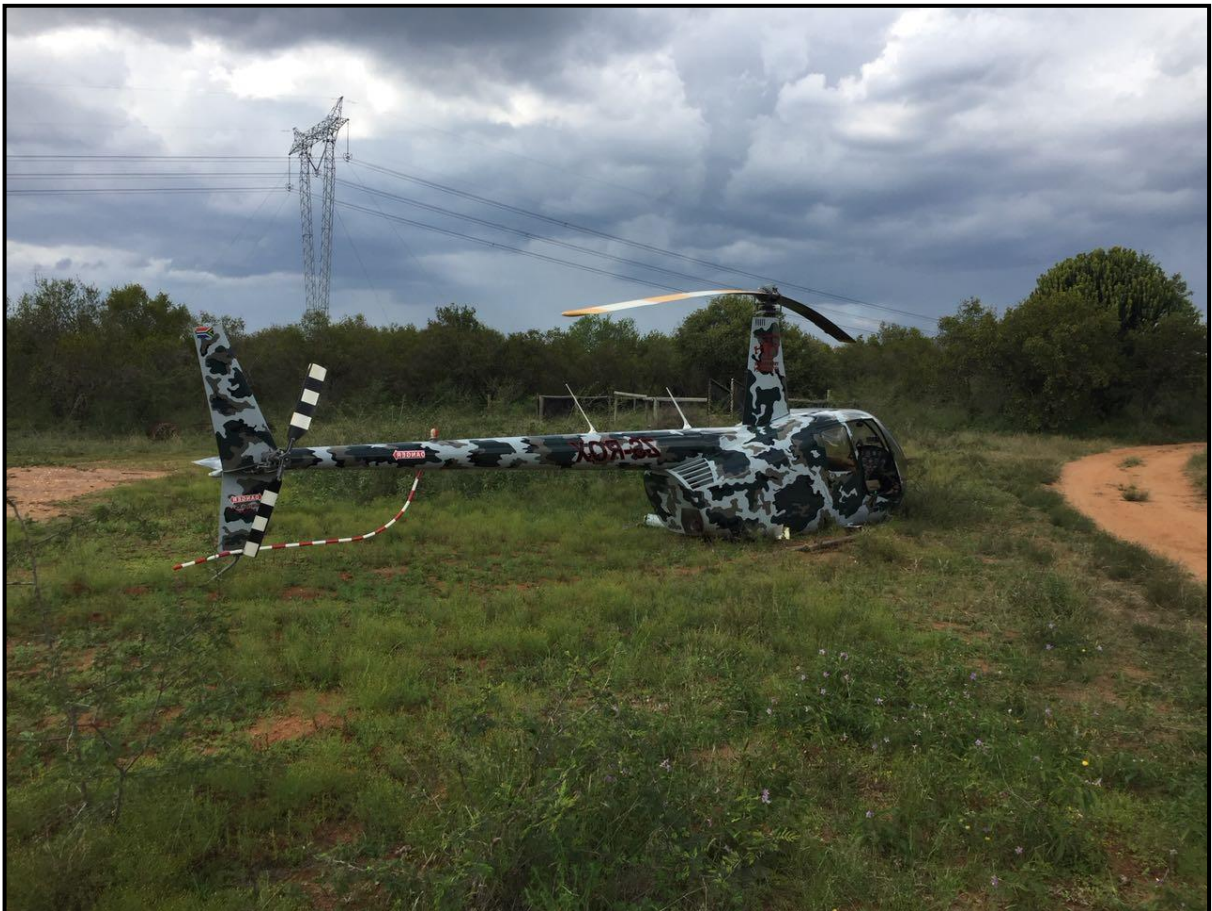
- 2.3 The helicopter sustained substantial damage during the hard landing. None of the occupants on board were injured.
- 2.4 The accident occurred during daylight conditions at a geographical position that was determined to be 25°30'15.12" South 027 47' 14.67" East at an elevation of 3 865ft above mean sea level (AMSL).

Figure 2: Aircraft after the accident

- 4.8 The weight of the helicopter at take-off was 2 298lb which was below the MTOW of 2 500lb.
- 4.9 The helicopter impacted hard with the ground and broke both skids following an emergency landing due to an undetermined decay in rotor RPM.

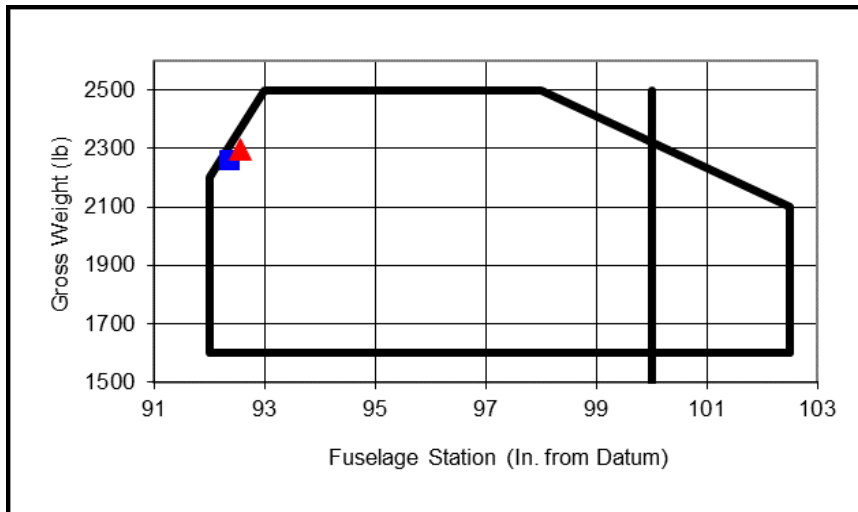
3.1 On the day of the accident, 25L of fuel was in the helicopter on take-off. The maximum take-off weight (MTOW) is 2 500 lbs and the helicopter weighed 2 298 lbs prior to take-off. The aircraft was being ferried to 1nm from its current position therefore 25L was adequate for it to reach its destination and the take-off weight was below its allowable maximum weight.

Figure 3: ZS-ROX weight and balance
